Manhole Inspection Report

Date:	04/27/2018	Weather:		Coding:	RZMACP
MH#:	M-706-032	Owner:	NA	Len. Surveyed:	9.2
P.O.#:		Surveyor:	Jen Costello	Rim to Invert:	8.8
Customer:		Cert. #:	U-907-5518	Wall Material:	Brick

Street:	Lake St. 159' South of 6th St.	Project:	Hobart, IN
City:	Hobart, IN	GPS Northing:	41.52854538
Location:		GPS Easting:	-87.2547226
Drain Area:	South	GPS Accuracy:	Nearest Meter
Cover Shape:	Circular	Evidence of Surcharge:	No
Cover Size:	22.5	Potential for Runoff:	None
Comments:

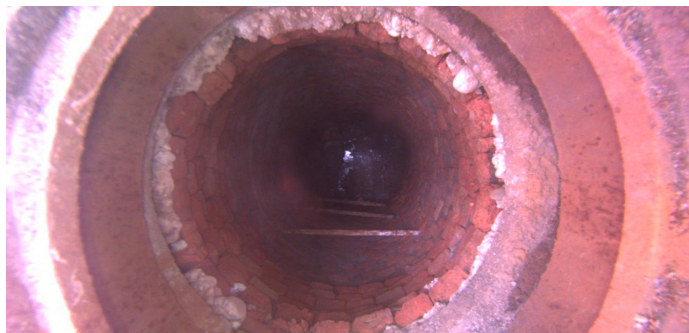
Code: **MGO**
Description: **General Observation**

Distance (ft): **.0**
Structural Grade: **0**
O&M Grade: **0**
Clock Start/From:
Clock To:
1st Value:
2nd Value:
Value Percent:
Step: **NO**
Remarks: **ACCESS MH**

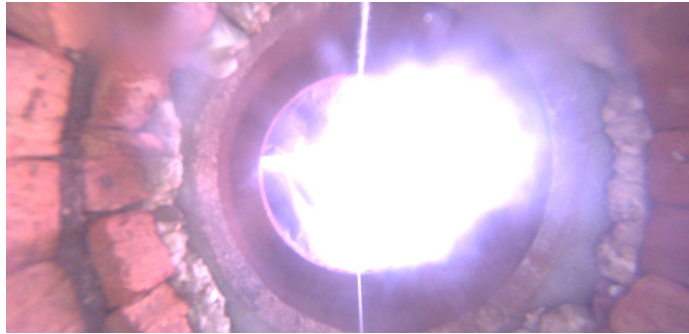
Code:	MGP
Description:	General Photo
Distance (ft):	2.6
Structural Grade:	0
O&M Grade:	0
Clock Start/From:	
Clock To:	
1st Value:	
2nd Value:	
Value Percent:	
Step:	NO
Remarks:	UNDERSIDE OF FRAME

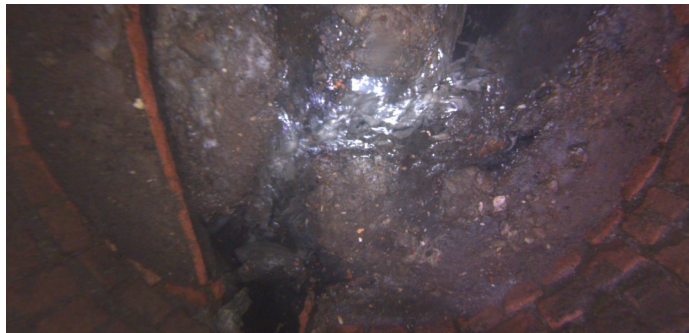
Code:	DSF
Description:	Deposits Settled Fine
Distance (ft):	8.2
Structural Grade:	0
O&M Grade:	2
Clock Start/From:	12
Clock To:	12
1st Value:	
2nd Value:	
Value Percent:	5.000
Step:	NO
Remarks:

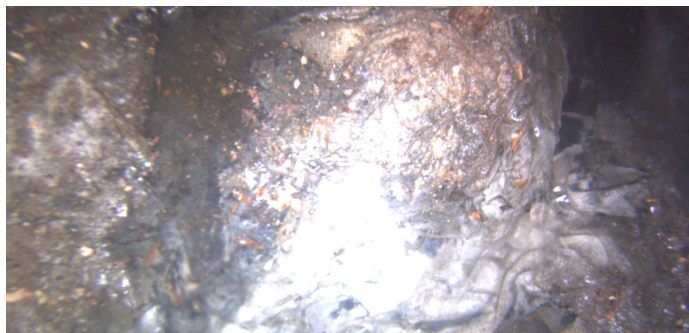
Code:	MGO
Description:	General Observation
Distance (ft):	9.2
Structural Grade:	0
O&M Grade:	0
Clock Start/From:	
Clock To:	
1st Value:	
2nd Value:	
Value Percent:	
Step:	NO
Remarks:	END SURVEY
