Manhole Inspection Report

Date:	04/27/2018	Weather:		Coding:	RZMACP
MH#:	M-706-033	Owner:	NA	Len. Surveyed:	8.9
P.O.#:		Surveyor:	Jen Costello	Rim to Invert:	7.6
Customer:		Cert. #:	U-907-5518	Wall Material:	Brick

Street:	Lake St. 321' North of 7th St.	Project:	Hobart, IN
City:	Hobart, IN	GPS Northing:	41.52801895
Location:		GPS Easting:	-87.2547226
Drain Area:	South	GPS Accuracy:	Nearest Meter
Cover Shape:	Circular	Evidence of Surcharge:	No
Cover Size:	22.5	Potential for Runoff:	None
Comments:

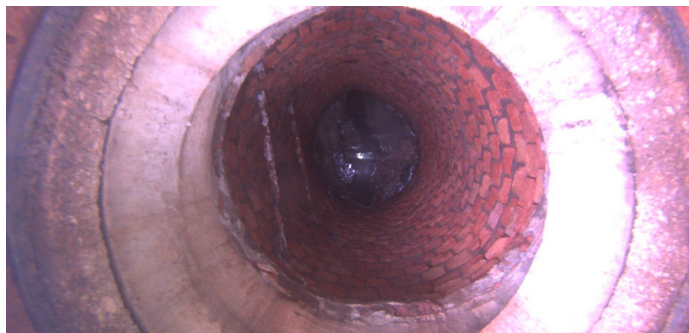
Code: **MGO**
Description: **General Observation**

Distance (ft): **1.1**
Structural Grade: **0**
O&M Grade: **0**
Clock Start/From:
Clock To:
1st Value:
2nd Value:
Value Percent:
Step: **NO**
Remarks: **ACCESS MH**

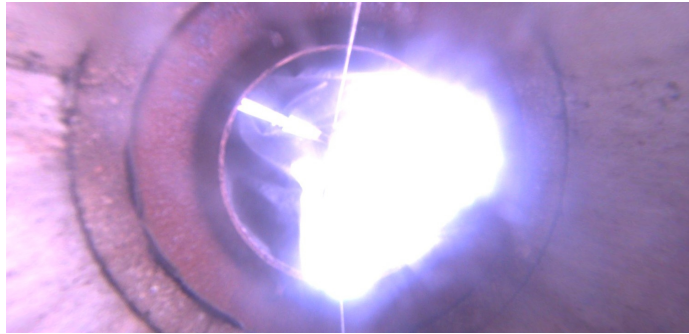
Code:	MGP
Description:	General Photo
Distance (ft):	2.7
Structural Grade:	0
O&M Grade:	0
Clock Start/From:	
Clock To:	
1st Value:	
2nd Value:	
Value Percent:	
Step:	NO
Remarks:	UNDERSIDE OF FRAME

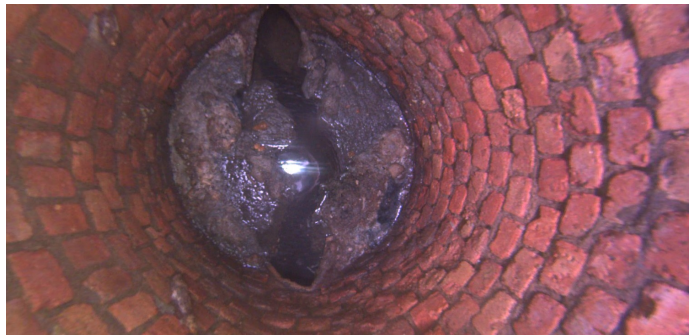
Code:	MGO
Description:	General Observation
Distance (ft):	5.7
Structural Grade:	0
O&M Grade:	0
Clock Start/From:	
Clock To:	
1st Value:	
2nd Value:	
Value Percent:	
Step:	NO
Remarks:	MISSING STEP

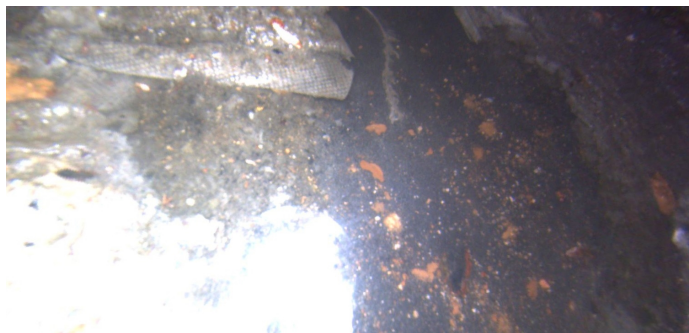
Code:	MGO
Description:	General Observation
Distance (ft):	8.9
Structural Grade:	0
O&M Grade:	0
Clock Start/From:	
Clock To:	
1st Value:	
2nd Value:	
Value Percent:	
Step:	NO
Remarks:	END SURVEY
