Manhole Inspection Report

Date:	04/27/2018	Weather:		Coding:	RZMACP
MH#:	M-706-037	Owner:	NA	Len. Surveyed:	8.6
P.O.#:		Surveyor:	Jen Costello	Rim to Invert:	7.5
Customer:		Cert. #:	U-907-5518	Wall Material:	Brick

Street:	Lake St. 333' South of 7th St.	Project:	Hobart, IN
City:	Hobart, IN	GPS Northing:	41.52632523
Location:		GPS Easting:	-87.25468445
Drain Area:	South	GPS Accuracy:	Nearest Meter
Cover Shape:	Circular	Evidence of Surcharge:	No
Cover Size:	22.5	Potential for Runoff:	None
Comments:

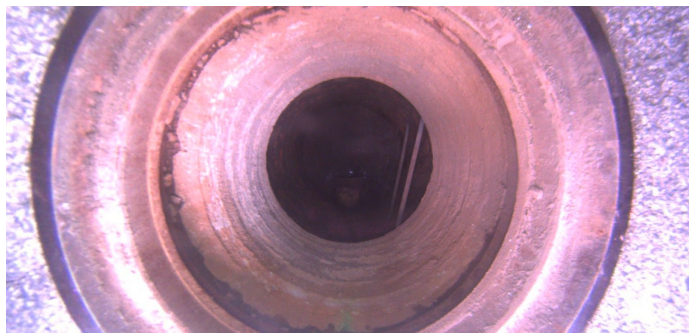
Code: **MGO**
Description: **General Observation**

Distance (ft): **.0**
Structural Grade: **0**
O&M Grade: **0**
Clock Start/From:
Clock To:
1st Value:
2nd Value:
Value Percent:
Step: **NO**
Remarks: **ACCESS MH**

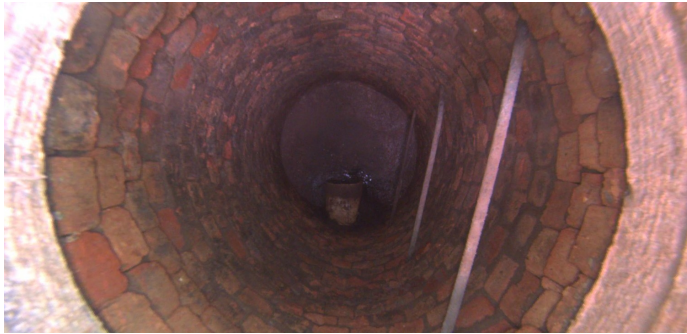
Code: **MMC**
Description: **Material Change**

Distance (ft): **2.3**
Structural Grade: **0**
O&M Grade: **0**
Clock Start/From:
Clock To:
1st Value:
2nd Value:
Value Percent:
Step: **NO**
Remarks: **BRICK**

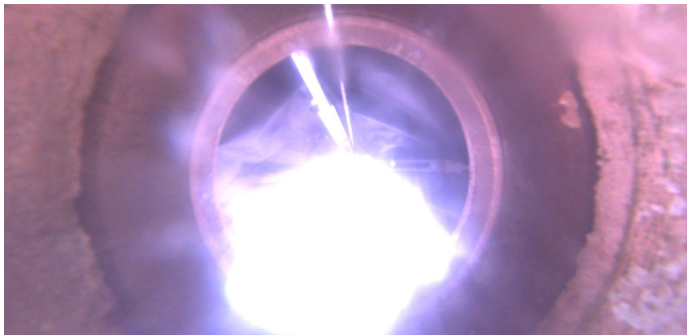
Code: **MGO**
Description: **General Observation**

Distance (ft): **2.3**
Structural Grade: **0**
O&M Grade: **0**
Clock Start/From:
Clock To:
1st Value:
2nd Value:
Value Percent:
Step: **NO**
Remarks: **UNDERSIDE OF FRAME**
