Manhole Inspection Report

| MH#: | M-706-039 | Owner: | NA | Len. Surveyed: | 6.8 |

| Street: | Water St. 195' South of 6th St. | Project: | Hobart, IN |

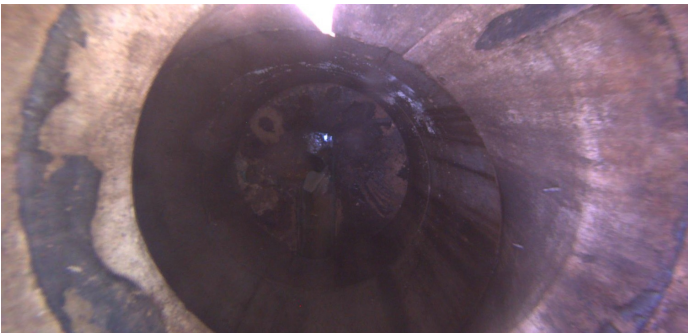
MGO

General Observation

ACCESS MH

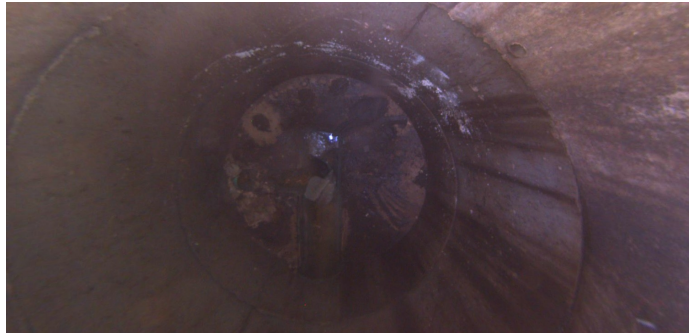
| | Position | Code | Observation | Video (sec) | Grade |
|---|---|---|---|---|---|
| | 1.9 | IW | Infil Weeper | 25 | M 2 |

Code: **IW**
Description: **Infil Weeper**

Distance (ft): **1.9**
Structural Grade: **0**
O&M Grade: **2**
Clock Start/From: **2**
Clock To: **6**
1st Value:
2nd Value:
Value Percent:
Step: **NO**
Remarks:

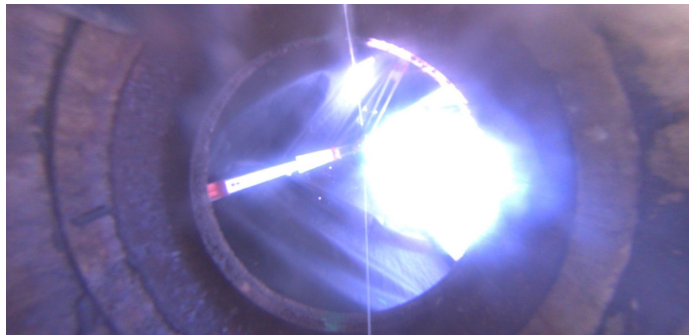
Code: **MGP**
Description: **General Photo**

Distance (ft): **2.2**
Structural Grade: **0**
O&M Grade: **0**
Clock Start/From:
Clock To:
1st Value:
2nd Value:
Value Percent:
Step: **NO**
Remarks: **UNDERSIDE OF FRAME**

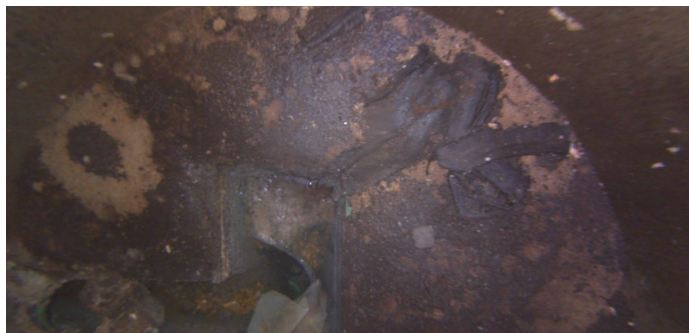
| | Position | Code | Observation | Video (sec) | Grade |
|---|---|---|---|---|---|
| | 5.5 | OBZ | Obstacle Other | 59 | M 2 |

Code: **OBZ**
Description: **Obstacle Other**

Distance (ft): **5.5**
Structural Grade: **0**
O&M Grade: **2**
Clock Start/From: **12**
Clock To: **2**
1st Value:
2nd Value:
Value Percent: **5.000**
Step: **NO**
Remarks: **MISC**

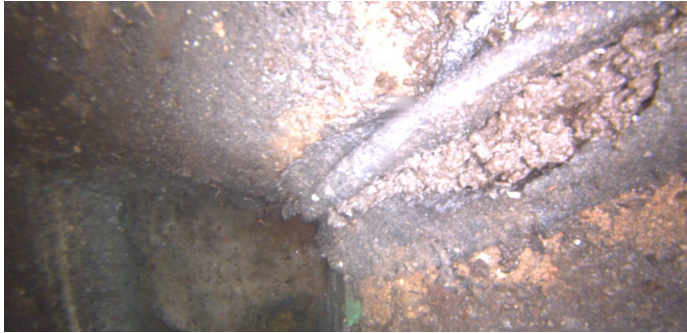
| Code: | MGO |
| Description: | General Observation |
| Remarks: | END SURVEY |
