# Manhole Inspection Report

Date:	04/27/2018	Weather:		Coding:	RZMACP
MH#:	M-706-043	Owner:	NA	Len. Surveyed:	3.2
P.O.#:		Surveyor:	Jen Costello	Rim to Invert:	2.5
Customer:		Cert. #:	U-907-5518	Wall Material:	Concrete (reinforced)

Street:	7th St. and Fleming St. to the East.	Project:	Hobart, IN
City:	Hobart, IN	GPS Northing:	41.52719879
Location:		GPS Easting:	-87.25649261
Drain Area:	South	GPS Accuracy:	Nearest Meter
Cover Shape:	Circular	Evidence of Surcharge:	No
Cover Size:	22.5	Potential for Runoff:	None
Comments:

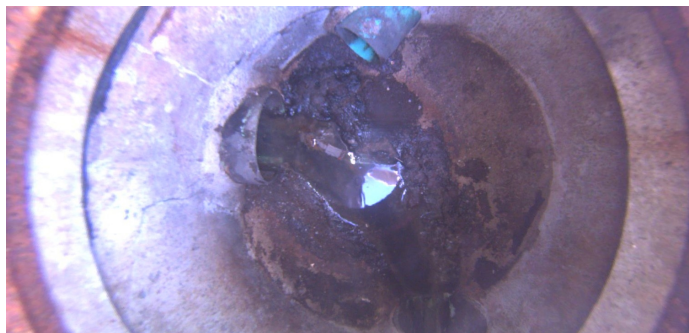
Code:	<b>MGO</b>
Description:	<b>General Observation</b>
Distance (ft):	<b>1.0</b>
Structural Grade:	<b>0</b>
O&M Grade:	<b>0</b>
Clock Start/From:	
Clock To:	
1st Value:	
2nd Value:	
Value Percent:	
Step:	<b>NO</b>
Remarks:	<b>ACCESS MH</b>

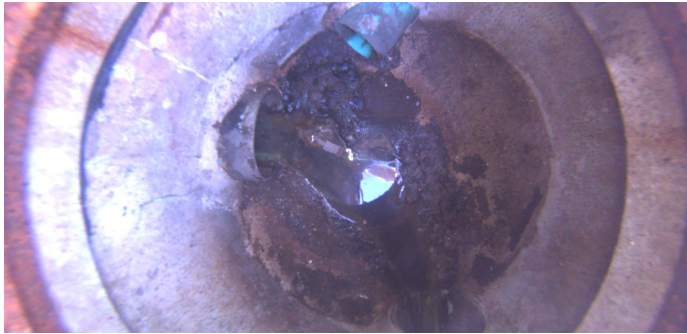
Code: **CM**  
Description: **Crack Multiple**

Distance (ft): **1.0**  
Structural Grade: **3**  
O&M Grade: **0**  
Clock Start/From: **9**  
Clock To: **10**  
1st Value:  
2nd Value:  
Value Percent:  
Step: **NO**  
Remarks:

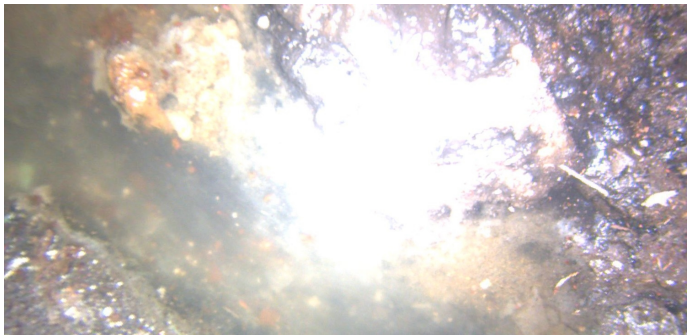
Code: **MGO**  
Description: **General Observation**

Distance (ft): **3.2**  
Structural Grade: **0**  
O&M Grade: **0**  
Clock Start/From:  
Clock To:  
1st Value:  
2nd Value:  
Value Percent:  
Step: **NO**  
Remarks: **END SURVEY**
