Manhole Inspection Report

Date:	04/29/2018	Weather:		Coding:	RZMACP
MH#:	M-706-049	Owner:	NA	Len. Surveyed:	6.5
P.O.#:		Surveyor:	Jen Costello	Rim to Invert:	6.3
Customer:		Cert. #:	U-907-5518	Wall Material:	Concrete (reinforced)

Street:	On Garfield St. 250' North of 8th St.	Project:	Hobart, IN
City:	Hobart, IN	GPS Northing:	41.52609634
Location:		GPS Easting:	-87.25106812
Drain Area:	South	GPS Accuracy:	Nearest Meter
Cover Shape:	Circular	Evidence of Surcharge:	No
Cover Size:	22.5	Potential for Runoff:	None
Comments:

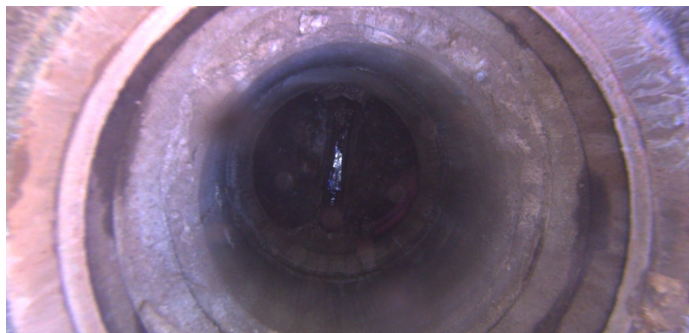
Code: **MGO**
Description: **General Observation**

Distance (ft): **.0**
Structural Grade: **0**
O&M Grade: **0**
Clock Start/From:
Clock To:
1st Value:
2nd Value:
Value Percent:
Step: **NO**
Remarks: **ACCESS MH**

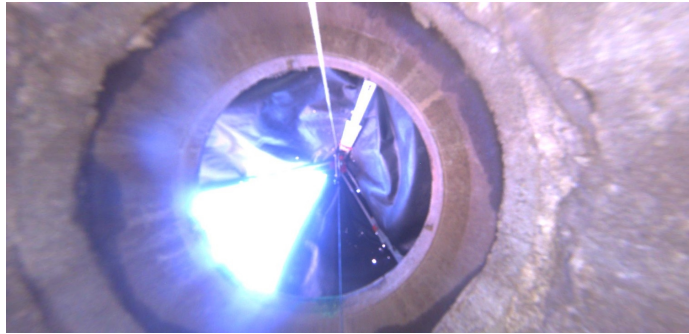
Code:	MGP
Description:	General Photo
Distance (ft):	1.8
Structural Grade:	0
O&M Grade:	0
Clock Start/From:	
Clock To:	
1st Value:	
2nd Value:	
Value Percent:	
Step:	NO
Remarks:	UNDERSIDE OF FRAME

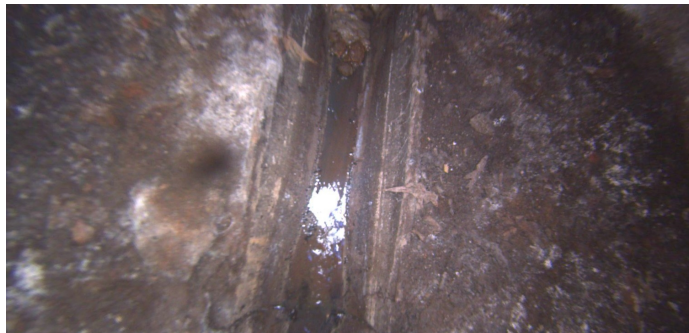
Code:	DSF
Description:	Deposits Settled Fine
Distance (ft):	5.3
Structural Grade:	0
O&M Grade:	2
Clock Start/From:	12
Clock To:	12
1st Value:	
2nd Value:	
Value Percent:	5.000
Step:	NO
Remarks:

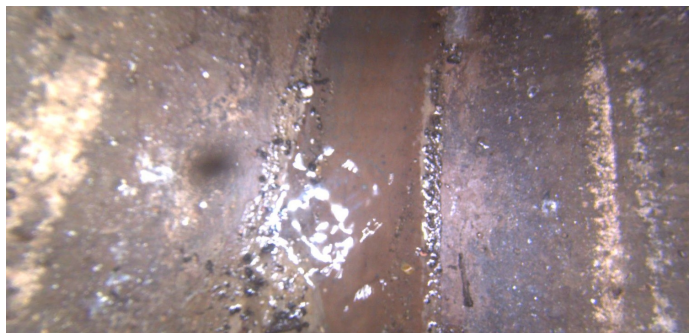
Code:	MGO
Description:	General Observation
Distance (ft):	6.5
Structural Grade:	0
O&M Grade:	0
Clock Start/From:	
Clock To:	
1st Value:	
2nd Value:	
Value Percent:	
Step:	NO
Remarks:	END SURVEY
