# Manhole Inspection Report

Date:	<b>04/23/2018</b>	Weather:		Coding:	<b>RZMACP</b>
MH#:	<b>M-706-051</b>	Owner:	<b>NA</b>	Len. Surveyed:	<b>3.0</b>
P.O.#:		Surveyor:	<b>John Kuglmaier</b>	Rim to Invert:	<b>2.7</b>
Customer:	<b>8.7</b>	Cert. #:	<b>U-1215-07002349</b>	Wall Material:	<b>Concrete (reinforced)</b>

Street:	<b>499' South of 8th St. 446' West of W</b>	Project:	<b>Hobart, IN</b>
City:	<b>Hobart, IN</b>	GPS Northing:	<b>0.0</b>
Location:		GPS Easting:	<b>0.0</b>
Drain Area:	<b>Southeast</b>	GPS Accuracy:	<b>Nearest Meter</b>
Cover Shape:	<b>Circular</b>	Evidence of Surcharge:	<b>No</b>
Cover Size:	<b>22.5</b>	Potential for Runoff:	<b>None</b>
Comments:

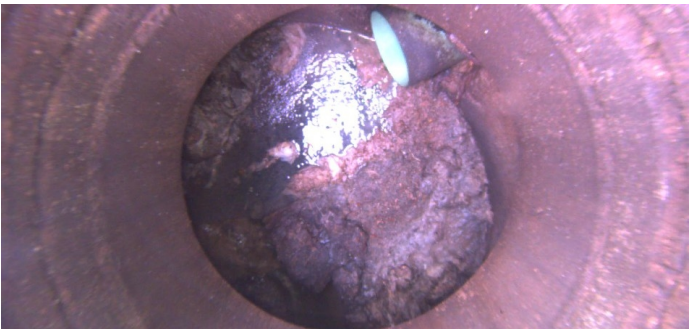
Code: **MGP**  
Description: **General Photo**

Distance (ft): **.0**  
Structural Grade: **0**  
O&M Grade: **0**  
Clock Start/From:  
Clock To:  
1st Value:  
2nd Value:  
Value Percent:  
Step: **NO**  
Remarks:

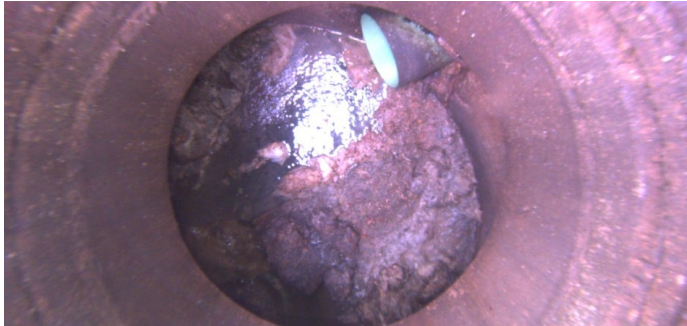
Code:	<b>DAZ</b>
Description:	<b>Deposits Attached Other</b>
Distance (ft):	<b>.2</b>
Structural Grade:	<b>0</b>
O&M Grade:	<b>3</b>
Clock Start/From:	<b>12</b>
Clock To:	<b>12</b>
1st Value:	
2nd Value:	
Value Percent:	<b>15.000</b>
Step:	<b>NO</b>
Remarks:	<b>Mixed materials</b>

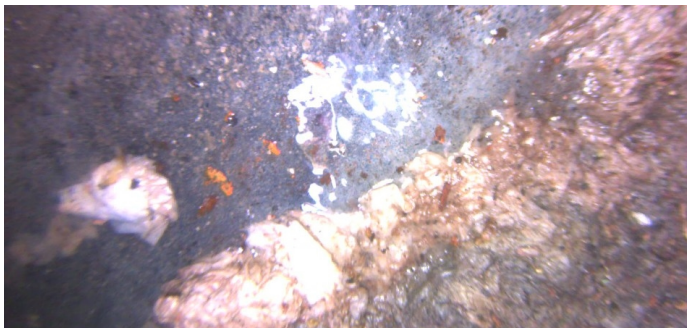
Code:	<b>MGO</b>
Description:	<b>General Observation</b>
Distance (ft):	<b>2.5</b>
Structural Grade:	<b>0</b>
O&M Grade:	<b>0</b>
Clock Start/From:	
Clock To:	
1st Value:	
2nd Value:	
Value Percent:	
Step:	<b>NO</b>
Remarks:	<b>Ins. Comp.</b>
