Manhole Inspection Report

Date:	04/23/2018	Weather:		Coding:	RZMACP
MH#:	M-706-052	Owner:	NA	Len. Surveyed:	4.0
P.O.#:		Surveyor:	John Kuglmaier	Rim to Invert:	4.6
Customer:	8.7	Cert. #:	U-1215-07002349	Wall Material:	Concrete (reinforced)

Street:	596' South of 8th St. 314' East of Lak	Project:	Hobart, IN
City:	Hobart, IN	GPS Northing:	0.0
Location:		GPS Easting:	0.0
Drain Area:	Southeast	GPS Accuracy:	Nearest Meter
Cover Shape:	Circular	Evidence of Surcharge:	Yes
Cover Size:	22.5	Potential for Runoff:	None
Comments:

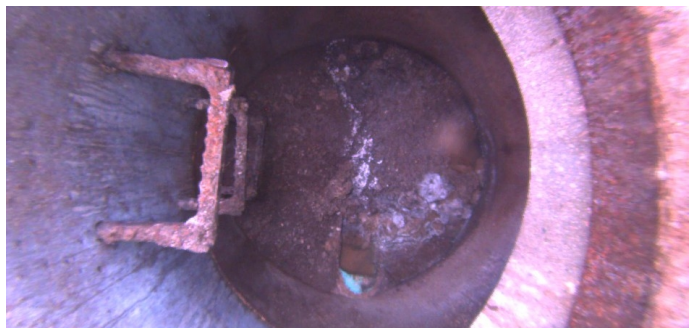
Code: **MGP**
Description: **General Photo**

Distance (ft): **.0**
Structural Grade: **0**
O&M Grade: **0**
Clock Start/From:
Clock To:
1st Value:
2nd Value:
Value Percent:
Step: **NO**
Remarks:

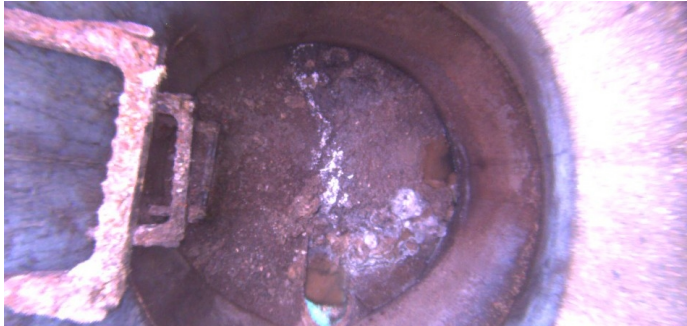
Code: **IS**
Description: **Infil Stain**

Distance (ft): **.6**
Structural Grade: **0**
O&M Grade: **0**
Clock Start/From: **12**
Clock To: **12**
1st Value:
2nd Value:
Value Percent:
Step: **NO**
Remarks:

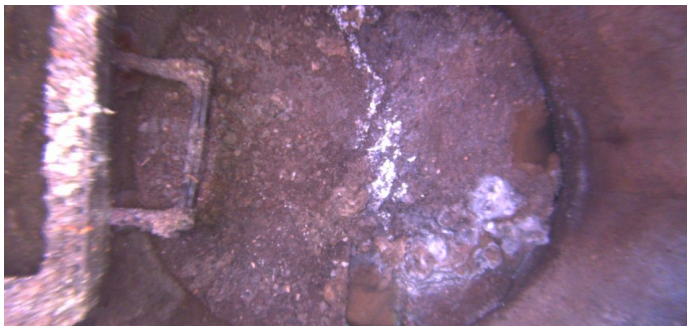
Code: **DAZ**
Description: **Deposits Attached Other**

Distance (ft): **1.8**
Structural Grade: **0**
O&M Grade: **3**
Clock Start/From: **12**
Clock To: **12**
1st Value:
2nd Value:
Value Percent: **15.000**
Step: **NO**
Remarks: **Mixed materials**

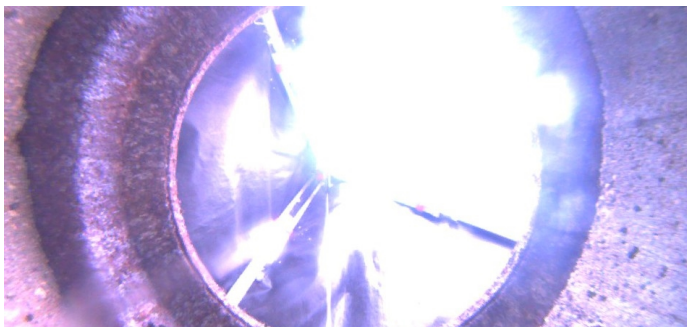
Code: **MGP**
Description: **General Photo**

Distance (ft): **2.1**
Structural Grade: **0**
O&M Grade: **0**
Clock Start/From:
Clock To:
1st Value:
2nd Value:
Value Percent:
Step: **NO**
Remarks:

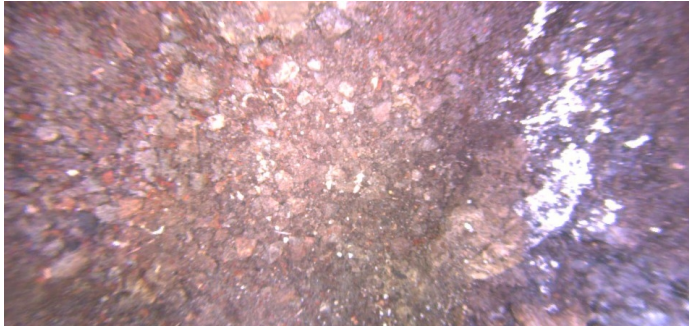
Code:	MGO
Description:	General Observation
Distance (ft):	3.4
Structural Grade:	0
O&M Grade:	0
Clock Start/From:	
Clock To:	
1st Value:	
2nd Value:	
Value Percent:	
Step:	NO
Remarks:	Ins. Comp.
