Manhole Inspection Report

Date:	04/23/2018	Weather:		Coding:	RZMACP
MH#:	M-706-053	Owner:	NA	Len. Surveyed:	2.5
P.O.#:		Surveyor:	John Kuglmaier	Rim to Invert:	3.1
Customer:	8.7	Cert. #:	U-1215-07002349	Wall Material:	Concrete (reinforced)

Street:	710' South of 8th St. 266' West of W	Project:	Hobart, IN
City:	Hobart, IN	GPS Northing:	0.0
Location:		GPS Easting:	0.0
Drain Area:	Southeast	GPS Accuracy:	Nearest Meter
Cover Shape:	Circular	Evidence of Surcharge:	No
Cover Size:	22.5	Potential for Runoff:	None
Comments:

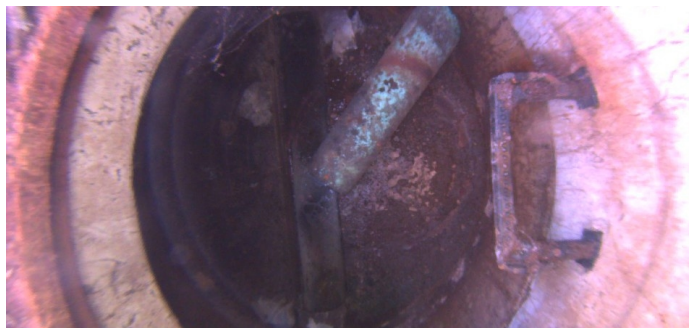
Code: **MGP**
Description: **General Photo**

Distance (ft): **.0**
Structural Grade: **0**
O&M Grade: **0**
Clock Start/From:
Clock To:
1st Value:
2nd Value:
Value Percent:
Step: **NO**
Remarks:

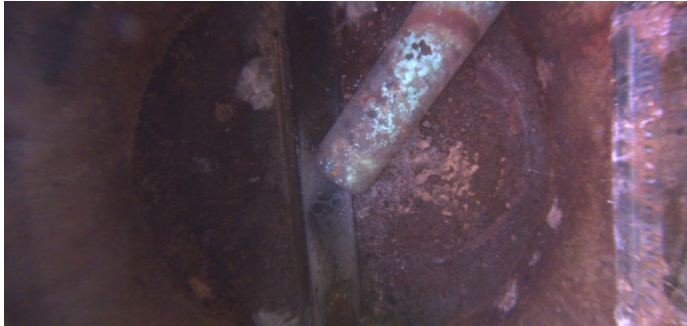
Code:	DSF
Description:	Deposits Settled Fine
Distance (ft):	.8
Structural Grade:	0
O&M Grade:	2
Clock Start/From:	12
Clock To:	12
1st Value:	
2nd Value:	
Value Percent:	5.000
Step:	NO
Remarks:

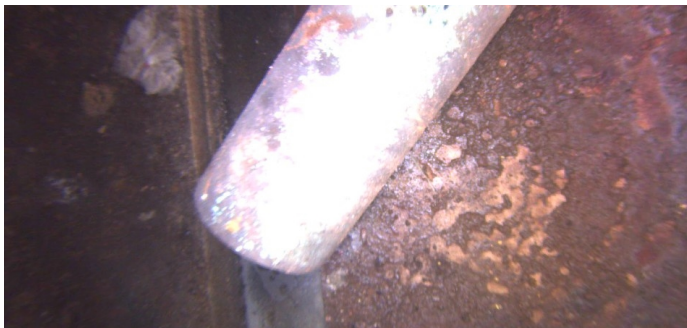
Code:	MGO
Description:	General Observation
Distance (ft):	2.1
Structural Grade:	0
O&M Grade:	0
Clock Start/From:	
Clock To:	
1st Value:	
2nd Value:	
Value Percent:	
Step:	NO
Remarks:	Ins. Comp.
