Manhole Inspection Report

Date:	04/23/2018	Weather:		Coding:	RZMACP
MH#:	M-706-054	Owner:	NA	Len. Surveyed:	2.9
P.O.#:		Surveyor:	John Kuglmaier	Rim to Invert:	3.1
Customer:	8.7	Cert. #:	U-1215-07002349	Wall Material:	Concrete (reinforced)

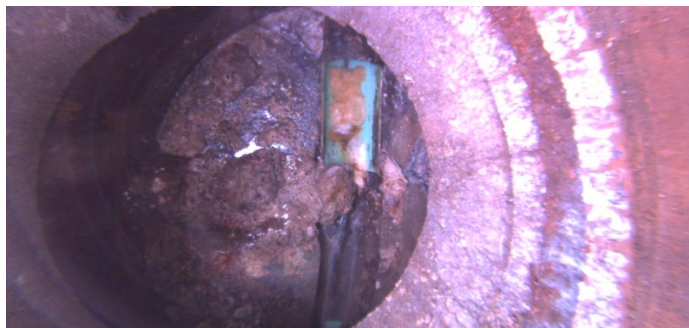
Code: **MGP**
Description: **General Photo**

Distance (ft): **.0**
Structural Grade: **0**
O&M Grade: **0**
Clock Start/From:
Clock To:
1st Value:
2nd Value:
Value Percent:
Step: **NO**
Remarks:

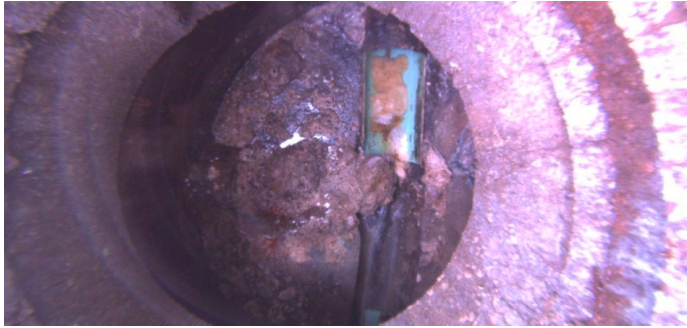
Code:	DAZ
Description:	Deposits Attached Other
Distance (ft):	.0
Structural Grade:	0
O&M Grade:	3
Clock Start/From:	12
Clock To:	12
1st Value:	
2nd Value:	
Value Percent:	15.000
Step:	NO
Remarks:	Mixed materials

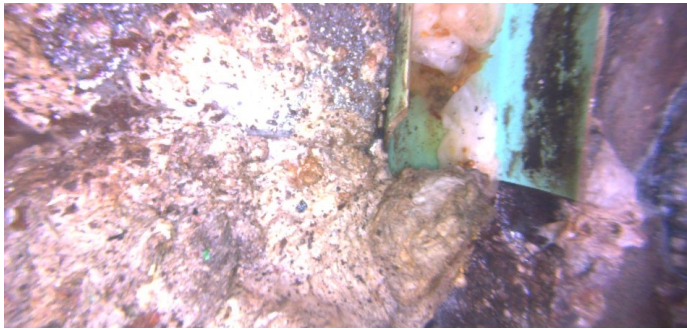
Code:	MGO
Description:	General Observation
Distance (ft):	2.4
Structural Grade:	0
O&M Grade:	0
Clock Start/From:	
Clock To:	
1st Value:	
2nd Value:	
Value Percent:	
Step:	NO
Remarks:	Ins. Comp.
