Manhole Inspection Report

Street:	599' North of 10th St. 293' East of La	Project:	Hobart, IN
City:	Hobart, IN	GPS Northing:	0.0
Location:		GPS Easting:	0.0
Drain Area:	Southeast	GPS Accuracy:	Nearest Meter
Cover Shape:	Circular	Evidence of Surcharge:	Yes
Cover Size:	22.5	Potential for Runoff:	None
Comments:

M-706-056

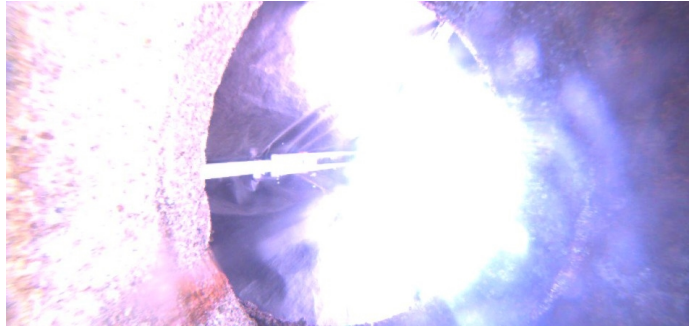
Code:	MGP
Description:	General Photo

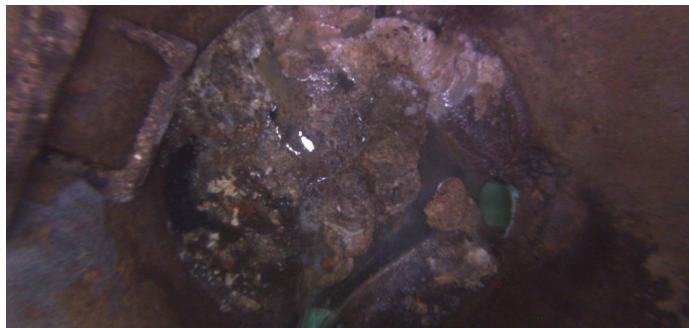
Code: **MGP**
Description: **General Photo**

Distance (ft): **2.1**
Structural Grade: **0**
O&M Grade: **0**
Clock Start/From:
Clock To:
1st Value:
2nd Value:
Value Percent:
Step: **NO**
Remarks:

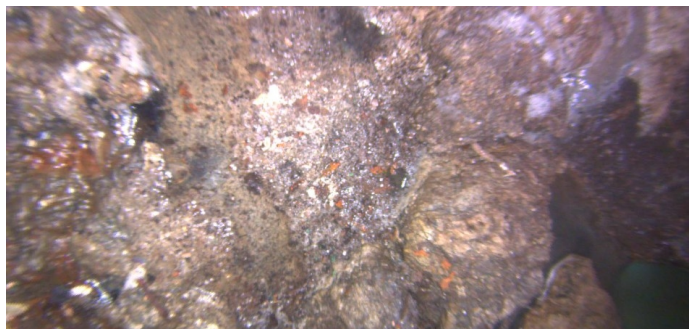
Code: **DAZ**
Description: **Deposits Attached Other**

Distance (ft): **2.8**
Structural Grade: **0**
O&M Grade: **3**
Clock Start/From: **12**
Clock To: **12**
1st Value:
2nd Value:
Value Percent: **20.000**
Step: **NO**
Remarks: **Mixed materials**
