# Manhole Inspection Report

Date:	<b>04/27/2018</b>	Weather:		Coding:	<b>RZMACP</b>
MH#:	<b>M-706-058</b>	Owner:	<b>NA</b>	Len. Surveyed:	<b>12.2</b>
P.O.#:		Surveyor:	<b>Jen Costello</b>	Rim to Invert:	<b>12.0</b>
Customer:		Cert. #:	<b>U-907-5518</b>	Wall Material:	<b>Concrete (reinforced)</b>

Street:	<b>On 10th St. 91' East of Lake Park Ave</b>	Project:	<b>Hobart, IN</b>
City:	<b>Hobart, IN</b>	GPS Northing:	<b>41.52181625</b>
Location:		GPS Easting:	<b>-87.25911713</b>
Drain Area:	<b>Southeast</b>	GPS Accuracy:	<b>Nearest Meter</b>
Cover Shape:	<b>Circular</b>	Evidence of Surcharge:	<b>No</b>
Cover Size:	<b>22.5</b>	Potential for Runoff:	<b>None</b>
Comments:

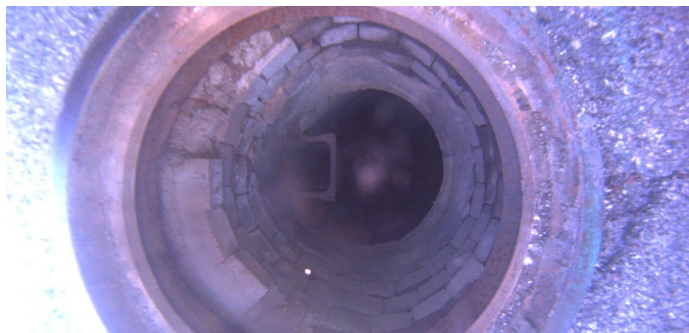
Code: **MGO**  
Description: **General Observation**

Distance (ft): **.0**  
Structural Grade: **0**  
O&M Grade: **0**  
Clock Start/From:  
Clock To:  
1st Value:  
2nd Value:  
Value Percent:  
Step: **NO**  
Remarks: **ACCESS MH**

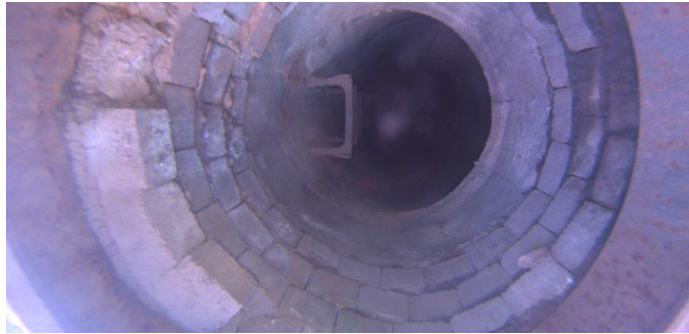
Code: **DB**  
Description: **Displaced Brick**

Distance (ft): **.6**  
Structural Grade: **3**  
O&M Grade: **0**  
Clock Start/From: **7**  
Clock To: **9**  
1st Value:  
2nd Value:  
Value Percent:  
Step: **NO**  
Remarks:

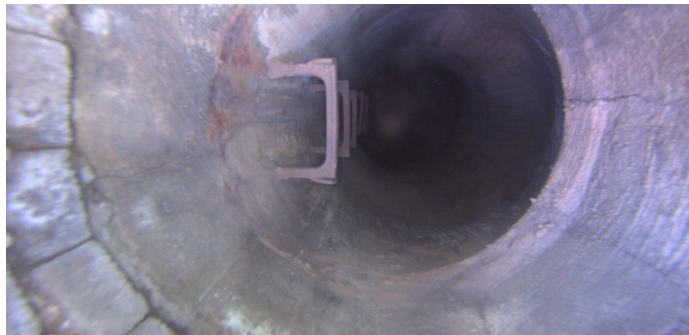
Code: **FL**  
Description: **Fracture Longitudinal**

Distance (ft): **1.9**  
Structural Grade: **3**  
O&M Grade: **0**  
Clock Start/From: **3**  
Clock To:  
1st Value:  
2nd Value:  
Value Percent:  
Step: **NO**  
Remarks:

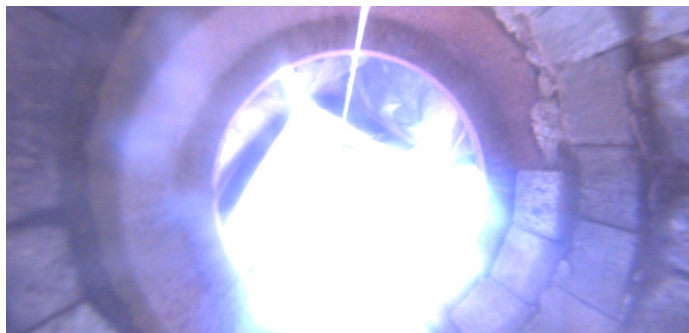
Code: **MGP**  
Description: **General Photo**

Distance (ft): **2.4**  
Structural Grade: **0**  
O&M Grade: **0**  
Clock Start/From:  
Clock To:  
1st Value:  
2nd Value:  
Value Percent:  
Step: **NO**  
Remarks: **UNDERSIDE OF FRAME**

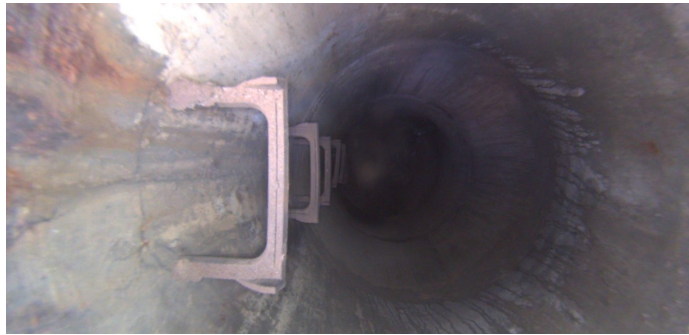
Code: **MMC**  
Description: **Material Change**

Distance (ft): **2.6**  
Structural Grade: **0**  
O&M Grade: **0**  
Clock Start/From:  
Clock To:  
1st Value:  
2nd Value:  
Value Percent:  
Step: **NO**  
Remarks: **CONCRETE**

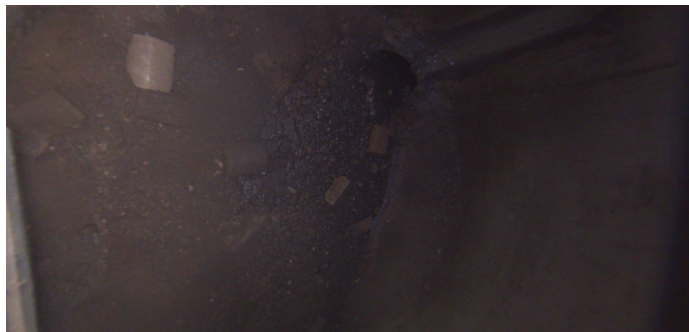
Code: **IW**  
Description: **Infil Weeper**

Distance (ft): **11.1**  
Structural Grade: **0**  
O&M Grade: **2**  
Clock Start/From: **2**  
Clock To:  
1st Value:  
2nd Value:  
Value Percent:  
Step: **NO**  
Remarks:

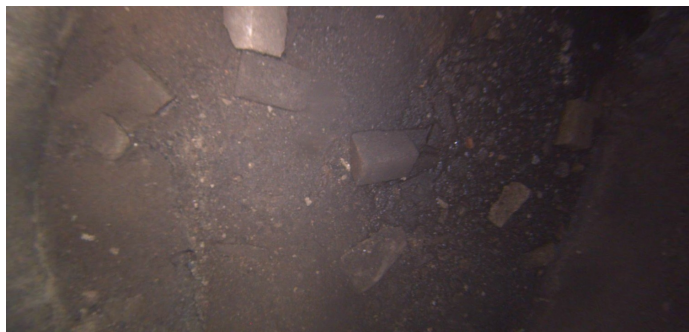
Code: **OBR**  
Description: **Obstacle Rocks**

Distance (ft): **12.0**  
Structural Grade: **0**  
O&M Grade: **2**  
Clock Start/From: **6**  
Clock To: **12**  
1st Value:  
2nd Value:  
Value Percent: **5.000**  
Step: **NO**  
Remarks:

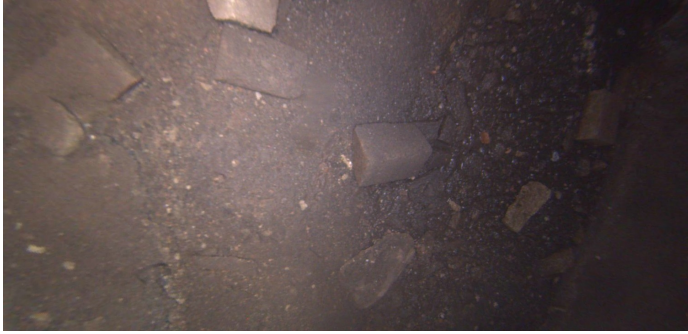
Code: **DSF**  
Description: **Deposits Settled Fine**

Distance (ft): **12.2**  
Structural Grade: **0**  
O&M Grade: **5**  
Clock Start/From: **3**  
Clock To: **9**  
1st Value:  
2nd Value:  
Value Percent: **40.000**  
Step: **NO**  
Remarks:

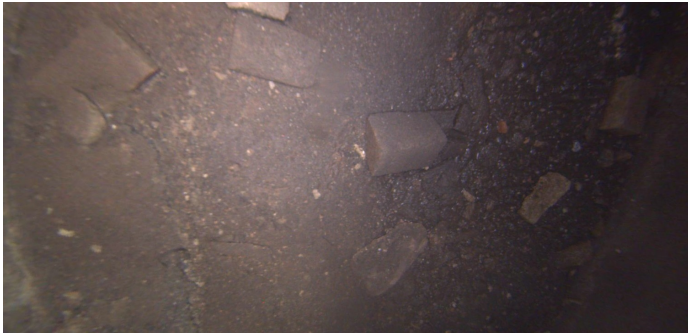
Code: **MGO**  
Description: **General Observation**

Distance (ft): **12.2**  
Structural Grade: **0**  
O&M Grade: **0**  
Clock Start/From:  
Clock To:  
1st Value:  
2nd Value:  
Value Percent:  
Step: **NO**  
Remarks: **END SURVEY**
