# Manhole Inspection Report

Date:	<b>04/23/2018</b>	Weather:		Coding:	<b>RZMACP</b>
MH#:	<b>M-706-061</b>	Owner:	<b>NA</b>	Len. Surveyed:	<b>7.0</b>
P.O.#:		Surveyor:	<b>John Kuglmaier</b>	Rim to Invert:	<b>7.1</b>
Customer:	<b>8.7</b>	Cert. #:	<b>U-1215-07002349</b>	Wall Material:	<b>Concrete (reinforced)</b>

Street:	<b>358' North of 10th St. 177' East of La</b>	Project:	<b>Hobart, IN</b>
City:	<b>Hobart, IN</b>	GPS Northing:	<b>0.0</b>
Location:		GPS Easting:	<b>0.0</b>
Drain Area:	<b>Southeast</b>	GPS Accuracy:	<b>Nearest Meter</b>
Cover Shape:	<b>Circular</b>	Evidence of Surcharge:	<b>No</b>
Cover Size:	<b>26.0</b>	Potential for Runoff:	<b>None</b>
Comments:

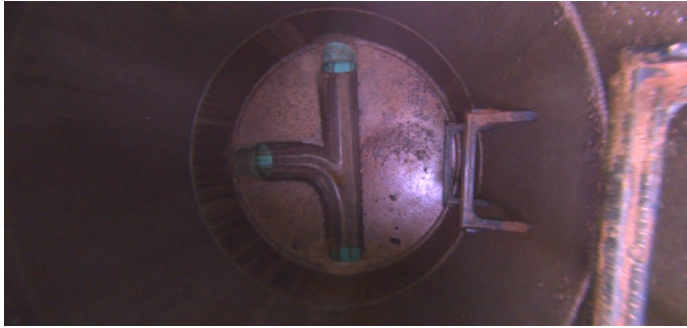
Code: **IS**  
Description: **Infil Stain**

Distance (ft): **2.1**  
Structural Grade: **0**  
O&M Grade: **0**  
Clock Start/From: **12**  
Clock To: **12**  
1st Value:  
2nd Value:  
Value Percent:  
Step: **NO**  
Remarks:

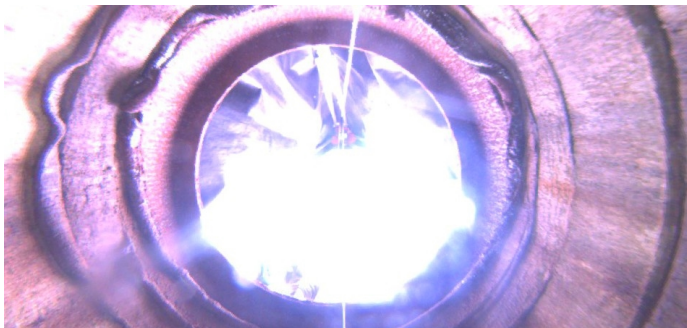
Code: **MGP**  
Description: **General Photo**

Distance (ft): **2.7**  
Structural Grade: **0**  
O&M Grade: **0**  
Clock Start/From:  
Clock To:  
1st Value:  
2nd Value:  
Value Percent:  
Step: **NO**  
Remarks:

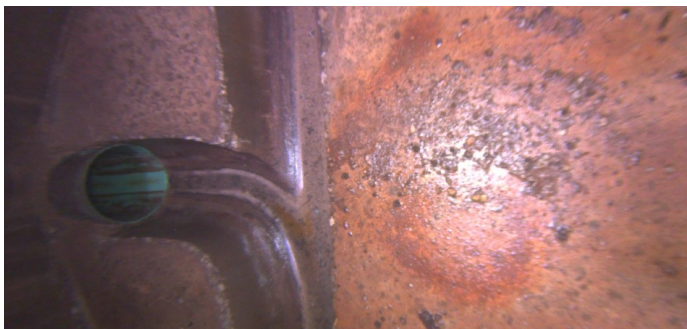
Code: **MGO**  
Description: **General Observation**

Distance (ft): **5.8**  
Structural Grade: **0**  
O&M Grade: **0**  
Clock Start/From:  
Clock To:  
1st Value:  
2nd Value:  
Value Percent:  
Step: **NO**  
Remarks: **Ins. Comp.**
