Manhole Inspection Report

Date:	04/26/2018	Weather:		Coding:	RZMACP
MH#:	M-706-062	Owner:	NA	Len. Surveyed:	7.5
P.O.#:		Surveyor:	Jen Costello	Rim to Invert:	7.7
Customer:		Cert. #:	U-907-5518	Wall Material:	Concrete (reinforced)

Street:	Debbie Ln. and Lake Park Ave.	Project:	Hobart, IN
City:	Hobart, IN	GPS Northing:	2904546.615
Location:		GPS Easting:	2904546.615
Drain Area:	Southeast	GPS Accuracy:	Sub-Meter
Cover Shape:	Circular	Evidence of Surcharge:	No
Cover Size:	22.5	Potential for Runoff:	None
Comments:

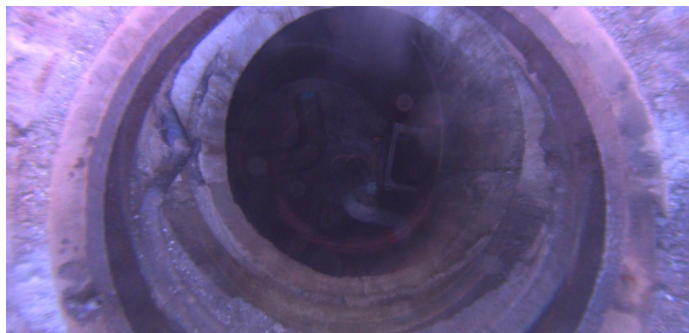
Code: **MGO**

Description: **General Observation**

Distance (ft): **.0**

Remarks: **ACCESS MH**

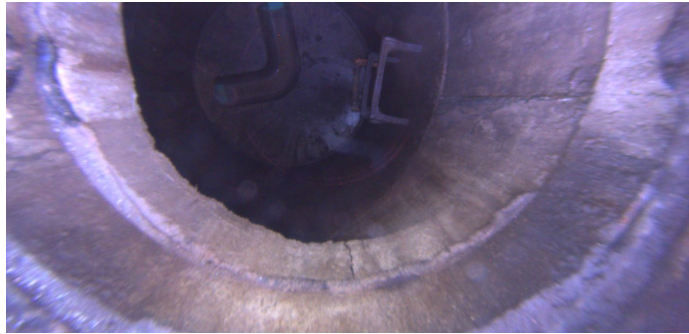
Code: **FL**
Description: **Fracture Longitudinal**

Distance (ft): **.8**
Structural Grade: **3**
O&M Grade: **0**
Clock Start/From: **6**
Clock To:
1st Value:
2nd Value:
Value Percent:
Step: **NO**
Remarks:

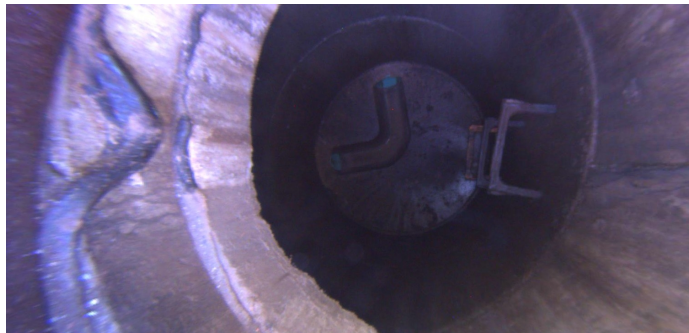
Code: **ISSR**
Description: **Intruding Sealing Ring**

Distance (ft): **1.0**
Structural Grade: **0**
O&M Grade: **2**
Clock Start/From: **9**
Clock To: **10**
1st Value:
2nd Value:
Value Percent: **5.000**
Step: **NO**
Remarks:

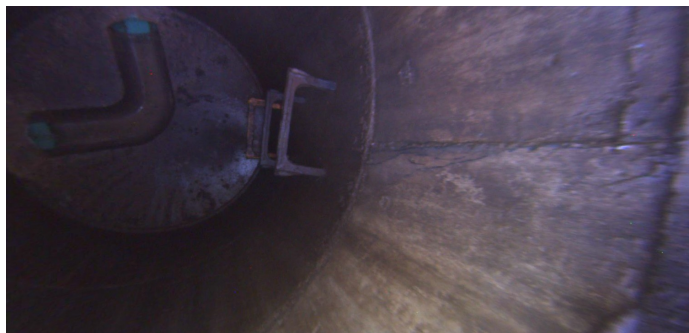
Code: **RFB**
Description: **Roots Fine Barrel**

Distance (ft): **1.5**
Structural Grade: **0**
O&M Grade: **2**
Clock Start/From: **3**
Clock To:
1st Value:
2nd Value:
Value Percent:
Step: **NO**
Remarks:

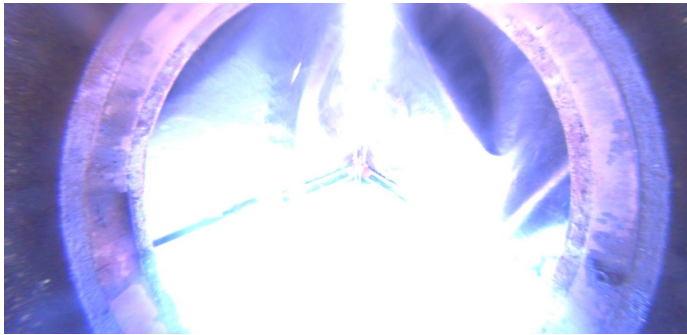
Code:	MGO
Description:	General Observation
Distance (ft):	1.8
Structural Grade:	0
O&M Grade:	0
Clock Start/From:	
Clock To:	
1st Value:	
2nd Value:	
Value Percent:	
Step:	NO
Remarks:	UNDERSIDE OF FRAME

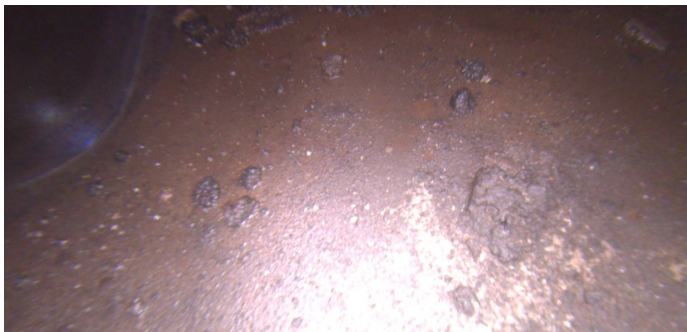
Code:	MGO
Description:	General Observation
Distance (ft):	7.5
Structural Grade:	0
O&M Grade:	0
Clock Start/From:	
Clock To:	
1st Value:	
2nd Value:	
Value Percent:	
Step:	NO
Remarks:	END SURVEY
