Manhole Inspection Report

Date:	04/26/2018	Weather:		Coding:	RZMACP
MH#:	M-706-063	Owner:	NA	Len. Surveyed:	8.3
P.O.#:		Surveyor:	Jen Costello	Rim to Invert:	8.0
Customer:		Cert. #:	U-907-5518	Wall Material:	Concrete (reinforced)

Street:	On Lake Park Ave. 71' South of Debb	Project:	Hobart, IN
City:	Hobart, IN	GPS Northing:	2904546.05
Location:		GPS Easting:	2904546.05
Drain Area:	Southeast	GPS Accuracy:	Sub-Meter
Cover Shape:	Circular	Evidence of Surcharge:	No
Cover Size:	22.5	Potential for Runoff:	None
Comments:

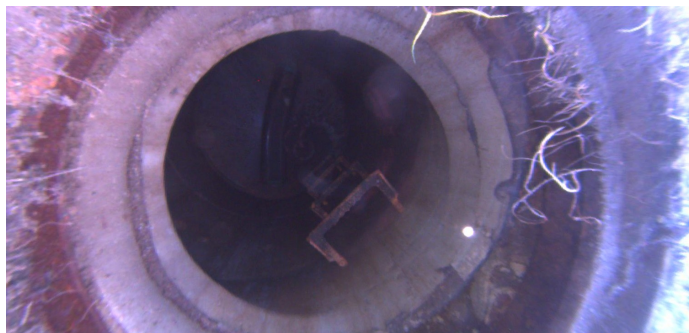
Code: **MGO**
Description: **General Observation**

Distance (ft): **.0**
Structural Grade: **0**
O&M Grade: **0**
Clock Start/From:
Clock To:
1st Value:
2nd Value:
Value Percent:
Step: **NO**
Remarks: **ACCESS MH**

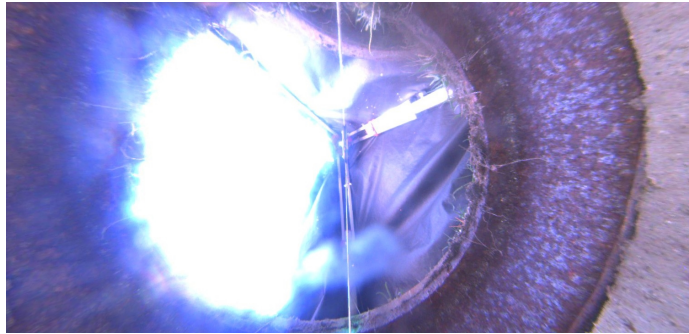
Code:	MGO
Description:	General Observation
Distance (ft):	2.1
Structural Grade:	0
O&M Grade:	0
Clock Start/From:	
Clock To:	
1st Value:	
2nd Value:	
Value Percent:	
Step:	NO
Remarks:	UNDERSIDE OF FRAME

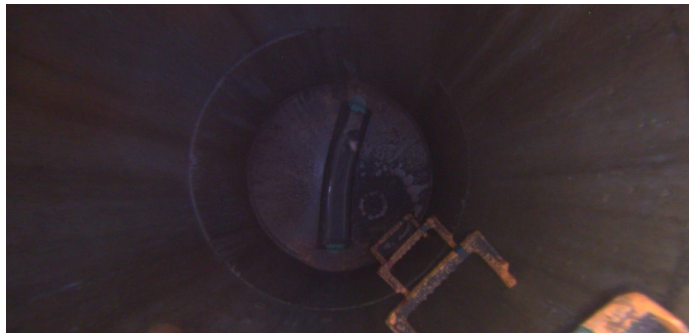
Code:	IS
Description:	Infil Stain
Distance (ft):	2.1
Structural Grade:	0
O&M Grade:	0
Clock Start/From:	12
Clock To:	12
1st Value:	
2nd Value:	
Value Percent:	
Step:	NO
Remarks:

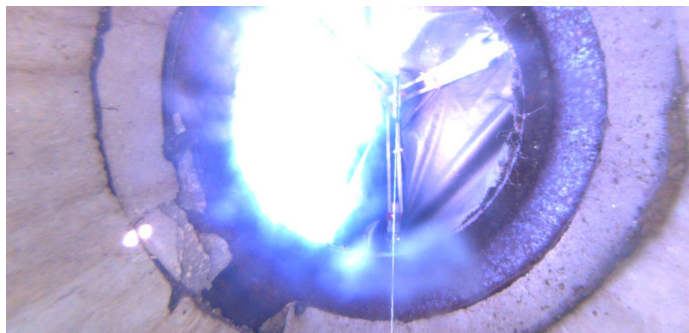
Code:	B
Description:	Broken
Distance (ft):	3.0
Structural Grade:	4
O&M Grade:	0
Clock Start/From:	4
Clock To:	5
1st Value:	
2nd Value:	
Value Percent:	
Step:	NO
Remarks:

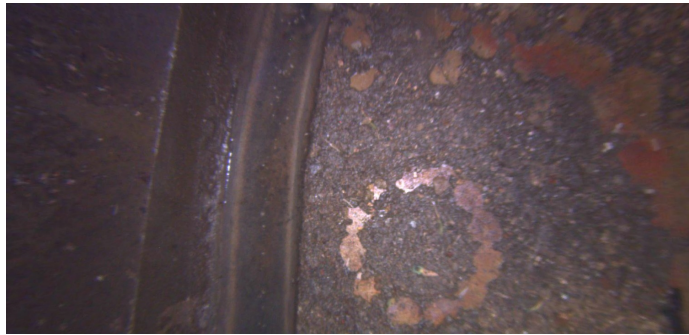
Code: **DSF**
Description: **Deposits Settled Fine**

Distance (ft): **7.4**
Structural Grade: **0**
O&M Grade: **2**
Clock Start/From: **12**
Clock To: **12**
1st Value:
2nd Value:
Value Percent: **5.000**
Step: **NO**
Remarks:

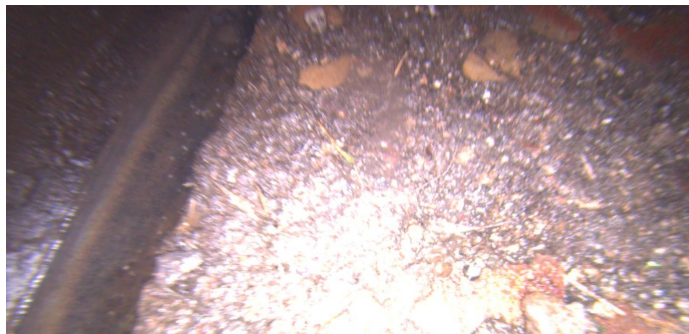
Code: **MGO**
Description: **General Observation**

Distance (ft): **8.3**
Structural Grade: **0**
O&M Grade: **0**
Clock Start/From:
Clock To:
1st Value:
2nd Value:
Value Percent:
Step: **NO**
Remarks: **END SURVEY**
