Manhole Inspection Report

Date:	04/27/2018	Weather:		Coding:	RZMACP
MH#:	M-706-064	Owner:	NA	Len. Surveyed:	5.4
P.O.#:		Surveyor:	Jen Costello	Rim to Invert:	5.6
Customer:		Cert. #:	U-907-5518	Wall Material:	Concrete (reinforced)

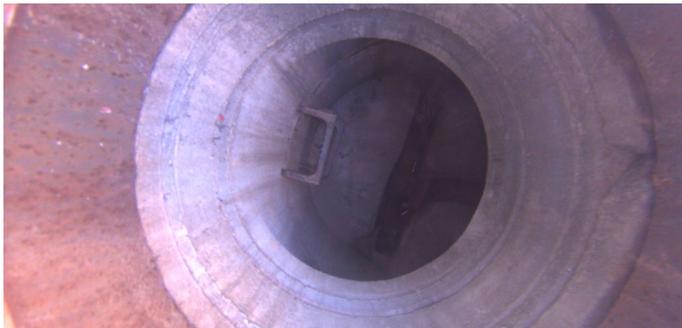
Code: **MGO**
Description: **General Observation**

Distance (ft): **1.0**
Structural Grade: **0**
O&M Grade: **0**
Clock Start/From:
Clock To:
1st Value:
2nd Value:
Value Percent:
Step: **NO**
Remarks: **access mh**

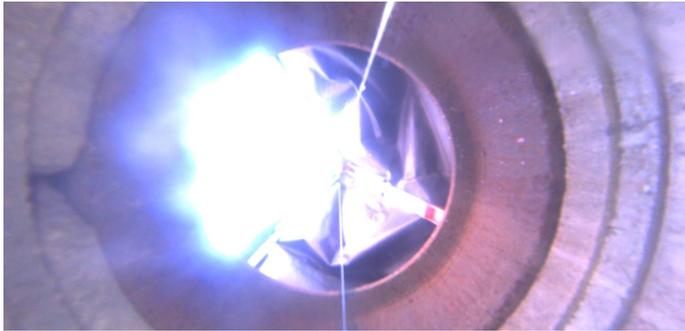
Code: **MGP**
Description: **General Photo**

Distance (ft): **2.6**
Structural Grade: **0**
O&M Grade: **0**
Clock Start/From:
Clock To:
1st Value:
2nd Value:
Value Percent:
Step: **NO**
Remarks: **underside of frame**

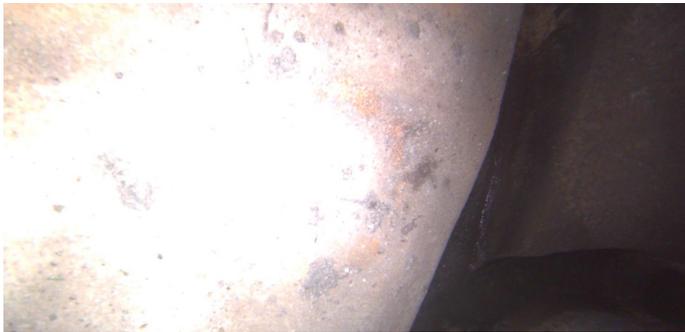
Code: **MGO**
Description: **General Observation**

Distance (ft): **5.4**
Structural Grade: **0**
O&M Grade: **0**
Clock Start/From:
Clock To:
1st Value:
2nd Value:
Value Percent:
Step: **NO**
Remarks: **end survey**
