# Manhole Inspection Report

Date:	<b>04/27/2018</b>	Weather:		Coding:	<b>RZMACP</b>
MH#:	<b>M-706-065</b>	Owner:	<b>NA</b>	Len. Surveyed:	<b>6.1</b>
P.O.#:		Surveyor:	<b>Jen Costello</b>	Rim to Invert:	<b>6.1</b>
Customer:		Cert. #:	<b>U-907-5518</b>	Wall Material:	<b>Brick</b>

Street:	<b>94' North of 8th St. 249' West of Fle</b>	Project:	<b>Hobart, IN</b>
City:	<b>Hobart, IN</b>	GPS Northing:	<b>41.52568817</b>
Location:		GPS Easting:	<b>-87.25794983</b>
Drain Area:	<b>South</b>	GPS Accuracy:	<b>Nearest Meter</b>
Cover Shape:	<b>Circular</b>	Evidence of Surcharge:	<b>No</b>
Cover Size:	<b>22.5</b>	Potential for Runoff:	<b>None</b>
Comments:

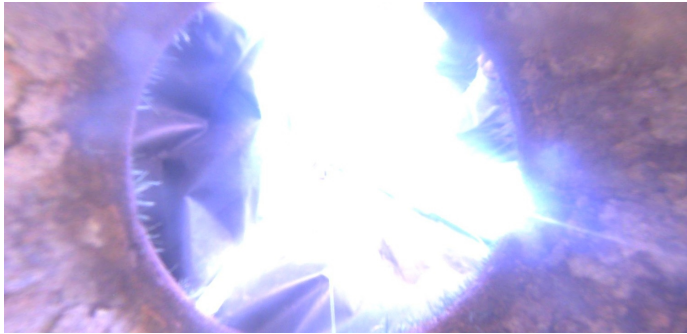
Code:	<b>MGO</b>
Description:	<b>General Observation</b>
Distance (ft):	<b>1.8</b>
Structural Grade:	<b>0</b>
O&M Grade:	<b>0</b>
Clock Start/From:	
Clock To:	
1st Value:	
2nd Value:	
Value Percent:	
Step:	<b>NO</b>
Remarks:	<b>UNDERSIDE OF FRAME</b>

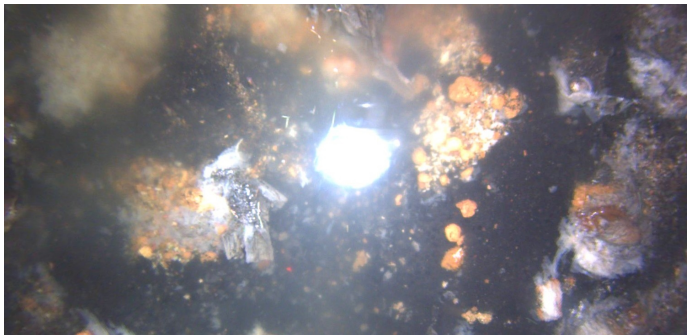
Code:	<b>MGO</b>
Description:	<b>General Observation</b>
Distance (ft):	<b>6.1</b>
Structural Grade:	<b>0</b>
O&M Grade:	<b>0</b>
Clock Start/From:	
Clock To:	
1st Value:	
2nd Value:	
Value Percent:	
Step:	<b>NO</b>
Remarks:	<b>END SURVEY BENCH IS SUBMERGED</b>
