# Manhole Inspection Report

Date:	<b>04/27/2018</b>	Weather:		Coding:	<b>RZMACP</b>
MH#:	<b>M-706-066</b>	Owner:	<b>NA</b>	Len. Surveyed:	<b>6.3</b>
P.O.#:		Surveyor:	<b>Jen Costello</b>	Rim to Invert:	<b>6.6</b>
Customer:		Cert. #:	<b>U-907-5518</b>	Wall Material:	<b>Concrete (reinforced)</b>

Street:	<b>428' North of 8th St. 627' West of Fl</b>	Project:	<b>Hobart, IN</b>
City:	<b>Hobart, IN</b>	GPS Northing:	<b>2904534.172</b>
Location:		GPS Easting:	<b>2904534.172</b>
Drain Area:	<b>South</b>	GPS Accuracy:	<b>Sub-Meter</b>
Cover Shape:	<b>Circular</b>	Evidence of Surcharge:	<b>No</b>
Cover Size:	<b>22.5</b>	Potential for Runoff:	<b>None</b>
Comments:

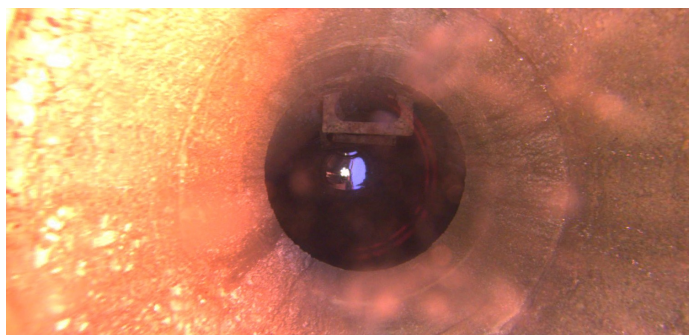
Code: **MGO**  
Description: **General Observation**

Distance (ft): **.0**  
Structural Grade: **0**  
O&M Grade: **0**  
Clock Start/From:  
Clock To:  
1st Value:  
2nd Value:  
Value Percent:  
Step: **NO**  
Remarks: **access MH**

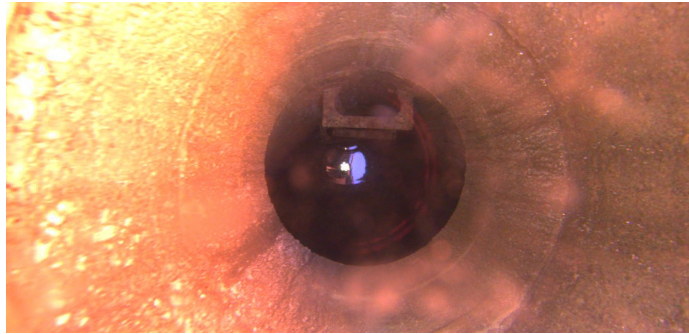
Code:	<b>SAV</b>
Description:	<b>Surface Aggregate Visible</b>
Distance (ft):	<b>.0</b>
Structural Grade:	<b>3</b>
O&M Grade:	<b>0</b>
Clock Start/From:	<b>12</b>
Clock To:	<b>12</b>
1st Value:	
2nd Value:	
Value Percent:	
Step:	<b>NO</b>
Remarks:

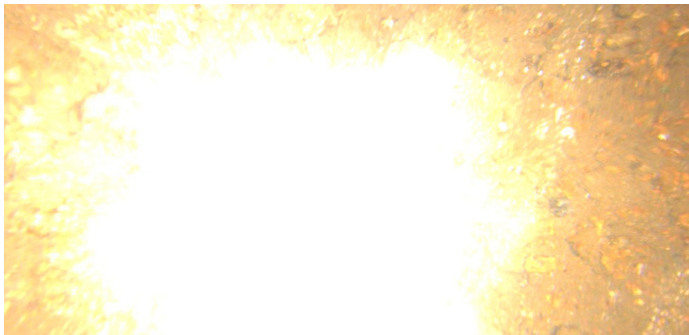
Code:	<b>MGO</b>
Description:	<b>General Observation</b>
Distance (ft):	<b>6.3</b>
Structural Grade:	<b>0</b>
O&M Grade:	<b>0</b>
Clock Start/From:	
Clock To:	
1st Value:	
2nd Value:	
Value Percent:	
Step:	<b>NO</b>
Remarks:	<b>BENCH IS SUBMERGED</b>
