Manhole Inspection Report

Date:	04/24/2018	Weather:		Coding:	RZMACP
MH#:	M-706-069	Owner:	NA	Len. Surveyed:	8.3
P.O.#:		Surveyor:	John Kuglmaier	Rim to Invert:	7.8
Customer:	8.7	Cert. #:	U-1215-07002349	Wall Material:	Concrete (reinforced)

Street:	On Linda St. 87' North of 10th St.	Project:	Hobart, IN
City:	Hobart, IN	GPS Northing:	0.0
Location:		GPS Easting:	0.0
Drain Area:	Southeast	GPS Accuracy:	Nearest Meter
Cover Shape:	Circular	Evidence of Surcharge:	No
Cover Size:	22.5	Potential for Runoff:	None
Comments:

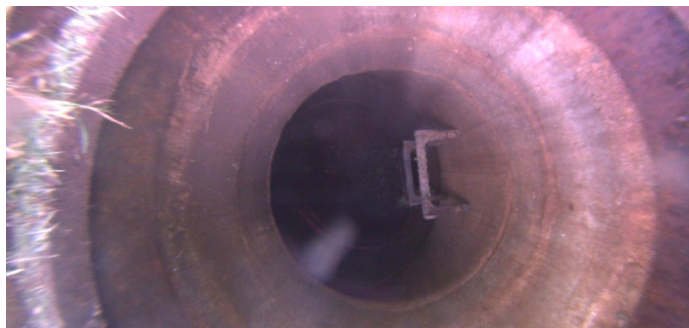
Code: **MGP**
Description: **General Photo**

Distance (ft): **.0**
Structural Grade: **0**
O&M Grade: **0**
Clock Start/From:
Clock To:
1st Value:
2nd Value:
Value Percent:
Step: **NO**
Remarks:

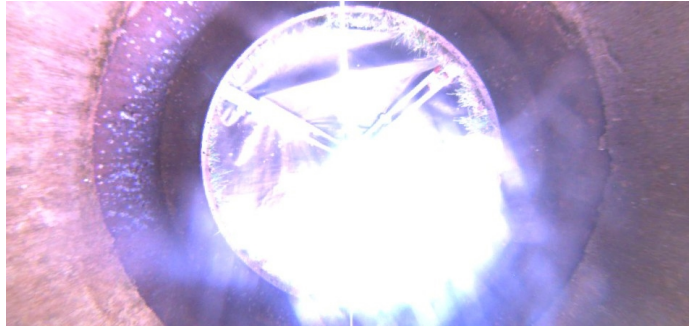
Code: **MGP**
Description: **General Photo**

Distance (ft): **2.8**
Structural Grade: **0**
O&M Grade: **0**
Clock Start/From:
Clock To:
1st Value:
2nd Value:
Value Percent:
Step: **NO**
Remarks:

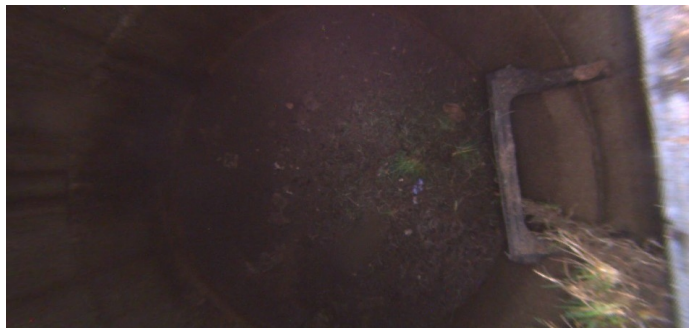
Code: **DAZ**
Description: **Deposits Attached Other**

Distance (ft): **5.5**
Structural Grade: **0**
O&M Grade: **3**
Clock Start/From: **12**
Clock To: **12**
1st Value:
2nd Value:
Value Percent: **15.000**
Step: **NO**
Remarks: **Mixed materials**

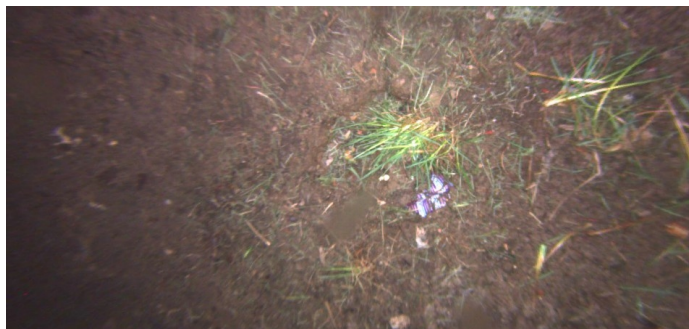
Code: **MGO**
Description: **General Observation**

Distance (ft): **7.7**
Structural Grade: **0**
O&M Grade: **0**
Clock Start/From:
Clock To:
1st Value:
2nd Value:
Value Percent:
Step: **NO**
Remarks: **Ins. Comp.**
