Manhole Inspection Report

Date:	09/20/2022	Weather:		Coding:	RZMACP
MH#:	M-707-001	Owner:	NA	Len. Surveyed:	9.9
P.O.#:		Surveyor:	Jen Costello	Rim to Invert:	10.6
Customer:		Cert. #:	U-907-5518	Wall Material:	Concrete (cast in place)

Street:	14th St. 177' West of Linda St.	Project:	Hobart, IN
City:	Hobart, IN	GPS Northing:	2282443.434
Location:	Local Rural Streets	GPS Easting:	2907155.22
Drain Area:	Southeast	GPS Accuracy:	Sub-Meter
Cover Shape:	Circular	Evidence of Surcharge:	No
Cover Size:	24.0	Potential for Runoff:	None
Comments:

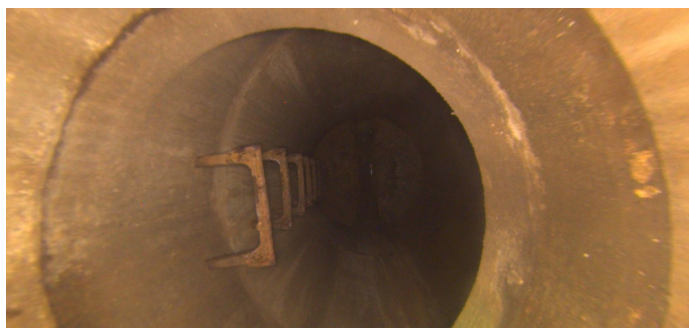
Code: **MGO**
Description: **General Observation**

Distance (ft): **.0**
Structural Grade: **0**
O&M Grade: **0**
Clock Start/From:
Clock To:
1st Value:
2nd Value:
Value Percent:
Step: **NO**
Remarks: **access mh**

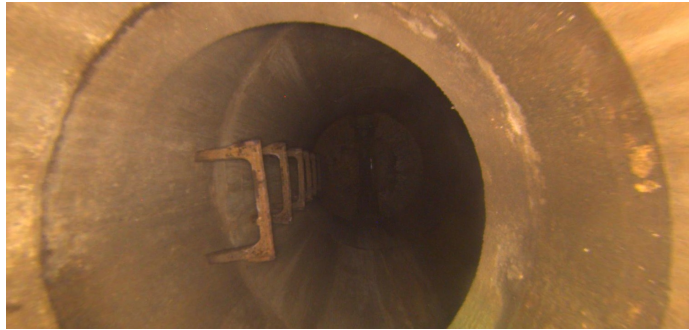
Code: **SRI**
Description: **Surface Roughness Increased**

Distance (ft): **.0**
Structural Grade: **1**
O&M Grade: **0**
Clock Start/From: **12**
Clock To: **12**
1st Value:
2nd Value:
Value Percent:
Step: **NO**
Remarks:

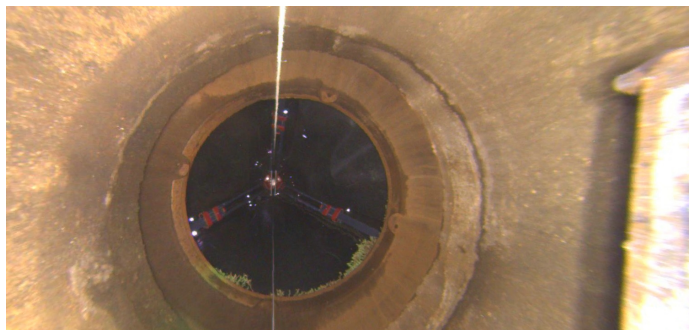
Code: **MGO**
Description: **General Observation**

Distance (ft): **2.9**
Structural Grade: **0**
O&M Grade: **0**
Clock Start/From:
Clock To:
1st Value:
2nd Value:
Value Percent:
Step: **NO**
Remarks: **underside of frame**

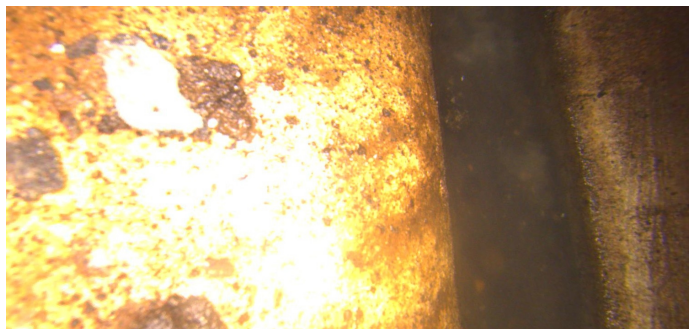
Code: **DSF**
Description: **Deposits Settled Fine**

Distance (ft): **9.9**
Structural Grade: **0**
O&M Grade: **2**
Clock Start/From: **12**
Clock To: **12**
1st Value:
2nd Value:
Value Percent: **5.000**
Step: **NO**
Remarks:

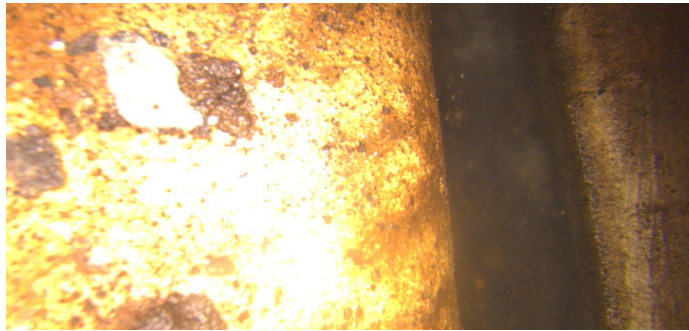
Code: **SRI**
Description: **Surface Roughness Increased**

Distance (ft): **9.9**
Structural Grade: **1**
O&M Grade: **0**
Clock Start/From: **12**
Clock To: **12**
1st Value:
2nd Value:
Value Percent:
Step: **NO**
Remarks:

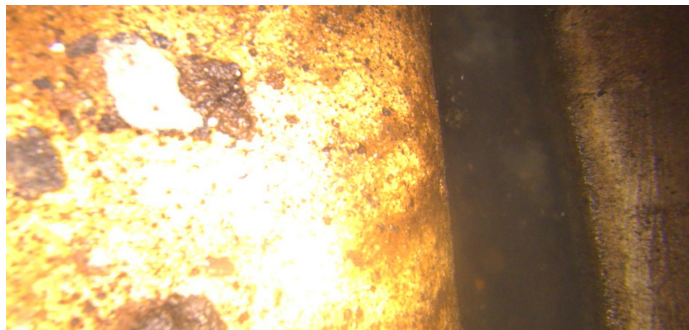
Code: **SRI**
Description: **Surface Roughness Increased**

Distance (ft): **9.9**
Structural Grade: **1**
O&M Grade: **0**
Clock Start/From: **3**
Clock To: **9**
1st Value:
2nd Value:
Value Percent:
Step: **NO**
Remarks:

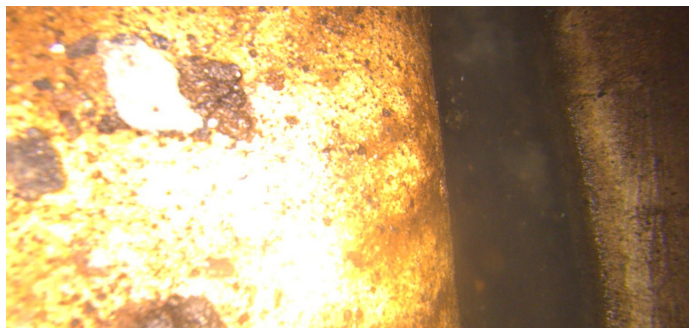
Code: **SRI**
Description: **Surface Roughness Increased**

Distance (ft): **9.9**
Structural Grade: **1**
O&M Grade: **0**
Clock Start/From: **12**
Clock To: **12**
1st Value:
2nd Value:
Value Percent:
Step: **NO**
Remarks:

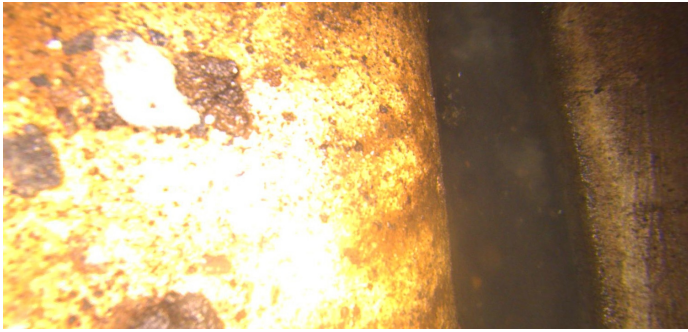
Code:	MGO
Description:	General Observation
Distance (ft):	9.9
Structural Grade:	0
O&M Grade:	0
Clock Start/From:	
Clock To:	
1st Value:	
2nd Value:	
Value Percent:	
Step:	NO
Remarks:	end of survey
