Manhole Inspection Report

Date:	04/18/2018	Weather:		Coding:	RZMACP
MH#:	M-707-002	Owner:	NA	Len. Surveyed:	8.6
P.O.#:		Surveyor:	John Kuglmaier	Rim to Invert:	11.8
Customer:		Cert. #:	U-1215-07002349	Wall Material:	Concrete (reinforced)

Street:	Intersection of 14th St. and Garfield	Project:	Hobart, IN
City:	Hobart, IN	GPS Northing:	2906903.255
Location:		GPS Easting:	2906903.255
Drain Area:	Southeast	GPS Accuracy:	Sub-Meter
Cover Shape:	Circular	Evidence of Surcharge:	No
Cover Size:	22.5	Potential for Runoff:	None
Comments:

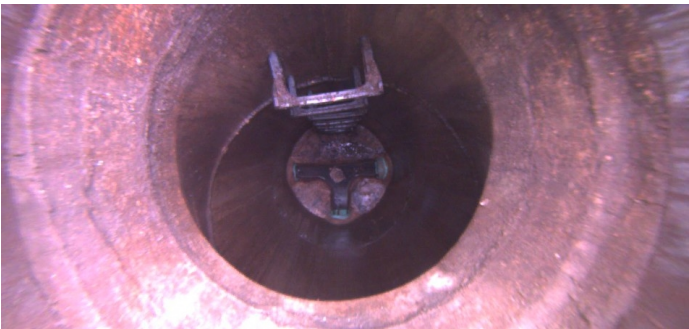
Code: **MGP**
 Description: **General Photo**

Distance (ft): **.0**
 Structural Grade: **0**
 O&M Grade: **0**
 Clock Start/From:
 Clock To:
 1st Value:
 2nd Value:
 Value Percent:
 Step: **NO**
 Remarks:

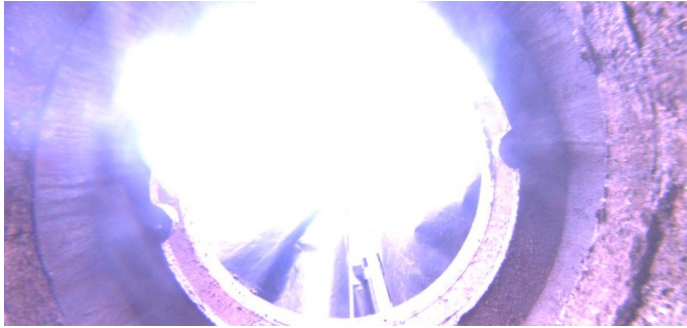
Code: **MGP**
Description: **General Photo**

Distance (ft): **2.2**
Structural Grade: **0**
O&M Grade: **0**
Clock Start/From:
Clock To:
1st Value:
2nd Value:
Value Percent:
Step: **NO**
Remarks:

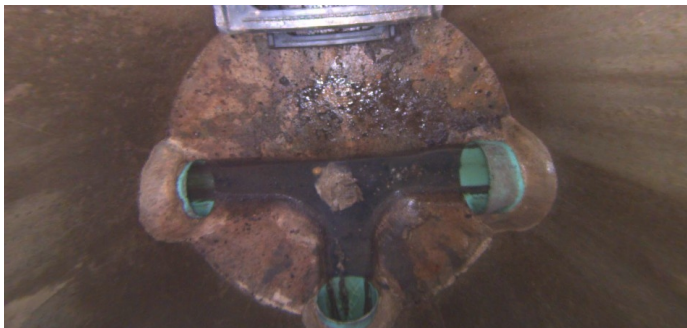
Code: **MGO**
Description: **General Observation**

Distance (ft): **8.6**
Structural Grade: **0**
O&M Grade: **0**
Clock Start/From:
Clock To:
1st Value:
2nd Value:
Value Percent:
Step: **NO**
Remarks: **Ins. Comp.**
