Manhole Inspection Report

Date:	04/18/2018	Weather:		Coding:	RZMACP
MH#:	M-707-003	Owner:	NA	Len. Surveyed:	6.8
P.O.#:		Surveyor:	John Kuglmaier	Rim to Invert:	10.2
Customer:		Cert. #:	U-1215-07002349	Wall Material:	Concrete (reinforced)

Street:	Intersection of 14th St. and Lincoln S	Project:	Hobart, IN
City:	Hobart, IN	GPS Northing:	2906557.399
Location:		GPS Easting:	2906557.399
Drain Area:	Southeast	GPS Accuracy:	Sub-Meter
Cover Shape:	Circular	Evidence of Surcharge:	No
Cover Size:	22.5	Potential for Runoff:	None
Comments:

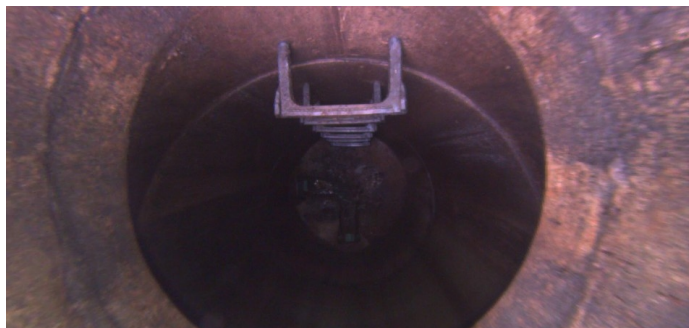
Code: **MGP**
Description: **General Photo**

Distance (ft): **.0**
Structural Grade: **0**
O&M Grade: **0**
Clock Start/From:
Clock To:
1st Value:
2nd Value:
Value Percent:
Step: **NO**
Remarks:

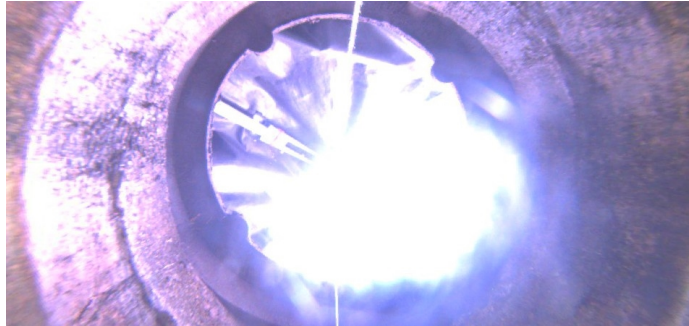
Code: **MGP**
Description: **General Photo**

Distance (ft): **2.3**
Structural Grade: **0**
O&M Grade: **0**
Clock Start/From:
Clock To:
1st Value:
2nd Value:
Value Percent:
Step: **NO**
Remarks:

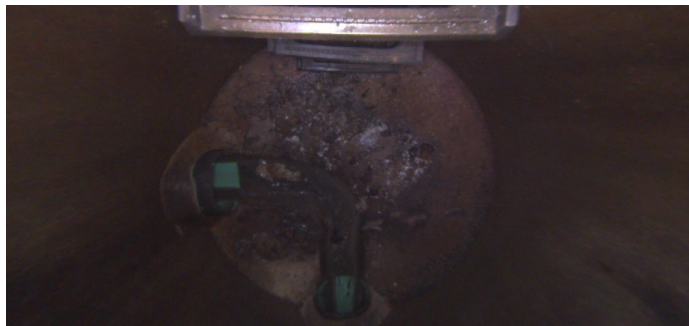
Code: **DAZ**
Description: **Deposits Attached Other**

Distance (ft): **6.4**
Structural Grade: **0**
O&M Grade: **2**
Clock Start/From: **12**
Clock To: **12**
1st Value:
2nd Value:
Value Percent: **5.000**
Step: **NO**
Remarks: **Mixed materials**

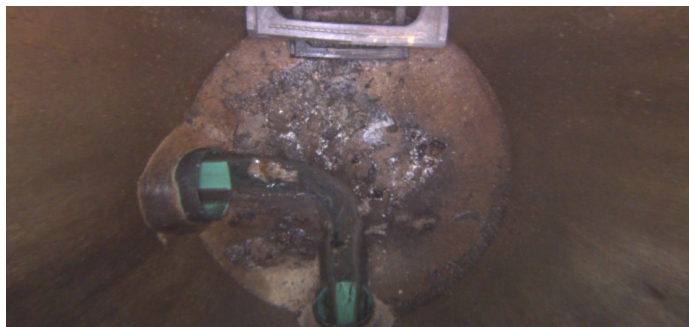
Code: **MGO**
Description: **General Observation**

Distance (ft): **6.8**
Structural Grade: **0**
O&M Grade: **0**
Clock Start/From:
Clock To:
1st Value:
2nd Value:
Value Percent:
Step: **NO**
Remarks: **Ins. Comp.**
