Manhole Inspection Report

Date:	09/20/2022	Weather:		Coding:	RZMACP
MH#:	M-707-005	Owner:	NA	Len. Surveyed:	11.3
P.O.#:		Surveyor:	Jen Costello	Rim to Invert:	12.1
Customer:		Cert. #:	U-907-5518	Wall Material:	Concrete (cast in place)

Street:	Garfield St. 258' South of 13th St.	Project:	Hobart, IN
City:	Hobart, IN	GPS Northing:	2282996.881
Location:	Local Rural Streets	GPS Easting:	2906884.247
Drain Area:	Southeast	GPS Accuracy:	Sub-Meter
Cover Shape:	Circular	Evidence of Surcharge:	No
Cover Size:	24.0	Potential for Runoff:	None
Comments:

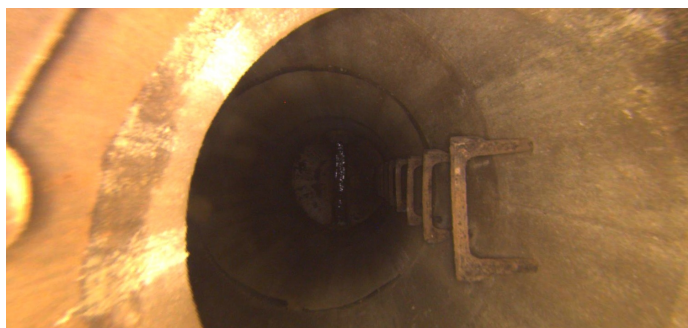
Code: **MGO**
 Description: **General Observation**

Distance (ft): **.0**
 Structural Grade: **0**
 O&M Grade: **0**
 Clock Start/From:
 Clock To:
 1st Value:
 2nd Value:
 Value Percent:
 Step: **NO**
 Remarks: **access mh**

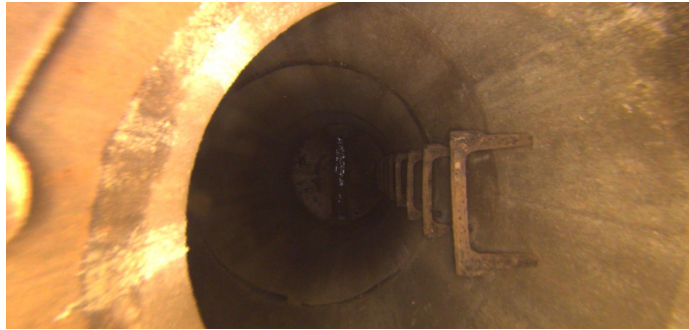
Code:	SRI
Description:	Surface Roughness Increased
Distance (ft):	.0
Structural Grade:	1
O&M Grade:	0
Clock Start/From:	12
Clock To:	12
1st Value:	
2nd Value:	
Value Percent:	
Step:	NO
Remarks:

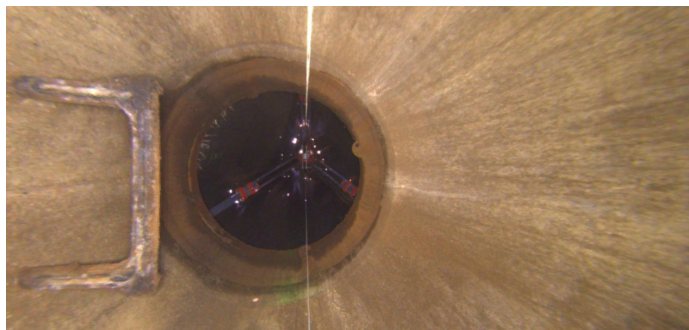
Code:	MGO
Description:	General Observation
Distance (ft):	3.5
Structural Grade:	0
O&M Grade:	0
Clock Start/From:	
Clock To:	
1st Value:	
2nd Value:	
Value Percent:	
Step:	NO
Remarks:	underside of frame

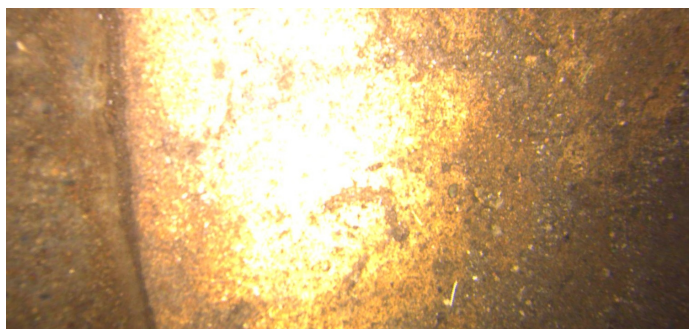
Code:	DSF
Description:	Deposits Settled Fine
Distance (ft):	11.3
Structural Grade:	0
O&M Grade:	2
Clock Start/From:	12
Clock To:	12
1st Value:	
2nd Value:	
Value Percent:	5.000
Step:	NO
Remarks:

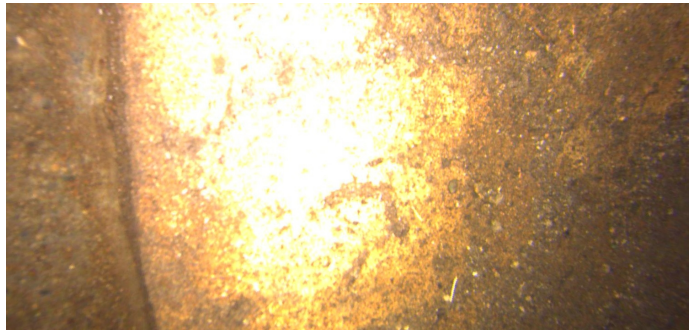
Code: **SRI**
Description: **Surface Roughness Increased**

Distance (ft): **11.3**
Structural Grade: **1**
O&M Grade: **0**
Clock Start/From: **3**
Clock To: **9**
1st Value:
2nd Value:
Value Percent:
Step: **NO**
Remarks:

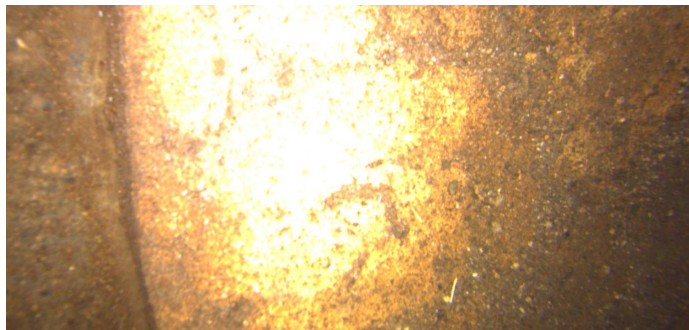
Code: **SRI**
Description: **Surface Roughness Increased**

Distance (ft): **11.3**
Structural Grade: **1**
O&M Grade: **0**
Clock Start/From: **12**
Clock To: **12**
1st Value:
2nd Value:
Value Percent:
Step: **NO**
Remarks:

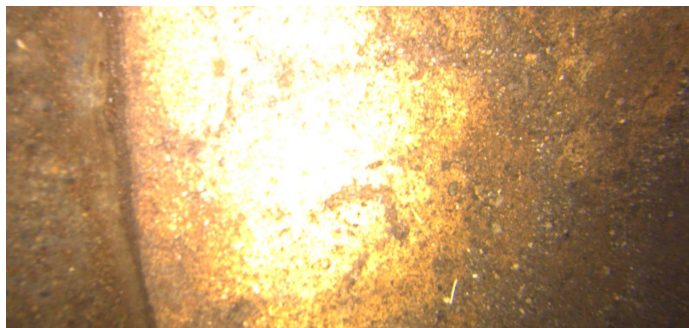
Code: **SRI**
Description: **Surface Roughness Increased**

Distance (ft): **11.3**
Structural Grade: **1**
O&M Grade: **0**
Clock Start/From: **12**
Clock To: **12**
1st Value:
2nd Value:
Value Percent:
Step: **NO**
Remarks:

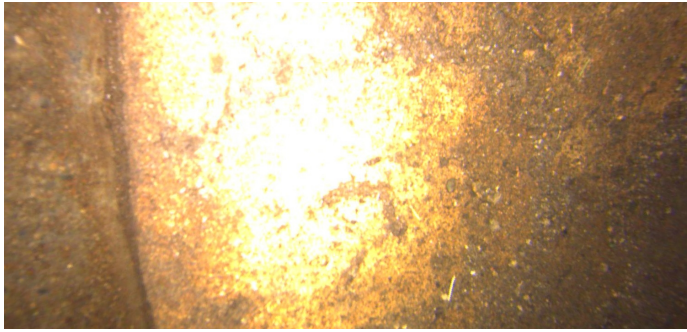
Code:	MGO
Description:	General Observation
Distance (ft):	11.3
Structural Grade:	0
O&M Grade:	0
Clock Start/From:	
Clock To:	
1st Value:	
2nd Value:	
Value Percent:	
Step:	NO
Remarks:	end of survey
