Manhole Inspection Report

Date:	04/18/2018	Weather:		Coding:	RZMACP
MH#:	M-707-006	Owner:	NA	Len. Surveyed:	11.7
P.O.#:		Surveyor:	John Kuglmaier	Rim to Invert:	12.0
Customer:		Cert. #:	U-1215-07002349	Wall Material:	Concrete (reinforced)

Street:	Intersection of Garfield St. and 13th	Project:	Hobart, IN
City:	Hobart, IN	GPS Northing:	0.0
Location:		GPS Easting:	0.0
Drain Area:	Southeast	GPS Accuracy:	Nearest Meter
Cover Shape:	Circular	Evidence of Surcharge:	No
Cover Size:	22.5	Potential for Runoff:	None
Comments:

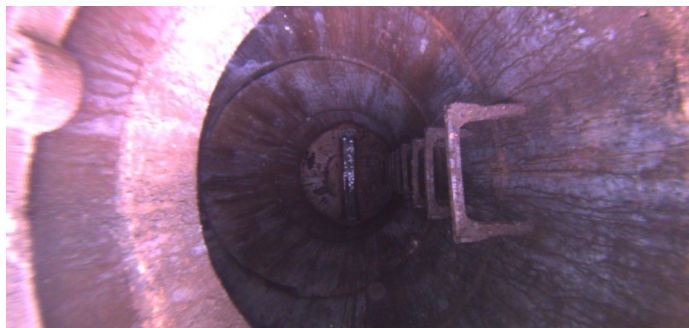
Code: **MGP**
Description: **General Photo**

Distance (ft): **.0**
Structural Grade: **0**
O&M Grade: **0**
Clock Start/From:
Clock To:
1st Value:
2nd Value:
Value Percent:
Step: **NO**
Remarks:

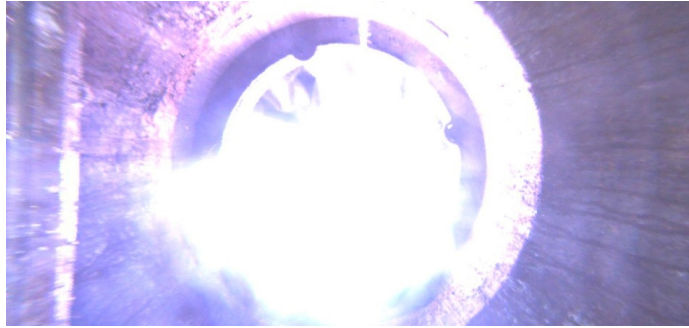
Code: **MGP**
Description: **General Photo**

Distance (ft): **2.8**
Structural Grade: **0**
O&M Grade: **0**
Clock Start/From:
Clock To:
1st Value:
2nd Value:
Value Percent:
Step: **NO**
Remarks:

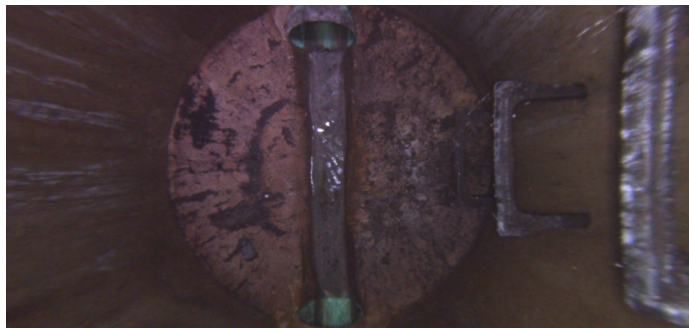
Code: **DSF**
Description: **Deposits Settled Fine**

Distance (ft): **8.6**
Structural Grade: **0**
O&M Grade: **2**
Clock Start/From: **12**
Clock To: **12**
1st Value:
2nd Value:
Value Percent: **5.000**
Step: **NO**
Remarks:

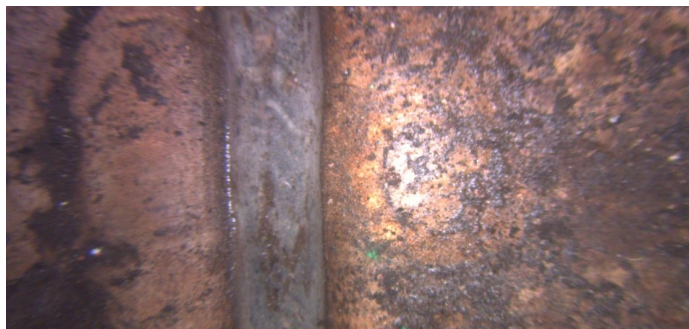
Code: **MGO**
Description: **General Observation**

Distance (ft): **11.3**
Structural Grade: **0**
O&M Grade: **0**
Clock Start/From:
Clock To:
1st Value:
2nd Value:
Value Percent:
Step: **NO**
Remarks: **Ins. Comp.**
