Manhole Inspection Report

Date:	04/18/2018	Weather:		Coding:	RZMACP
MH#:	M-707-006	Owner:	NA	Len. Surveyed:	11.9
P.O.#:		Surveyor:	John Kuglmaier	Rim to Invert:	12.6
Customer:		Cert. #:	U-1215-07002349	Wall Material:	Concrete (reinforced)

Street:	Intersection of Garfield St. and 13th	Project:	Hobart, IN
City:	Hobart, IN	GPS Northing:	0.0
Location:		GPS Easting:	0.0
Drain Area:	Southeast	GPS Accuracy:	Nearest Meter
Cover Shape:	Circular	Evidence of Surcharge:	No
Cover Size:	22.5	Potential for Runoff:	None
Comments:

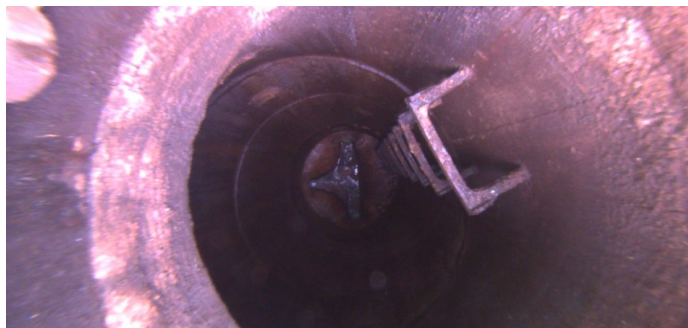
Code: **MGP**
Description: **General Photo**

Distance (ft): **.0**
Structural Grade: **0**
O&M Grade: **0**
Clock Start/From:
Clock To:
1st Value:
2nd Value:
Value Percent:
Step: **NO**
Remarks:

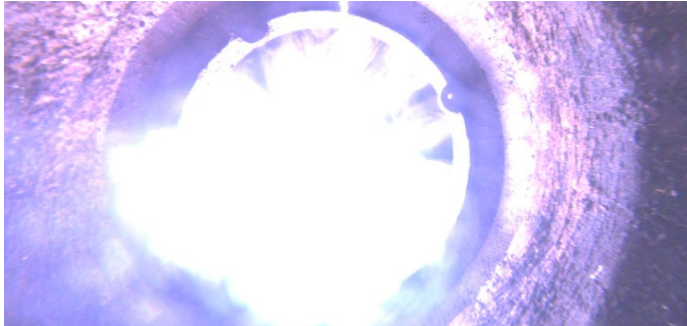
Code:	MGP
Description:	General Photo
Distance (ft):	2.5
Structural Grade:	0
O&M Grade:	0
Clock Start/From:	
Clock To:	
1st Value:	
2nd Value:	
Value Percent:	
Step:	NO
Remarks:

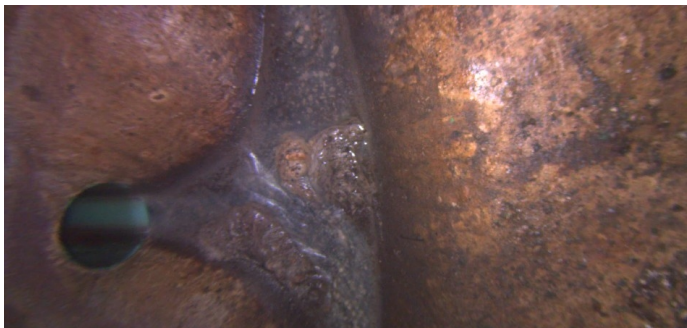
Code:	MGO
Description:	General Observation
Distance (ft):	10.9
Structural Grade:	0
O&M Grade:	0
Clock Start/From:	
Clock To:	
1st Value:	
2nd Value:	
Value Percent:	
Step:	NO
Remarks:	Ins. Comp.
