Manhole Inspection Report

Date:	04/17/2018	Weather:		Coding:	RZMACP
MH#:	M-707-007	Owner:	NA	Len. Surveyed:	10.6
P.O.#:		Surveyor:	John Kuglmaier	Rim to Invert:	10.8
Customer:		Cert. #:	U-1215-07002349	Wall Material:	Concrete (reinforced)

Street:	13th St. 10' West of Linda St.	Project:	Hobart, IN
City:	Hobart, IN	GPS Northing:	2907295.507
Location:		GPS Easting:	2907295.507
Drain Area:	Southeast	GPS Accuracy:	Sub-Meter
Cover Shape:	Circular	Evidence of Surcharge:	No
Cover Size:	22.5	Potential for Runoff:	None
Comments:

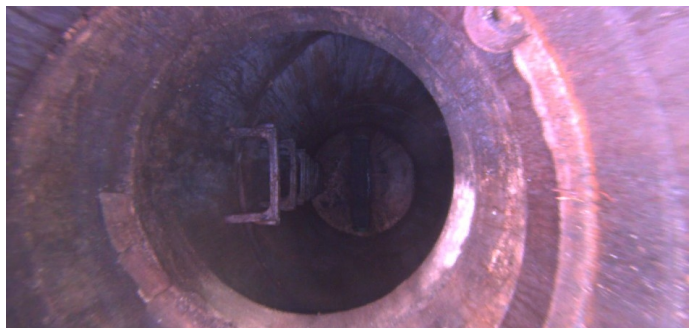
Code: **MGP**
Description: **General Photo**

Distance (ft): **.0**
Structural Grade: **0**
O&M Grade: **0**
Clock Start/From:
Clock To:
1st Value:
2nd Value:
Value Percent:
Step: **NO**
Remarks:

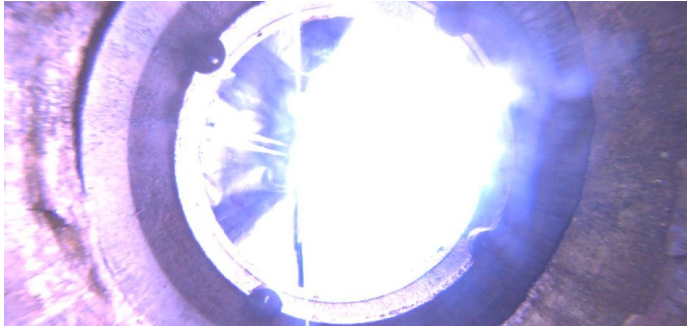
Code: **MGP**
Description: **General Photo**

Distance (ft): **2.4**
Structural Grade: **0**
O&M Grade: **0**
Clock Start/From:
Clock To:
1st Value:
2nd Value:
Value Percent:
Step: **NO**
Remarks:

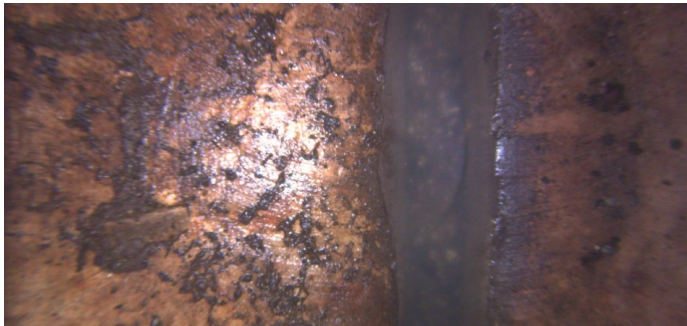
Code: **MGO**
Description: **General Observation**

Distance (ft): **9.7**
Structural Grade: **0**
O&M Grade: **0**
Clock Start/From:
Clock To:
1st Value:
2nd Value:
Value Percent:
Step: **NO**
Remarks: **Ins. Comp.**
