# Manhole Inspection Report

Date:	<b>04/18/2018</b>	Weather:		Coding:	<b>RZMACP</b>
MH#:	<b>M-707-008</b>	Owner:	<b>NA</b>	Len. Surveyed:	<b>11.9</b>
P.O.#:		Surveyor:	<b>John Kuglmaier</b>	Rim to Invert:	<b>12.7</b>
Customer:		Cert. #:	<b>U-1215-07002349</b>	Wall Material:	<b>Concrete (reinforced)</b>

Street:	<b>Garfield St. 243' North of 13th St.</b>	Project:	<b>Hobart, IN</b>
City:	<b>Hobart, IN</b>	GPS Northing:	<b>2906888.942</b>
Location:		GPS Easting:	<b>2906888.942</b>
Drain Area:	<b>Southeast</b>	GPS Accuracy:	<b>Sub-Meter</b>
Cover Shape:	<b>Circular</b>	Evidence of Surcharge:	<b>No</b>
Cover Size:	<b>22.5</b>	Potential for Runoff:	<b>None</b>
Comments:

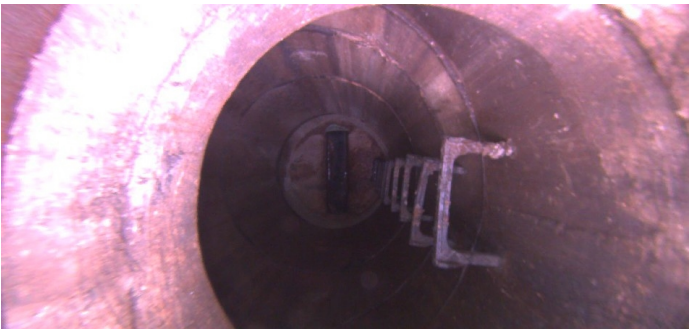
Code: **MGP**  
 Description: **General Photo**

Distance (ft): **.0**  
 Structural Grade: **0**  
 O&M Grade: **0**  
 Clock Start/From:  
 Clock To:  
 1st Value:  
 2nd Value:  
 Value Percent:  
 Step: **NO**  
 Remarks:

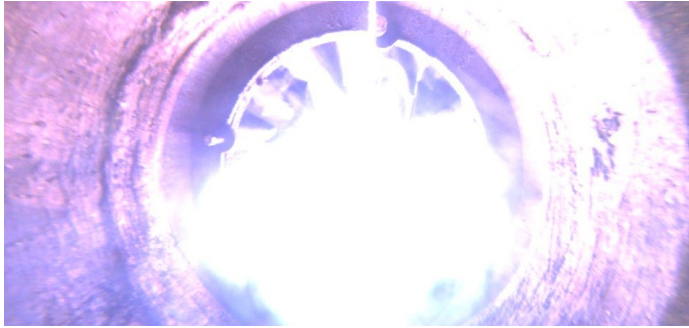
Code: **MGP**  
Description: **General Photo**

Distance (ft): **2.6**  
Structural Grade: **0**  
O&M Grade: **0**  
Clock Start/From:  
Clock To:  
1st Value:  
2nd Value:  
Value Percent:  
Step: **NO**  
Remarks:

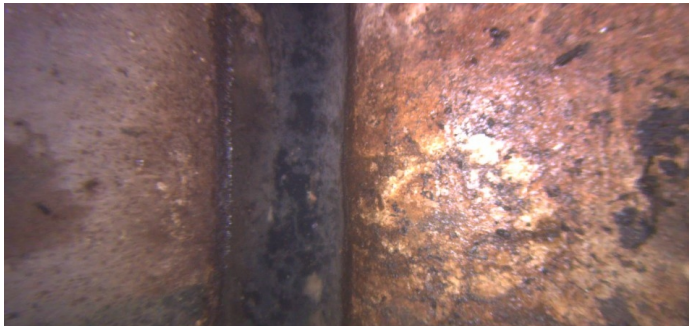
Code: **MGO**  
Description: **General Observation**

Distance (ft): **11.5**  
Structural Grade: **0**  
O&M Grade: **0**  
Clock Start/From:  
Clock To:  
1st Value:  
2nd Value:  
Value Percent:  
Step: **NO**  
Remarks: **Ins. Comp.**
