Manhole Inspection Report

Date:	04/18/2018	Weather:		Coding:	RZMACP
MH#:	M-707-012	Owner:	NA	Len. Surveyed:	10.5
P.O.#:		Surveyor:	John Kuglmaier	Rim to Invert:	13.3
Customer:		Cert. #:	U-1215-07002349	Wall Material:	Concrete (reinforced)

Street:	Intersection of 11th St. and Garfield	Project:	Hobart, IN
City:	Hobart, IN	GPS Northing:	2906873.098
Location:		GPS Easting:	2906873.098
Drain Area:	Southeast	GPS Accuracy:	Sub-Meter
Cover Shape:	Circular	Evidence of Surcharge:	No
Cover Size:	22.5	Potential for Runoff:	None
Comments:

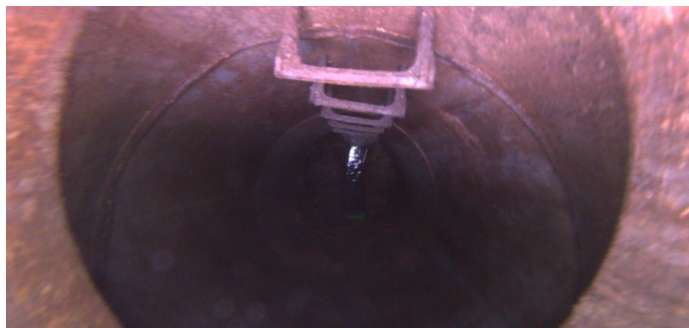
Code: **MGP**
Description: **General Photo**

Distance (ft): **.0**
Structural Grade: **0**
O&M Grade: **0**
Clock Start/From:
Clock To:
1st Value:
2nd Value:
Value Percent:
Step: **NO**
Remarks:

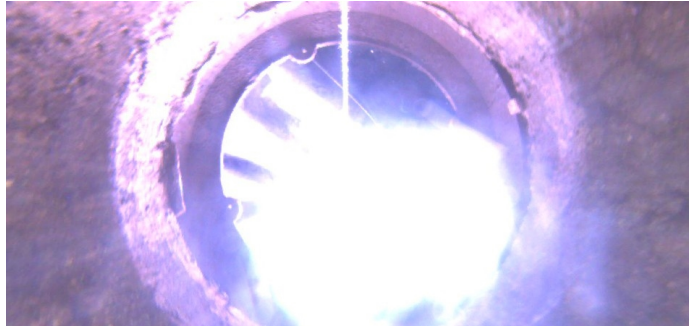
Code: **MGP**
Description: **General Photo**

Distance (ft): **2.3**
Structural Grade: **0**
O&M Grade: **0**
Clock Start/From:
Clock To:
1st Value:
2nd Value:
Value Percent:
Step: **NO**
Remarks:

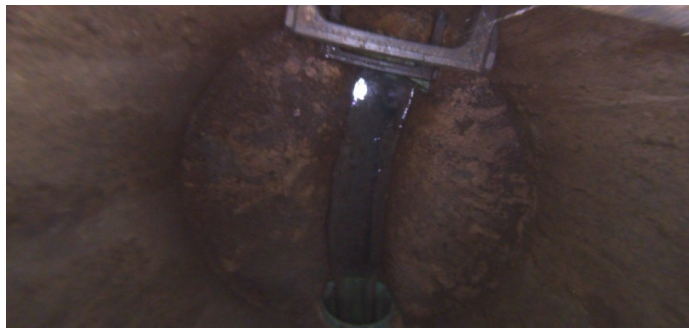
Code: **DSF**
Description: **Deposits Settled Fine**

Distance (ft): **9.7**
Structural Grade: **0**
O&M Grade: **2**
Clock Start/From: **12**
Clock To: **12**
1st Value:
2nd Value:
Value Percent: **5.000**
Step: **NO**
Remarks:

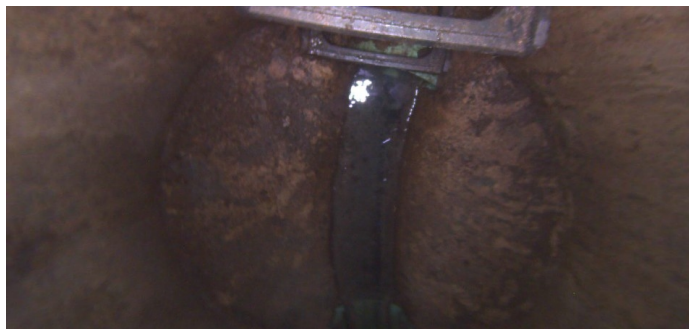
Code: **MGO**
Description: **General Observation**

Distance (ft): **10.3**
Structural Grade: **0**
O&M Grade: **0**
Clock Start/From:
Clock To:
1st Value:
2nd Value:
Value Percent:
Step: **NO**
Remarks: **Ins. Comp.**
