Manhole Inspection Report

Date:	04/23/2018	Weather:		Coding:	RZMACP
MH#:	M-707-013	Owner:	NA	Len. Surveyed:	12.8
P.O.#:		Surveyor:	John Kuglmaier	Rim to Invert:	13.8
Customer:	8.7	Cert. #:	U-1215-07002349	Wall Material:	Concrete (reinforced)

Street:	Intersection of 11th St. and Garfield	Project:	Hobart, IN
City:	Hobart, IN	GPS Northing:	0.0
Location:		GPS Easting:	0.0
Drain Area:	Southeast	GPS Accuracy:	Nearest Meter
Cover Shape:	Circular	Evidence of Surcharge:	Yes
Cover Size:	22.5	Potential for Runoff:	None
Comments:

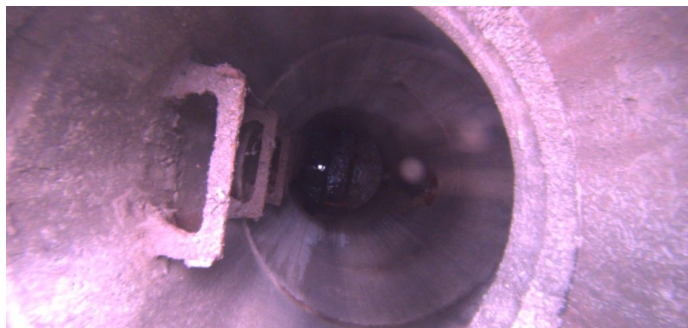
Code: **MGP**
Description: **General Photo**

Distance (ft): **.0**
Structural Grade: **0**
O&M Grade: **0**
Clock Start/From:
Clock To:
1st Value:
2nd Value:
Value Percent:
Step: **NO**
Remarks:

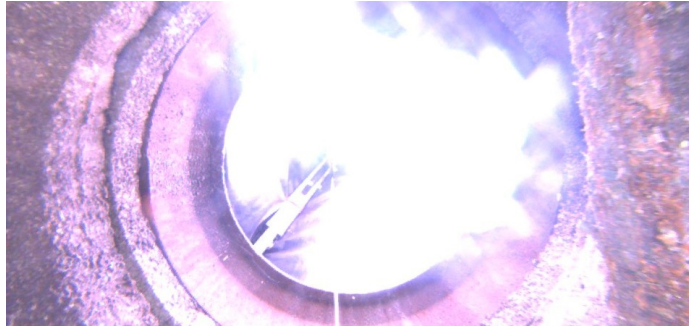
Code: **MGP**
Description: **General Photo**

Distance (ft): **2.5**
Structural Grade: **0**
O&M Grade: **0**
Clock Start/From:
Clock To:
1st Value:
2nd Value:
Value Percent:
Step: **NO**
Remarks:

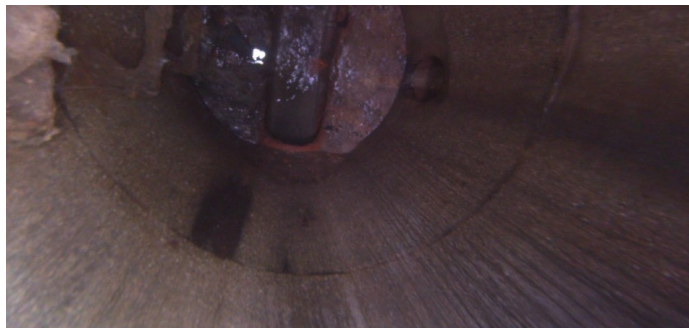
Code: **IS**
Description: **Infil Stain**

Distance (ft): **8.2**
Structural Grade: **0**
O&M Grade: **0**
Clock Start/From: **7**
Clock To:
1st Value:
2nd Value:
Value Percent:
Step: **NO**
Remarks:

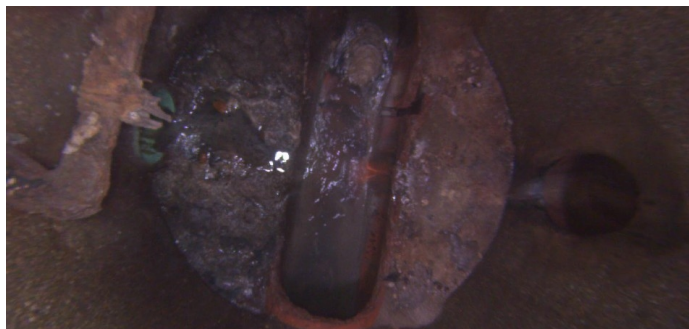
Code: **DAZ**
Description: **Deposits Attached Other**

Distance (ft): **10.8**
Structural Grade: **0**
O&M Grade: **2**
Clock Start/From: **12**
Clock To: **12**
1st Value:
2nd Value:
Value Percent: **10.000**
Step: **NO**
Remarks: **Mixed materials**

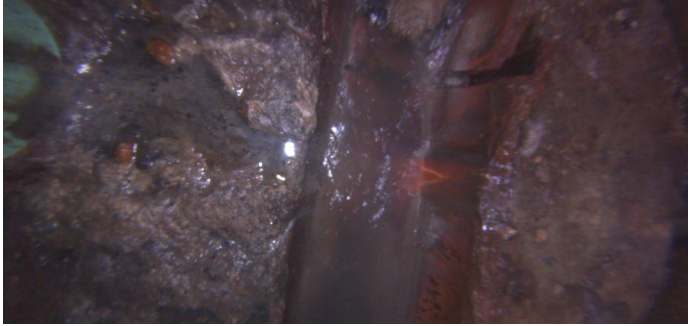
Code:	MGO
Description:	General Observation
Distance (ft):	12.3
Structural Grade:	0
O&M Grade:	0
Clock Start/From:	
Clock To:	
1st Value:	
2nd Value:	
Value Percent:	
Step:	NO
Remarks:	Ins. Comp.
