Manhole Inspection Report

Date:	04/18/2018	Weather:		Coding:	RZMACP
MH#:	M-707-019	Owner:	NA	Len. Surveyed:	4.5
P.O.#:		Surveyor:	John Kuglmaier	Rim to Invert:	5.3
Customer:		Cert. #:	U-1215-07002349	Wall Material:	Concrete (reinforced)

Street:	Lincoln St. 14th St. to the North.	Project:	Hobart, IN
City:	Hobart, IN	GPS Northing:	2906568.299
Location:		GPS Easting:	2906568.299
Drain Area:	Southeast	GPS Accuracy:	Sub-Meter
Cover Shape:	Circular	Evidence of Surcharge:	No
Cover Size:	22.5	Potential for Runoff:	None
Comments:

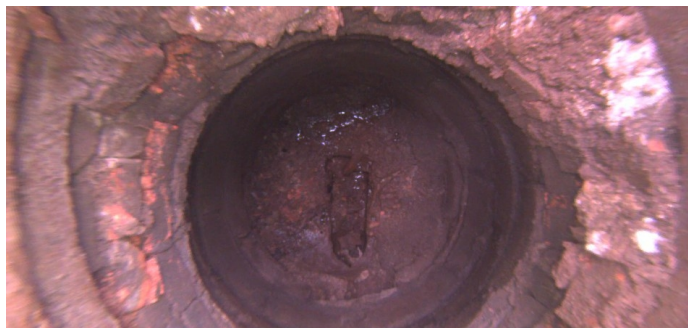
Code: **MGP**
Description: **General Photo**

Distance (ft): **.0**
Structural Grade: **0**
O&M Grade: **0**
Clock Start/From:
Clock To:
1st Value:
2nd Value:
Value Percent:
Step: **NO**
Remarks:

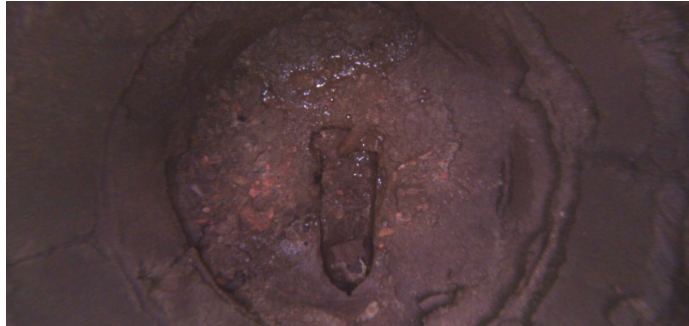
Code:	DAZ
Description:	Deposits Attached Other
Distance (ft):	1.9
Structural Grade:	0
O&M Grade:	3
Clock Start/From:	12
Clock To:	12
1st Value:	
2nd Value:	
Value Percent:	15.000
Step:	NO
Remarks:	Mixed materials

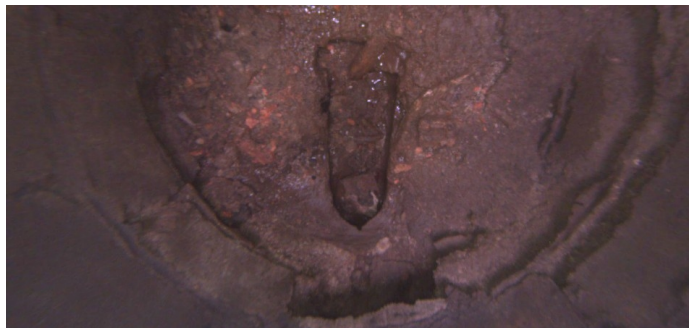
Code:	MB
Description:	Missing Brick
Distance (ft):	2.2
Structural Grade:	4
O&M Grade:	0
Clock Start/From:	6
Clock To:	
1st Value:	
2nd Value:	
Value Percent:	
Step:	NO
Remarks:

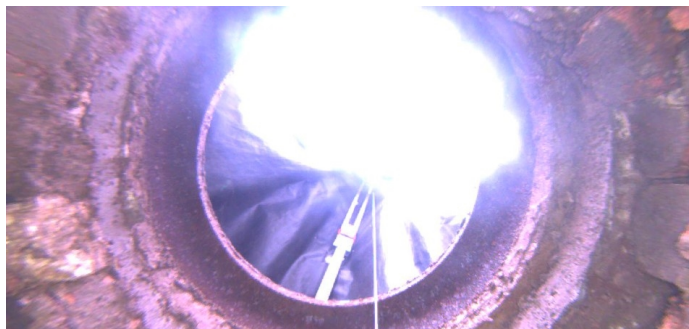
Code:	MGP
Description:	General Photo
Distance (ft):	2.2
Structural Grade:	0
O&M Grade:	0
Clock Start/From:	
Clock To:	
1st Value:	
2nd Value:	
Value Percent:	
Step:	NO
Remarks:

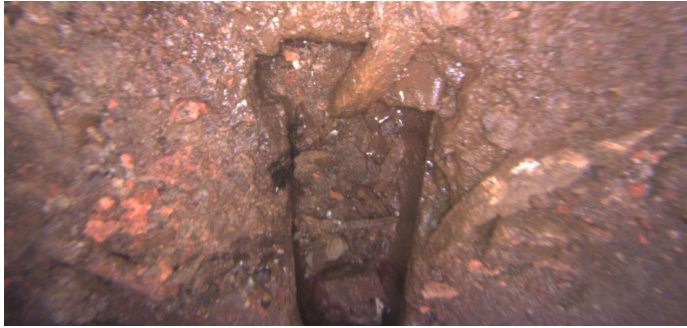
Code:	MGO
Description:	General Observation
Distance (ft):	3.8
Structural Grade:	0
O&M Grade:	0
Clock Start/From:	
Clock To:	
1st Value:	
2nd Value:	
Value Percent:	
Step:	NO
Remarks:	Ins. Comp.
