Manhole Inspection Report

Date:	04/18/2018	Weather:		Coding:	RZMACP
MH#:	M-707-020	Owner:	NA	Len. Surveyed:	5.3
P.O.#:		Surveyor:	John Kuglmaier	Rim to Invert:	5.6
Customer:		Cert. #:	U-1215-07002349	Wall Material:	Concrete (reinforced)

Street:	Lincoln St. 291' North of 14th St.	Project:	Hobart, IN
City:	Hobart, IN	GPS Northing:	2906560.232
Location:		GPS Easting:	2906560.232
Drain Area:	Southeast	GPS Accuracy:	Sub-Meter
Cover Shape:	Circular	Evidence of Surcharge:	No
Cover Size:	22.5	Potential for Runoff:	None
Comments:

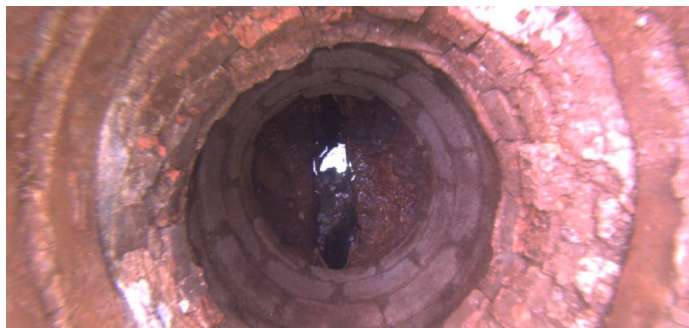
Code: **MGP**
Description: **General Photo**

Distance (ft): **.0**
Structural Grade: **0**
O&M Grade: **0**
Clock Start/From:
Clock To:
1st Value:
2nd Value:
Value Percent:
Step: **NO**
Remarks:

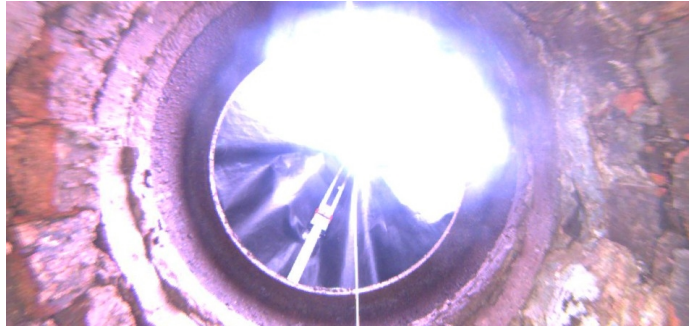
Code: **MGP**
Description: **General Photo**

Distance (ft): **2.4**
Structural Grade: **0**
O&M Grade: **0**
Clock Start/From:
Clock To:
1st Value:
2nd Value:
Value Percent:
Step: **NO**
Remarks:

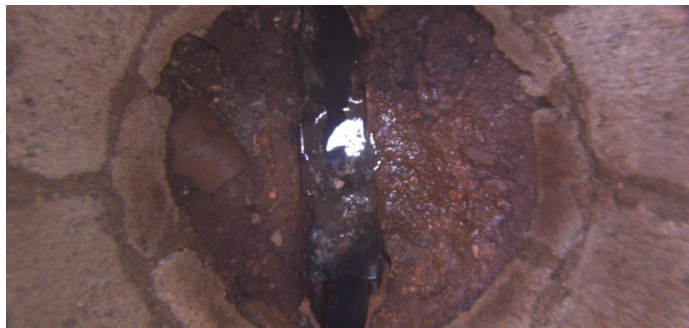
Code: **DAZ**
Description: **Deposits Attached Other**

Distance (ft): **2.8**
Structural Grade: **0**
O&M Grade: **3**
Clock Start/From: **12**
Clock To: **12**
1st Value:
2nd Value:
Value Percent: **15.000**
Step: **NO**
Remarks: **Mixed materials**

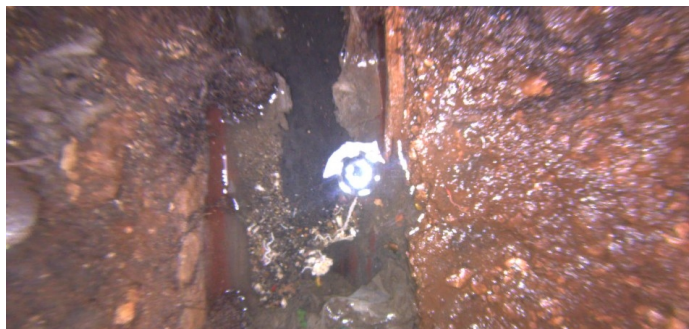
Code: **MGO**
Description: **General Observation**

Distance (ft): **4.5**
Structural Grade: **0**
O&M Grade: **0**
Clock Start/From:
Clock To:
1st Value:
2nd Value:
Value Percent:
Step: **NO**
Remarks: **Ins. Comp.**
