Manhole Inspection Report

Date:	04/17/2018	Weather:		Coding:	RZMACP
MH#:	M-707-023	Owner:	NA	Len. Surveyed:	5.2
P.O.#:		Surveyor:	John Kuglmaier	Rim to Invert:	5.6
Customer:		Cert. #:	U-1215-07002349	Wall Material:	Concrete (reinforced)

Street:	13th St. Between Lincoln St. and Gar	Project:	Hobart, IN
City:	Hobart, IN	GPS Northing:	2906721.425
Location:		GPS Easting:	2906721.425
Drain Area:	Southeast	GPS Accuracy:	Sub-Meter
Cover Shape:	Circular	Evidence of Surcharge:	No
Cover Size:	22.5	Potential for Runoff:	None
Comments:

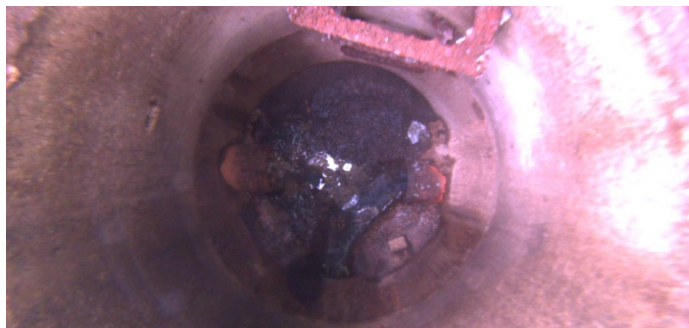
Code: **MGP**
 Description: **General Photo**

Distance (ft): **.0**
 Structural Grade: **0**
 O&M Grade: **0**
 Clock Start/From:
 Clock To:
 1st Value:
 2nd Value:
 Value Percent:
 Step: **NO**
 Remarks:

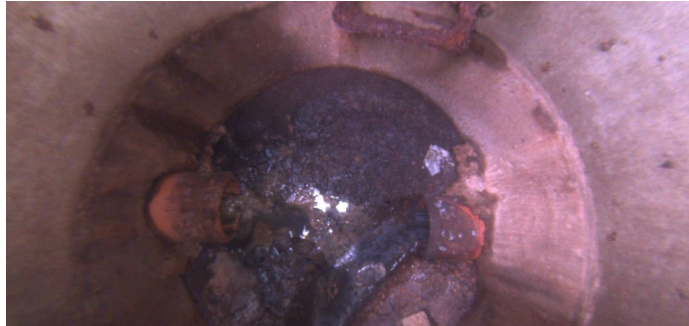
Code: **IS**
Description: **Infil Stain**

Distance (ft): **1.5**
Structural Grade: **0**
O&M Grade: **0**
Clock Start/From: **4**
Clock To: **11**
1st Value:
2nd Value:
Value Percent:
Step: **NO**
Remarks:

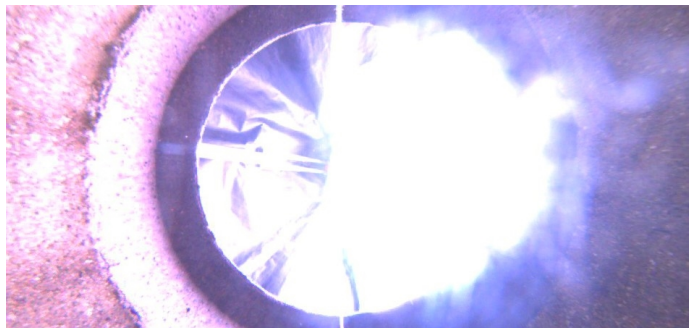
Code: **MGP**
Description: **General Photo**

Distance (ft): **2.3**
Structural Grade: **0**
O&M Grade: **0**
Clock Start/From:
Clock To:
1st Value:
2nd Value:
Value Percent:
Step: **NO**
Remarks:

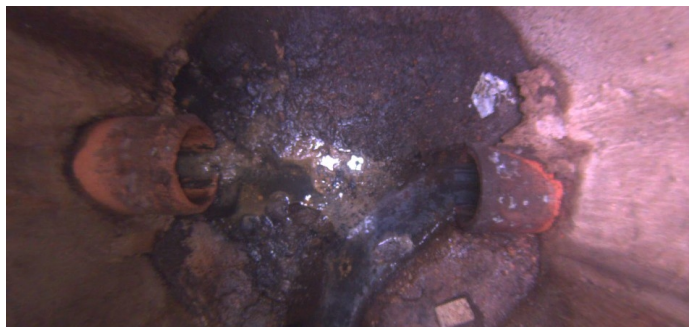
Code: **DAZ**
Description: **Deposits Attached Other**

Distance (ft): **2.7**
Structural Grade: **0**
O&M Grade: **3**
Clock Start/From: **12**
Clock To: **12**
1st Value:
2nd Value:
Value Percent: **15.000**
Step: **NO**
Remarks: **Mixed materials**

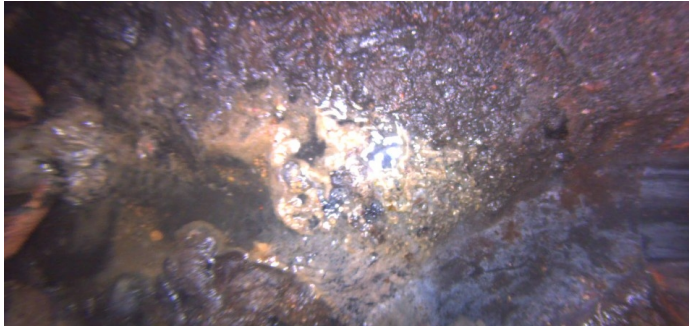
Code:	MGO
Description:	General Observation
Distance (ft):	4.5
Structural Grade:	0
O&M Grade:	0
Clock Start/From:	
Clock To:	
1st Value:	
2nd Value:	
Value Percent:	
Step:	NO
Remarks:	Ins. Comp.
