Manhole Inspection Report

Date:	04/17/2018	Weather:		Coding:	RZMACP
MH#:	M-707-025	Owner:	NA	Len. Surveyed:	3.2
P.O.#:		Surveyor:	John Kuglmaier	Rim to Invert:	3.5
Customer:		Cert. #:	U-1215-07002349	Wall Material:	Concrete (reinforced)

Street:	343' North of 13th St. and East of Lin	Project:	Hobart, IN
City:	Hobart, IN	GPS Northing:	2906718.634
Location:		GPS Easting:	2906718.634
Drain Area:	Southeast	GPS Accuracy:	Sub-Meter
Cover Shape:	Circular	Evidence of Surcharge:	Yes
Cover Size:	22.5	Potential for Runoff:	None
Comments:

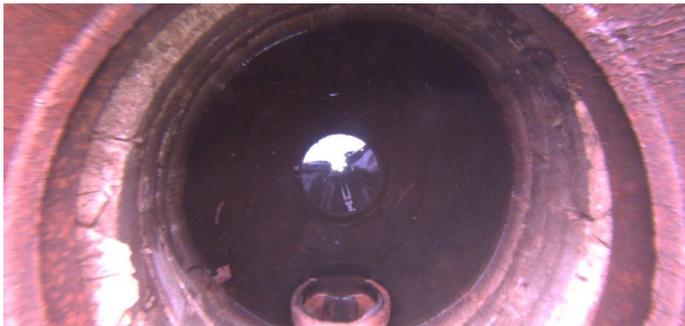
Code: **MGP**
Description: **General Photo**

Distance (ft): **.0**
Structural Grade: **0**
O&M Grade: **0**
Clock Start/From:
Clock To:
1st Value:
2nd Value:
Value Percent:
Step: **NO**
Remarks:

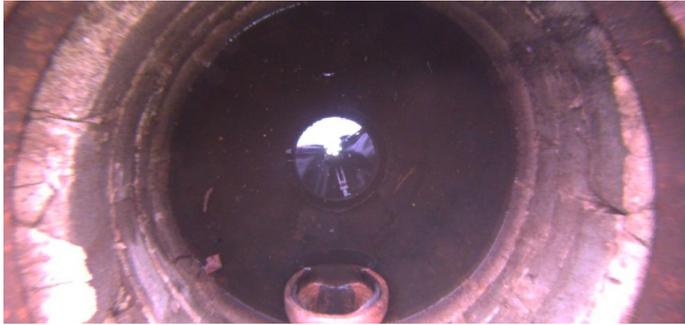
Code: **MGO**
Description: **General Observation**

Distance (ft): **.3**
Structural Grade: **0**
O&M Grade: **0**
Clock Start/From:
Clock To:
1st Value:
2nd Value:
Value Percent:
Step: **NO**
Remarks: **Surcharge**

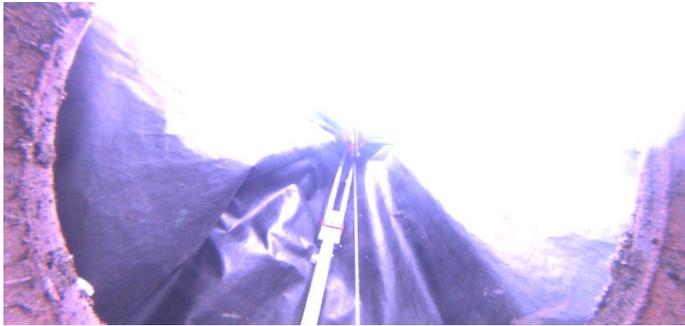
Code: **MGP**
Description: **General Photo**

Distance (ft): **1.3**
Structural Grade: **0**
O&M Grade: **0**
Clock Start/From:
Clock To:
1st Value:
2nd Value:
Value Percent:
Step: **NO**
Remarks:

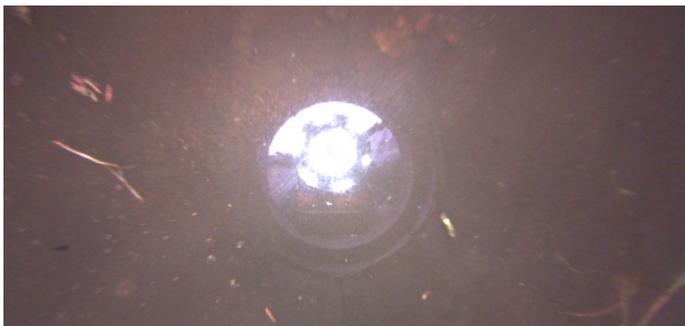
Code: **MGO**
Description: **General Observation**

Distance (ft): **2.8**
Structural Grade: **0**
O&M Grade: **0**
Clock Start/From:
Clock To:
1st Value:
2nd Value:
Value Percent:
Step: **NO**
Remarks: **Ins. Comp.**
