Manhole Inspection Report

Date:	04/18/2018	Weather:		Coding:	RZMACP
MH#:	M-707-026	Owner:	NA	Len. Surveyed:	6.4
P.O.#:		Surveyor:	John Kuglmaier	Rim to Invert:	6.8
Customer:		Cert. #:	U-1215-07002349	Wall Material:	Concrete (reinforced)

Street:	Lincoln St. 248' North of 13th St.	Project:	Hobart, IN
City:	Hobart, IN	GPS Northing:	2906550.634
Location:		GPS Easting:	2906550.634
Drain Area:	Southeast	GPS Accuracy:	Sub-Meter
Cover Shape:	Circular	Evidence of Surcharge:	No
Cover Size:	22.5	Potential for Runoff:	None
Comments:

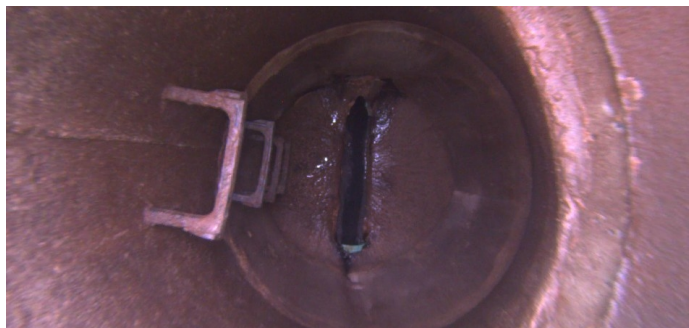
Code: **MGP**
Description: **General Photo**

Distance (ft): **.0**
Structural Grade: **0**
O&M Grade: **0**
Clock Start/From:
Clock To:
1st Value:
2nd Value:
Value Percent:
Step: **NO**
Remarks:

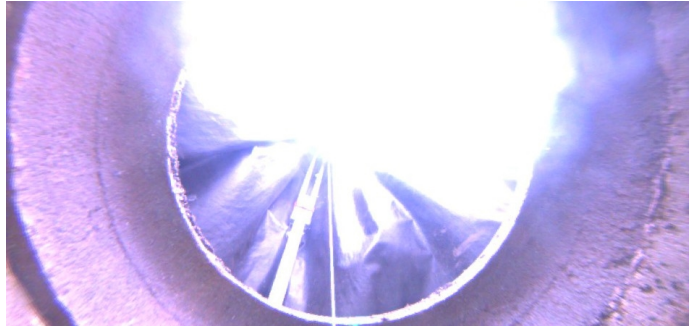
Code: **MGP**
Description: **General Photo**

Distance (ft): **2.0**
Structural Grade: **0**
O&M Grade: **0**
Clock Start/From:
Clock To:
1st Value:
2nd Value:
Value Percent:
Step: **NO**
Remarks:

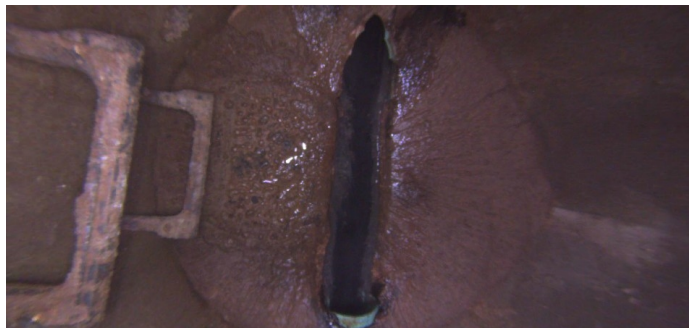
Code: **DSF**
Description: **Deposits Settled Fine**

Distance (ft): **3.5**
Structural Grade: **0**
O&M Grade: **2**
Clock Start/From: **12**
Clock To: **12**
1st Value:
2nd Value:
Value Percent: **10.000**
Step: **NO**
Remarks:

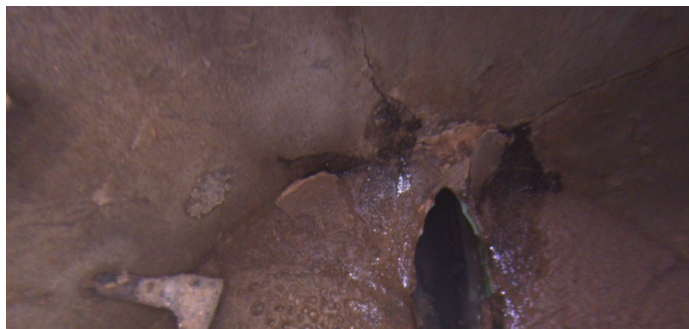
Code: **CM**
Description: **Crack Multiple**

Distance (ft): **4.4**
Structural Grade: **3**
O&M Grade: **0**
Clock Start/From: **11**
Clock To: **1**
1st Value:
2nd Value:
Value Percent:
Step: **NO**
Remarks:

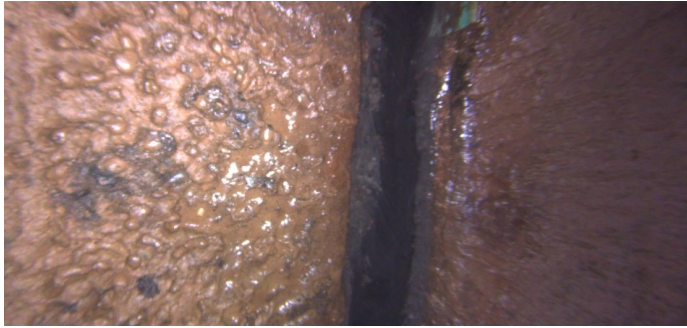
Code:	MGO
Description:	General Observation
Distance (ft):	5.4
Structural Grade:	0
O&M Grade:	0
Clock Start/From:	
Clock To:	
1st Value:	
2nd Value:	
Value Percent:	
Step:	NO
Remarks:	Ins. Comp.
