Manhole Inspection Report

Date:	04/17/2018	Weather:		Coding:	RZMACP
MH#:	M-707-028	Owner:	NA	Len. Surveyed:	4.3
P.O.#:		Surveyor:	John Kuglmaier	Rim to Invert:	4.8
Customer:		Cert. #:	U-1215-07002349	Wall Material:	Concrete (reinforced)

Street:	12th St. Between Garfield St. and Li	Project:	Hobart, IN
City:	Hobart, IN	GPS Northing:	2906717.99
Location:		GPS Easting:	2906717.99
Drain Area:	Southeast	GPS Accuracy:	Sub-Meter
Cover Shape:	Circular	Evidence of Surcharge:	No
Cover Size:	22.5	Potential for Runoff:	None
Comments:

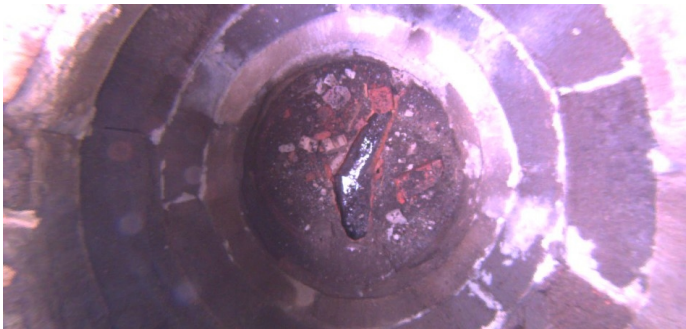
Code:	MGP
Description:	General Photo

Distance (ft):	.0
Structural Grade:	0
O&M Grade:	0
Clock Start/From:	
Clock To:	
1st Value:	
2nd Value:	
Value Percent:	
Step:	NO
Remarks:

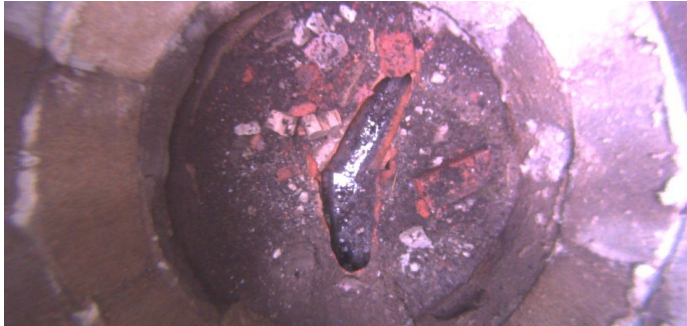
Code: **DAZ**
Description: **Deposits Attached Other**

Distance (ft): **1.6**
Structural Grade: **0**
O&M Grade: **2**
Clock Start/From: **12**
Clock To: **12**
1st Value:
2nd Value:
Value Percent: **10.000**
Step: **NO**
Remarks: **Mixed materials**

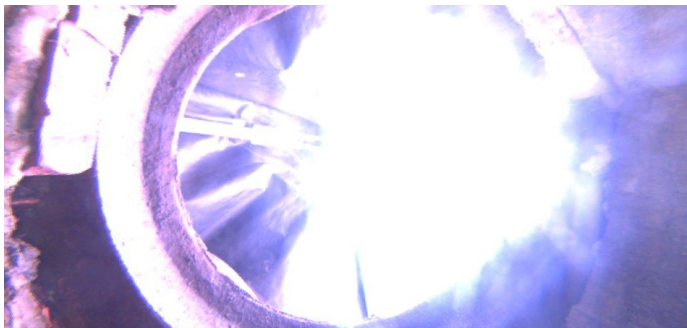
Code: **MGP**
Description: **General Photo**

Distance (ft): **2.1**
Structural Grade: **0**
O&M Grade: **0**
Clock Start/From:
Clock To:
1st Value:
2nd Value:
Value Percent:
Step: **NO**
Remarks:

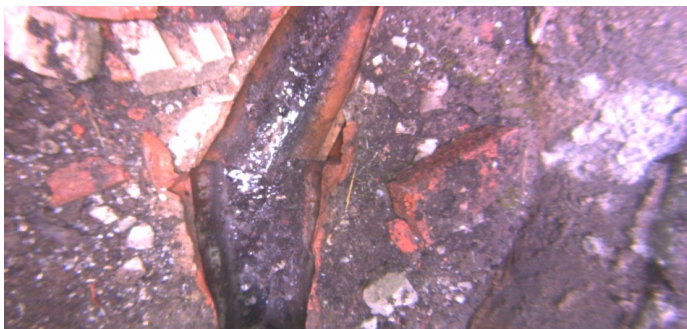
Code: **OBB**
Description: **Obstacle Brick**

Distance (ft): **3.2**
Structural Grade: **0**
O&M Grade: **2**
Clock Start/From: **3**
Clock To:
1st Value:
2nd Value:
Value Percent: **5.000**
Step: **NO**
Remarks:

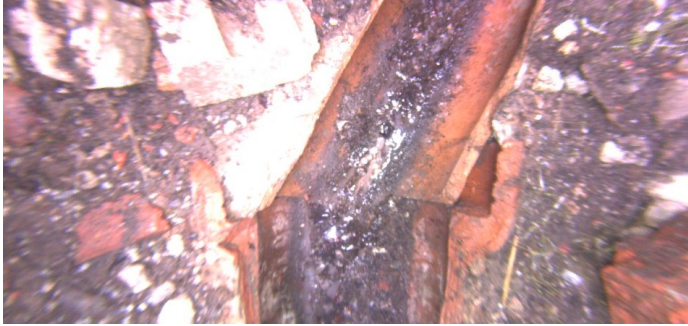
Code:	MGO
Description:	General Observation
Distance (ft):	3.8
Structural Grade:	0
O&M Grade:	0
Clock Start/From:	
Clock To:	
1st Value:	
2nd Value:	
Value Percent:	
Step:	NO
Remarks:	Ins. Comp.
