Manhole Inspection Report

Street:	Lincoln St. 232' North of 12th St.	Project:	Hobart, IN
City:	Hobart, IN	GPS Northing:	0.0
Location:		GPS Easting:	0.0
Drain Area:	Southeast	GPS Accuracy:	Nearest Meter
Cover Shape:	Circular	Evidence of Surcharge:	No
Cover Size:	22.5	Potential for Runoff:	None
Comments:

M-707-029

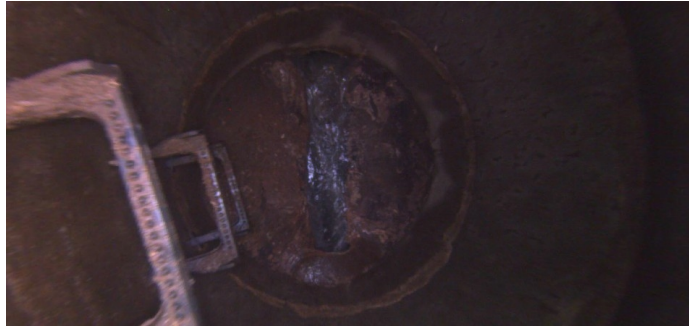
Code:	MGP
Description:	General Photo

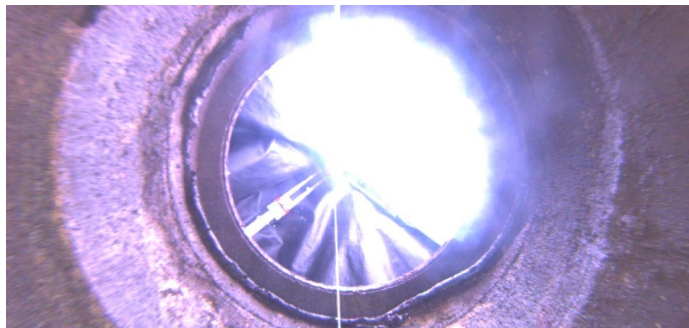
Code: **IS**
Description: **Infil Stain**

Distance (ft): **1.4**
Structural Grade: **0**
O&M Grade: **0**
Clock Start/From: **12**
Clock To: **12**
1st Value:
2nd Value:
Value Percent:
Step: **NO**
Remarks:

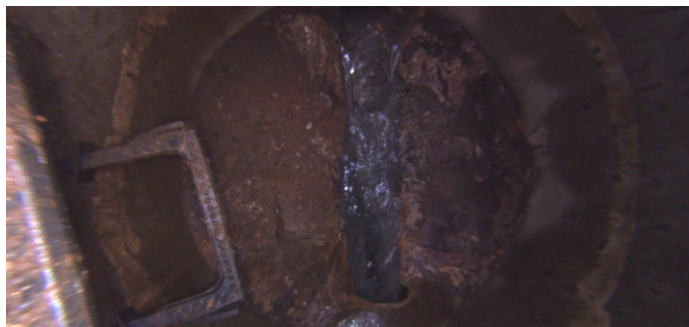
Code: **MGP**
Description: **General Photo**

Distance (ft): **2.5**
Structural Grade: **0**
O&M Grade: **0**
Clock Start/From:
Clock To:
1st Value:
2nd Value:
Value Percent:
Step: **NO**
Remarks:

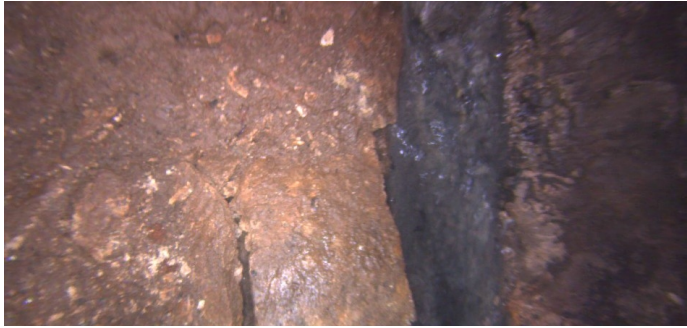
Code: **DAZ**
Description: **Deposits Attached Other**

Distance (ft): **3.3**
Structural Grade: **0**
O&M Grade: **3**
Clock Start/From: **12**
Clock To: **12**
1st Value:
2nd Value:
Value Percent: **15.000**
Step: **NO**
Remarks: **Mixed materials**
