Manhole Inspection Report

Date:	04/23/2018	Weather:		Coding:	RZMACP
MH#:	M-707-031	Owner:	NA	Len. Surveyed:	7.1
P.O.#:		Surveyor:	John Kuglmaier	Rim to Invert:	7.0
Customer:	8.7	Cert. #:	U-1215-07002349	Wall Material:	Brick

Street:	Intersection of Lincoln St. and 11th S	Project:	Hobart, IN
City:	Hobart, IN	GPS Northing:	0.0
Location:		GPS Easting:	0.0
Drain Area:	Southeast	GPS Accuracy:	Nearest Meter
Cover Shape:	Circular	Evidence of Surcharge:	No
Cover Size:	22.5	Potential for Runoff:	None
Comments:

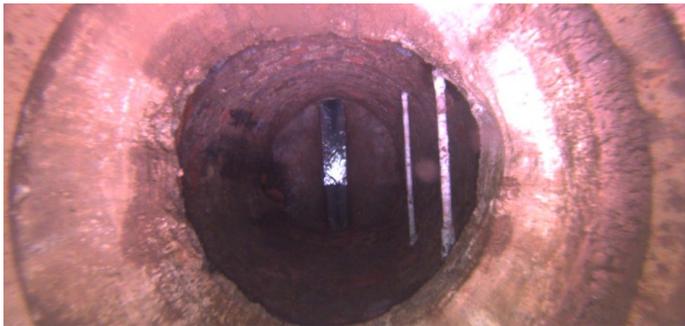
Code: **MGP**
Description: **General Photo**

Distance (ft): **.0**
Structural Grade: **0**
O&M Grade: **0**
Clock Start/From:
Clock To:
1st Value:
2nd Value:
Value Percent:
Step: **NO**
Remarks:

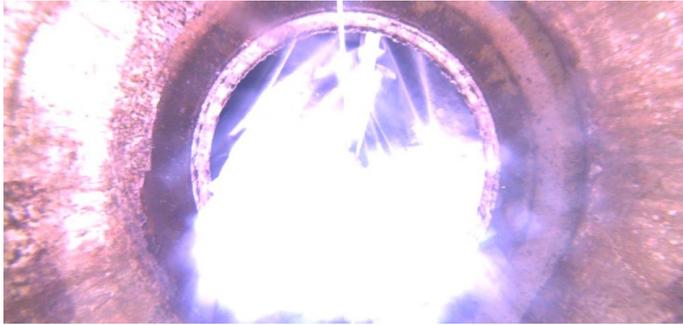
Code: **MGP**
Description: **General Photo**

Distance (ft): **2.4**
Structural Grade: **0**
O&M Grade: **0**
Clock Start/From:
Clock To:
1st Value:
2nd Value:
Value Percent:
Step: **NO**
Remarks:

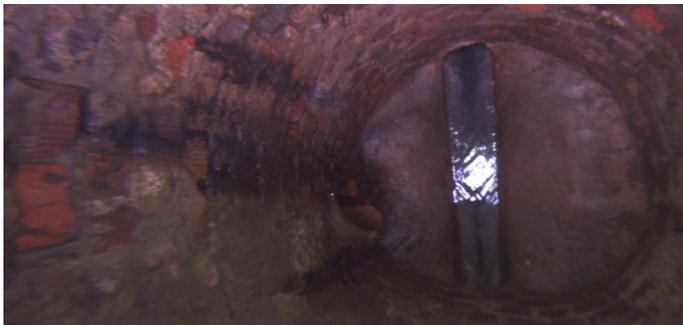
Code: **IS**
Description: **Infil Stain**

Distance (ft): **2.9**
Structural Grade: **0**
O&M Grade: **0**
Clock Start/From: **8**
Clock To: **10**
1st Value:
2nd Value:
Value Percent:
Step: **NO**
Remarks:

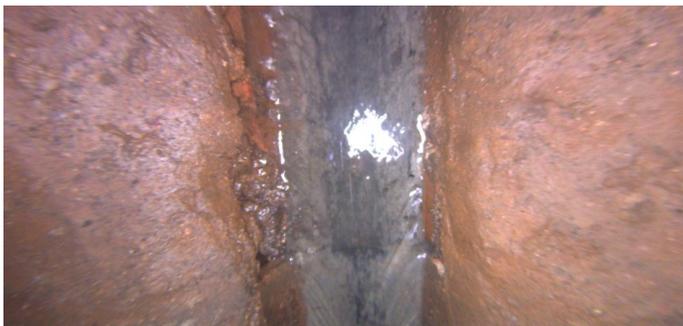
Code: **MGO**
Description: **General Observation**

Distance (ft): **6.3**
Structural Grade: **0**
O&M Grade: **0**
Clock Start/From:
Clock To:
1st Value:
2nd Value:
Value Percent:
Step: **NO**
Remarks: **Ins. Comp.**
