Manhole Inspection Report

Date:	04/18/2018	Weather:		Coding:	RZMACP
MH#:	M-707-035	Owner:	NA	Len. Surveyed:	4.9
P.O.#:		Surveyor:	John Kuglmaier	Rim to Invert:	5.2
Customer:		Cert. #:	U-1215-07002349	Wall Material:	Concrete (reinforced)

Street:	Intersection of State St. and 14th St.	Project:	Hobart, IN
City:	Hobart, IN	GPS Northing:	2906234.774
Location:		GPS Easting:	2906234.774
Drain Area:	Southeast	GPS Accuracy:	Sub-Meter
Cover Shape:	Circular	Evidence of Surcharge:	No
Cover Size:	22.5	Potential for Runoff:	None
Comments:

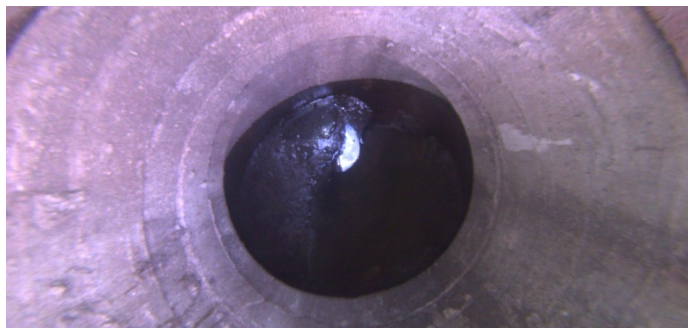
Code: **MGP**
Description: **General Photo**

Distance (ft): **.0**
Structural Grade: **0**
O&M Grade: **0**
Clock Start/From:
Clock To:
1st Value:
2nd Value:
Value Percent:
Step: **NO**
Remarks:

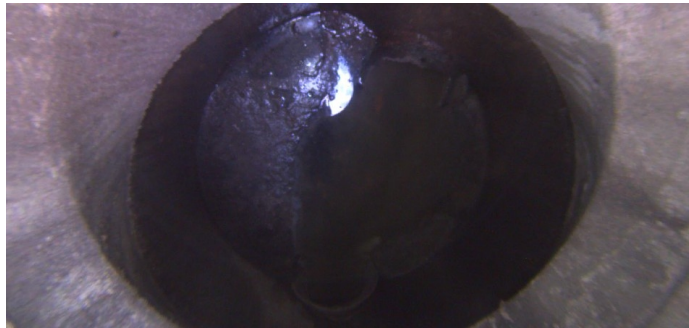
Code: **IS**
Description: **Infil Stain**

Distance (ft): **1.4**
Structural Grade: **0**
O&M Grade: **0**
Clock Start/From: **12**
Clock To: **12**
1st Value:
2nd Value:
Value Percent:
Step: **NO**
Remarks:

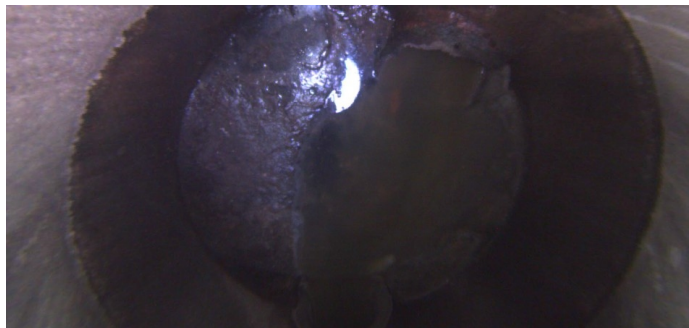
Code: **DSF**
Description: **Deposits Settled Fine**

Distance (ft): **2.0**
Structural Grade: **0**
O&M Grade: **3**
Clock Start/From: **12**
Clock To: **12**
1st Value:
2nd Value:
Value Percent: **15.000**
Step: **NO**
Remarks:

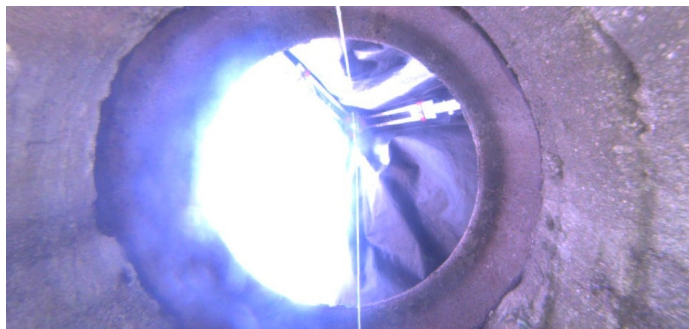
Code: **MGP**
Description: **General Photo**

Distance (ft): **2.2**
Structural Grade: **0**
O&M Grade: **0**
Clock Start/From:
Clock To:
1st Value:
2nd Value:
Value Percent:
Step: **NO**
Remarks:

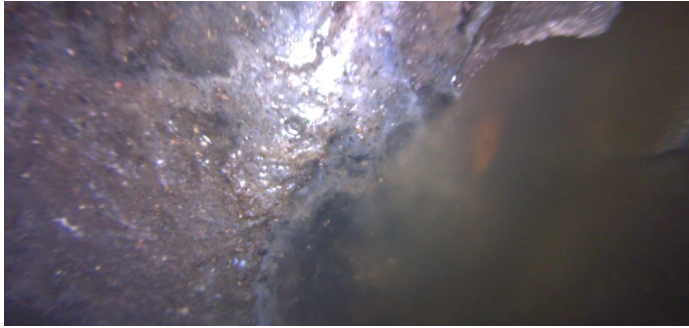
Code:	MGO
Description:	General Observation
Distance (ft):	4.0
Structural Grade:	0
O&M Grade:	0
Clock Start/From:	
Clock To:	
1st Value:	
2nd Value:	
Value Percent:	
Step:	NO
Remarks:	Ins. Comp.
