Manhole Inspection Report

Date:	04/24/2018	Weather:		Coding:	RZMACP
MH#:	M-707-040	Owner:	NA	Len. Surveyed:	8.3
P.O.#:		Surveyor:	John Kuglmaier	Rim to Invert:	8.0
Customer:	8.7	Cert. #:	U-1215-07002349	Wall Material:	Concrete (reinforced)

Street:	State St. 338' South of 10th St.	Project:	Hobart, IN
City:	Hobart, IN	GPS Northing:	0.0
Location:		GPS Easting:	0.0
Drain Area:	Southeast	GPS Accuracy:	Nearest Meter
Cover Shape:	Circular	Evidence of Surcharge:	No
Cover Size:	22.5	Potential for Runoff:	None
Comments:

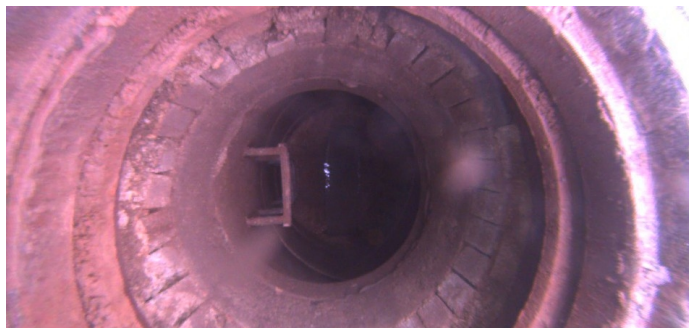
Code: **MGP**
Description: **General Photo**

Distance (ft): **.0**
Structural Grade: **0**
O&M Grade: **0**
Clock Start/From:
Clock To:
1st Value:
2nd Value:
Value Percent:
Step: **NO**
Remarks:

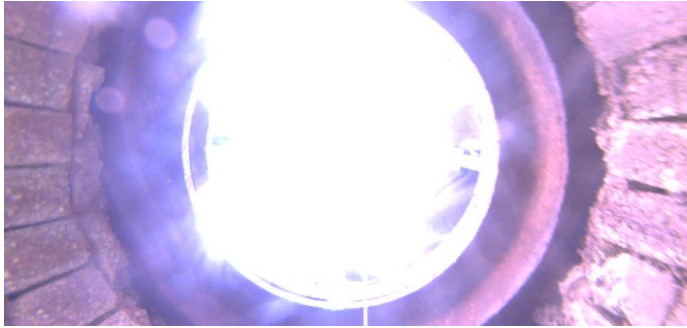
Code: **MGP**
Description: **General Photo**

Distance (ft): **2.9**
Structural Grade: **0**
O&M Grade: **0**
Clock Start/From:
Clock To:
1st Value:
2nd Value:
Value Percent:
Step: **NO**
Remarks:

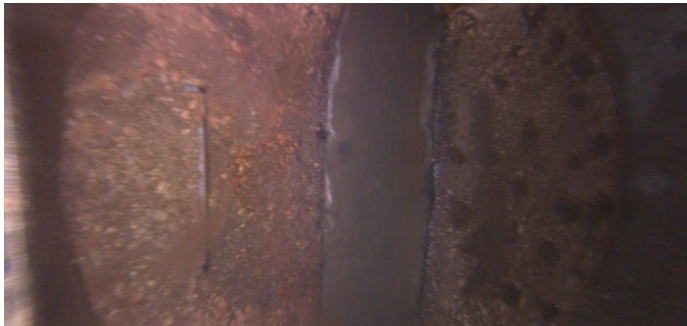
Code: **MGO**
Description: **General Observation**

Distance (ft): **7.0**
Structural Grade: **0**
O&M Grade: **0**
Clock Start/From:
Clock To:
1st Value:
2nd Value:
Value Percent:
Step: **NO**
Remarks: **Ins. Comp.**
