Manhole Inspection Report

Date:	04/16/2018	Weather:		Coding:	RZMACP
MH#:	M-707-042	Owner:	NA	Len. Surveyed:	4.8
P.O.#:		Surveyor:	John Kuglmaier	Rim to Invert:	5.0
Customer:		Cert. #:	U-1215-07002349	Wall Material:	Concrete (reinforced)

Street:	13th St. 157' West of Maple St.	Project:	Hobart, IN
City:	Hobart, IN	GPS Northing:	2905810.574
Location:		GPS Easting:	2905810.574
Drain Area:	Southeast	GPS Accuracy:	Sub-Meter
Cover Shape:	Circular	Evidence of Surcharge:	Yes
Cover Size:	29.0	Potential for Runoff:	None
Comments:

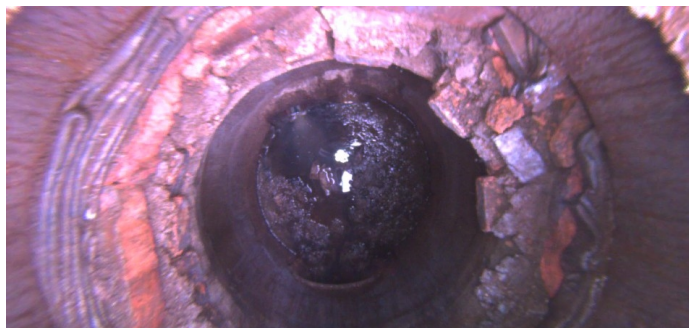
Code: **MGP**
Description: **General Photo**

Distance (ft): **.0**
Structural Grade: **0**
O&M Grade: **0**
Clock Start/From:
Clock To:
1st Value:
2nd Value:
Value Percent:
Step: **NO**
Remarks:

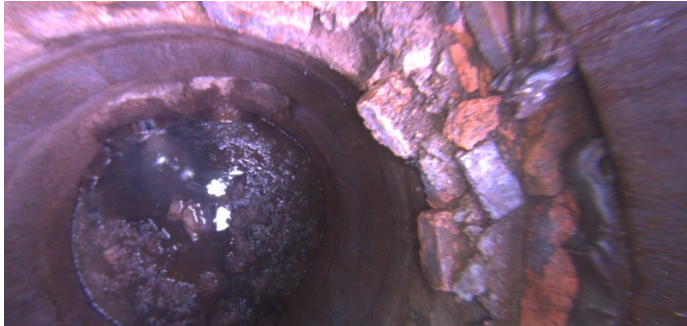
Code: **DB**
Description: **Displaced Brick**

Distance (ft): **.8**
Structural Grade: **3**
O&M Grade: **0**
Clock Start/From: **2**
Clock To: **4**
1st Value:
2nd Value:
Value Percent:
Step: **NO**
Remarks:

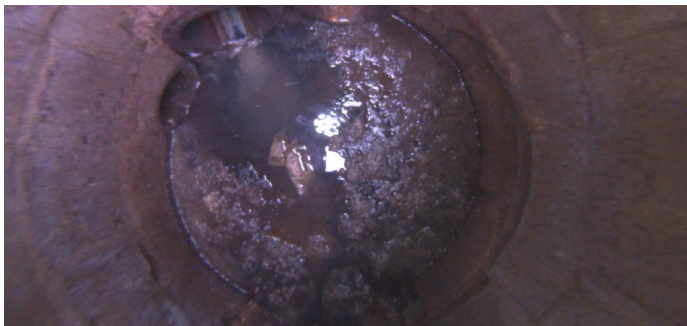
Code: **DAZ**
Description: **Deposits Attached Other**

Distance (ft): **2.4**
Structural Grade: **0**
O&M Grade: **2**
Clock Start/From: **12**
Clock To: **12**
1st Value:
2nd Value:
Value Percent: **10.000**
Step: **NO**
Remarks: **Mixed materials**

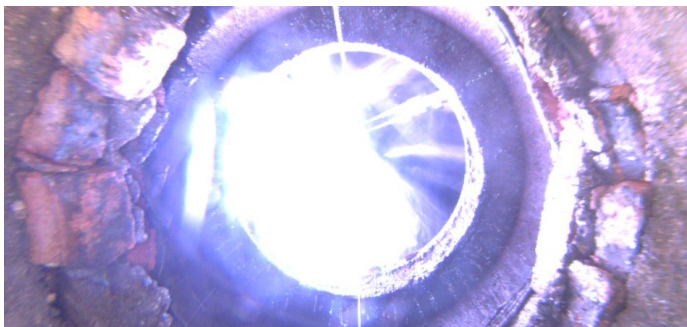
Code: **MGP**
Description: **General Photo**

Distance (ft): **2.6**
Structural Grade: **0**
O&M Grade: **0**
Clock Start/From:
Clock To:
1st Value:
2nd Value:
Value Percent:
Step: **NO**
Remarks:

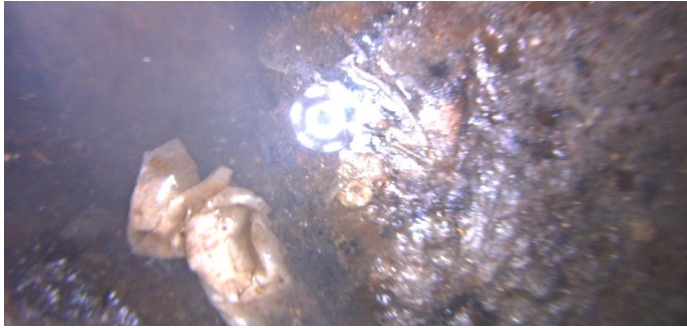
Code:	MGO
Description:	General Observation
Distance (ft):	4.3
Structural Grade:	0
O&M Grade:	0
Clock Start/From:	
Clock To:	
1st Value:	
2nd Value:	
Value Percent:	
Step:	NO
Remarks:	Ins. Comp.
