# Manhole Inspection Report

| MH#: | <b>M-707-048</b> | Owner: | <b>NA</b> | Len. Surveyed: | <b>7.3</b> |

| Street: | <b>13th Pl. 259' West of Flemming St.</b> | Project: | <b>Hobart, IN</b> |

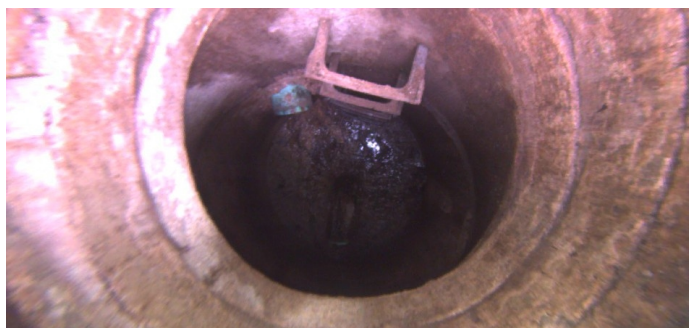
Code: **MGP**  
Description: **General Photo**

Distance (ft): **.0**  
Structural Grade: **0**  
O&M Grade: **0**  
Clock Start/From:  
Clock To:  
1st Value:  
2nd Value:  
Value Percent:  
Step: **NO**  
Remarks:

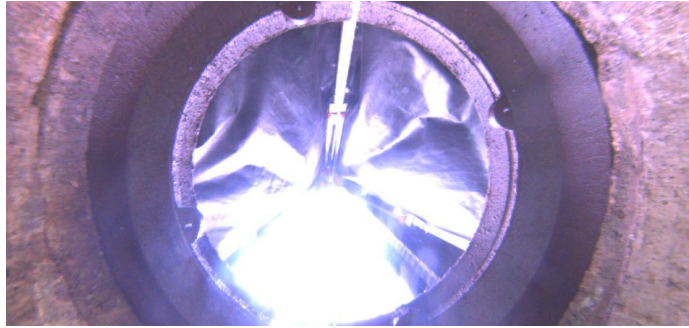
Code: **MGP**  
Description: **General Photo**

Distance (ft): **2.2**  
Structural Grade: **0**  
O&M Grade: **0**  
Clock Start/From:  
Clock To:  
1st Value:  
2nd Value:  
Value Percent:  
Step: **NO**  
Remarks:

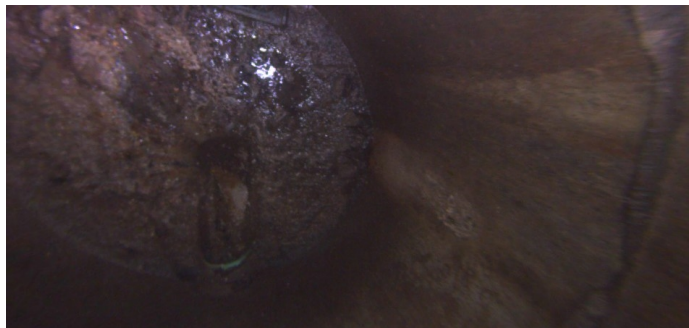
Code: **IS**  
Description: **Infil Stain**

Distance (ft): **3.8**  
Structural Grade: **0**  
O&M Grade: **0**  
Clock Start/From: **4**  
Clock To:  
1st Value:  
2nd Value:  
Value Percent:  
Step: **NO**  
Remarks:

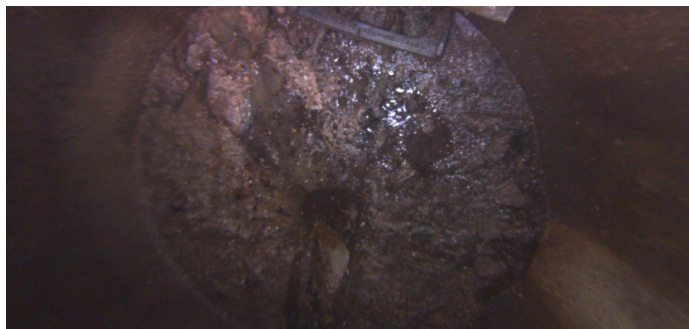
Code: **DAZ**  
Description: **Deposits Attached Other**

Distance (ft): **4.7**  
Structural Grade: **0**  
O&M Grade: **3**  
Clock Start/From: **12**  
Clock To: **12**  
1st Value:  
2nd Value:  
Value Percent: **15.000**  
Step: **NO**  
Remarks: **Mixed materials**

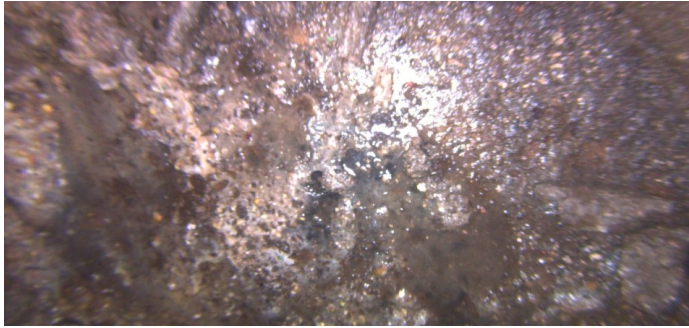
| Code: | <b>MGO</b> |
| Description: | <b>General Observation</b> |
| Distance (ft): | <b>6.4</b> |
| Remarks: | <b>Ins. Comp.</b> |
