Manhole Inspection Report

Date:	04/16/2018	Weather:		Coding:	RZMACP
MH#:	M-707-049	Owner:	NA	Len. Surveyed:	9.0
P.O.#:		Surveyor:	John Kuglmaier	Rim to Invert:	9.5
Customer:		Cert. #:	U-1215-07002349	Wall Material:	Concrete (reinforced)

Street:	Fleming St. 151' South of 13th St.	Project:	Hobart, IN
City:	Hobart, IN	GPS Northing:	2905346.323
Location:		GPS Easting:	2905346.323
Drain Area:	Southwest	GPS Accuracy:	Sub-Meter
Cover Shape:	Circular	Evidence of Surcharge:	No
Cover Size:	29.0	Potential for Runoff:	None
Comments:

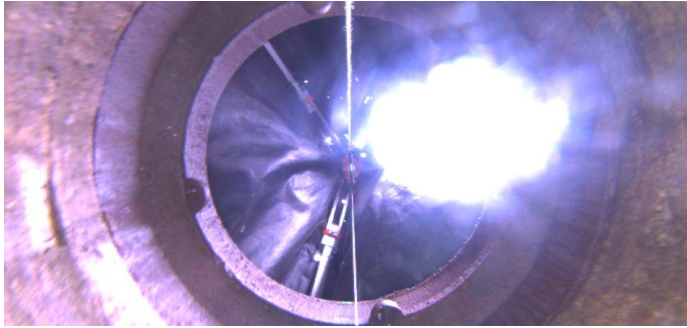
Code: **MGP**
Description: **General Photo**

Distance (ft): **2.2**
Structural Grade: **0**
O&M Grade: **0**
Clock Start/From:
Clock To:
1st Value:
2nd Value:
Value Percent:
Step: **NO**
Remarks:

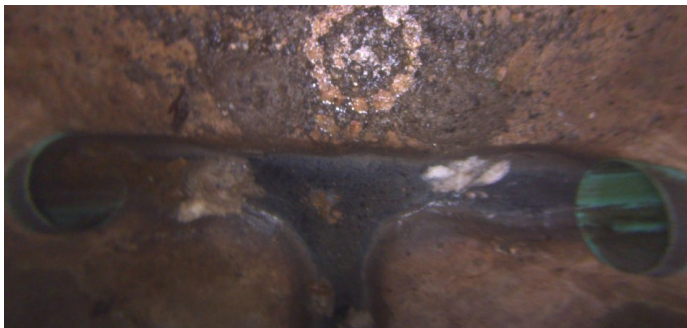
Code: **MGO**
Description: **General Observation**

Distance (ft): **7.8**
Structural Grade: **0**
O&M Grade: **0**
Clock Start/From:
Clock To:
1st Value:
2nd Value:
Value Percent:
Step: **NO**
Remarks: **Ins. Comp.**
