# Manhole Inspection Report

Date:	<b>04/17/2018</b>	Weather:		Coding:	<b>RZMACP</b>
MH#:	<b>M-707-050</b>	Owner:	<b>NA</b>	Len. Surveyed:	<b>9.6</b>
P.O.#:		Surveyor:	<b>John Kuglmaier</b>	Rim to Invert:	<b>9.9</b>
Customer:		Cert. #:	<b>U-1215-07002349</b>	Wall Material:	<b>Concrete (reinforced)</b>

Street:	<b>North of 13th Pl. 267' West of Flem</b>	Project:	<b>Hobart, IN</b>
City:	<b>Hobart, IN</b>	GPS Northing:	<b>2905076.323</b>
Location:		GPS Easting:	<b>2905076.323</b>
Drain Area:	<b>Southwest</b>	GPS Accuracy:	<b>Sub-Meter</b>
Cover Shape:	<b>Circular</b>	Evidence of Surcharge:	<b>No</b>
Cover Size:	<b>22.5</b>	Potential for Runoff:	<b>None</b>
Comments:

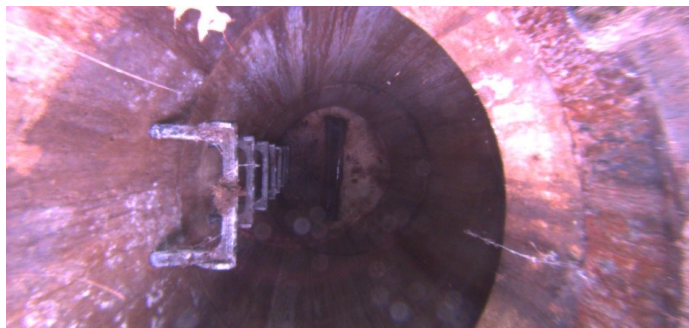
Code: **MGP**  
Description: **General Photo**

Distance (ft): **.0**  
Structural Grade: **0**  
O&M Grade: **0**  
Clock Start/From:  
Clock To:  
1st Value:  
2nd Value:  
Value Percent:  
Step: **NO**  
Remarks:

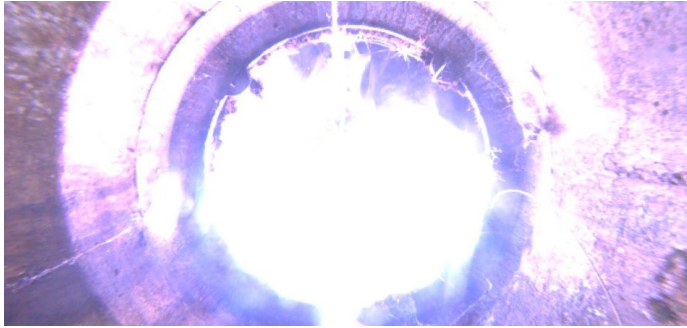
Code: **MGP**  
Description: **General Photo**

Distance (ft): **2.3**  
Structural Grade: **0**  
O&M Grade: **0**  
Clock Start/From:  
Clock To:  
1st Value:  
2nd Value:  
Value Percent:  
Step: **NO**  
Remarks:

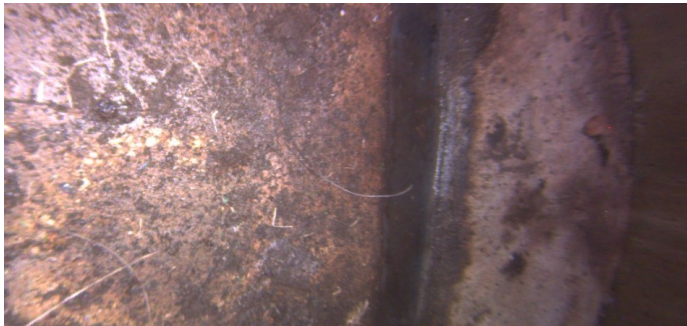
Code: **MGO**  
Description: **General Observation**

Distance (ft): **9.0**  
Structural Grade: **0**  
O&M Grade: **0**  
Clock Start/From:  
Clock To:  
1st Value:  
2nd Value:  
Value Percent:  
Step: **NO**  
Remarks: **Ins. Comp.**
