# Manhole Inspection Report

Date:	04/17/2018	Weather:		Coding:	RZMACP
MH#:	M-707-051	Owner:	NA	Len. Surveyed:	10.2
P.O.#:		Surveyor:	John Kuglmaier	Rim to Invert:	10.5
Customer:		Cert. #:	U-1215-07002349	Wall Material:	Concrete (reinforced)

Street:	North of 13th Pl. 161' East of Lake P	Project:	Hobart, IN
City:	Hobart, IN	GPS Northing:	2904814.242
Location:		GPS Easting:	2904814.242
Drain Area:	Southwest	GPS Accuracy:	Sub-Meter
Cover Shape:	Circular	Evidence of Surcharge:	No
Cover Size:	22.5	Potential for Runoff:	None
Comments:

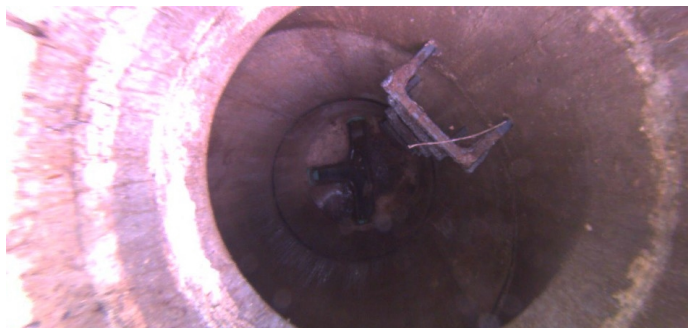
Code: **MGP**  
Description: **General Photo**

Distance (ft): **.0**  
Structural Grade: **0**  
O&M Grade: **0**  
Clock Start/From:  
Clock To:  
1st Value:  
2nd Value:  
Value Percent:  
Step: **NO**  
Remarks:

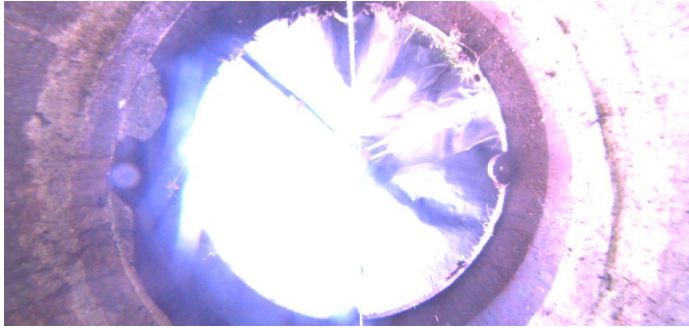
Code: **MGP**  
Description: **General Photo**

Distance (ft): **2.1**  
Structural Grade: **0**  
O&M Grade: **0**  
Clock Start/From:  
Clock To:  
1st Value:  
2nd Value:  
Value Percent:  
Step: **NO**  
Remarks:

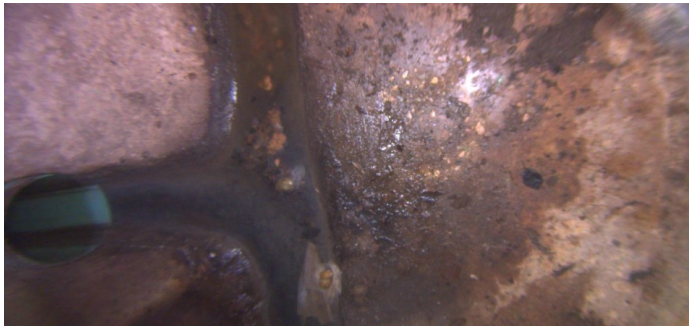
Code: **MGO**  
Description: **General Observation**

Distance (ft): **9.0**  
Structural Grade: **0**  
O&M Grade: **0**  
Clock Start/From:  
Clock To:  
1st Value:  
2nd Value:  
Value Percent:  
Step: **NO**  
Remarks: **Ins. Comp.**
