Manhole Inspection Report

Date:	04/17/2018	Weather:		Coding:	RZMACP
MH#:	M-707-052	Owner:	NA	Len. Surveyed:	11.3
P.O.#:		Surveyor:	John Kuglmaier	Rim to Invert:	11.5
Customer:		Cert. #:	U-1215-07002349	Wall Material:	Concrete (reinforced)

Street:	13th St. 160' East of Lake Park Ave.	Project:	Hobart, IN
City:	Hobart, IN	GPS Northing:	2904807.946
Location:		GPS Easting:	2904807.946
Drain Area:	Southwest	GPS Accuracy:	Sub-Meter
Cover Shape:	Circular	Evidence of Surcharge:	No
Cover Size:	22.5	Potential for Runoff:	None
Comments:

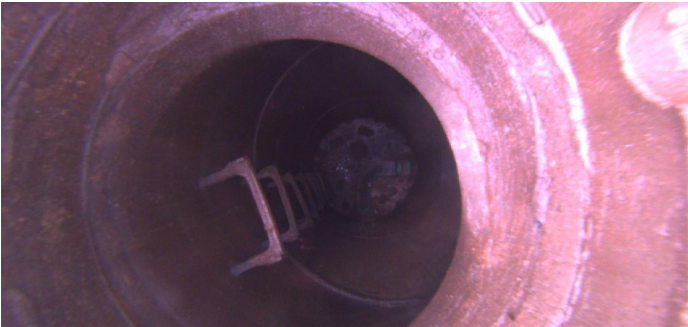
Code:

Description:

MGP

General Photo

Distance (ft):

.0

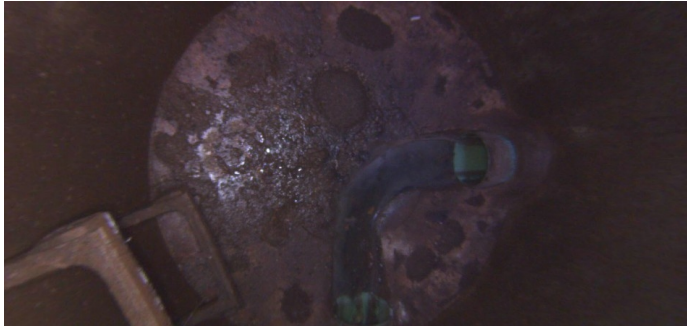
Code:	DSF
Description:	Deposits Settled Fine
Distance (ft):	8.6
Structural Grade:	0
O&M Grade:	2
Clock Start/From:	12
Clock To:	12
1st Value:	
2nd Value:	
Value Percent:	5.000
Step:	NO
Remarks:

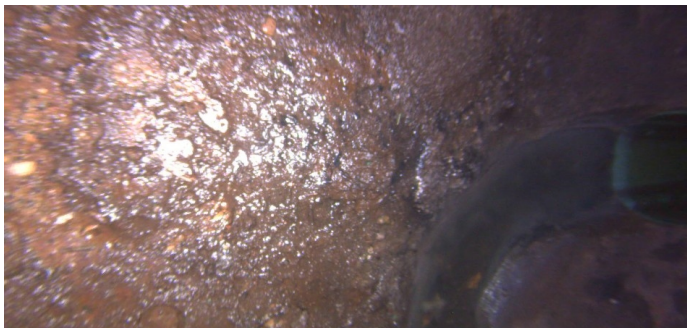
Code:	MGO
Description:	General Observation
Distance (ft):	10.8
Structural Grade:	0
O&M Grade:	0
Clock Start/From:	
Clock To:	
1st Value:	
2nd Value:	
Value Percent:	
Step:	NO
Remarks:	Ins. Comp.
