Manhole Inspection Report

Date:	04/06/2018	Weather:		Coding:	RZMACP
MH#:	M-707-053	Owner:	NA	Len. Surveyed:	12.0
P.O.#:		Surveyor:	John Kuglmaier	Rim to Invert:	12.1
Customer:		Cert. #:	U-1215-07002349	Wall Material:	Concrete (reinforced)

Street:	Intersection of 13th St. and Lake Par	Project:	Hobart, IN
City:	Hobart, IN	GPS Northing:	0.0
Location:		GPS Easting:	0.0
Drain Area:	Southwest	GPS Accuracy:	Nearest Meter
Cover Shape:	Circular	Evidence of Surcharge:	No
Cover Size:	22.5	Potential for Runoff:	None
Comments:

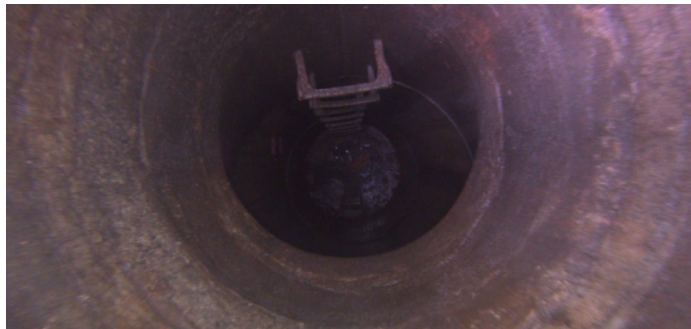
Code: **MGP**
Description: **General Photo**

Distance (ft): **.0**
Structural Grade: **0**
O&M Grade: **0**
Clock Start/From:
Clock To:
1st Value:
2nd Value:
Value Percent:
Step: **NO**
Remarks:

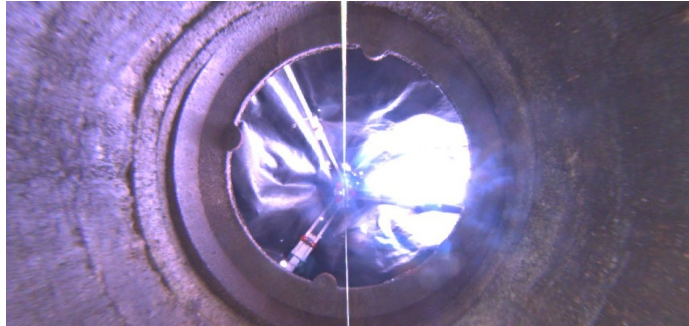
Code: **MGP**
Description: **General Photo**

Distance (ft): **2.6**
Structural Grade: **0**
O&M Grade: **0**
Clock Start/From:
Clock To:
1st Value:
2nd Value:
Value Percent:
Step: **NO**
Remarks:

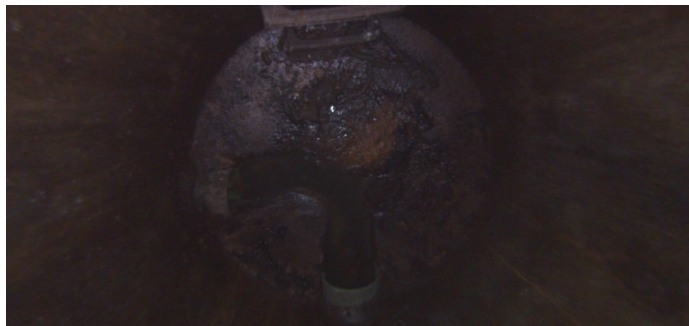
Code: **DAZ**
Description: **Deposits Attached Other**

Distance (ft): **8.3**
Structural Grade: **0**
O&M Grade: **2**
Clock Start/From: **12**
Clock To: **12**
1st Value:
2nd Value:
Value Percent: **10.000**
Step: **NO**
Remarks: **Mixed materials**

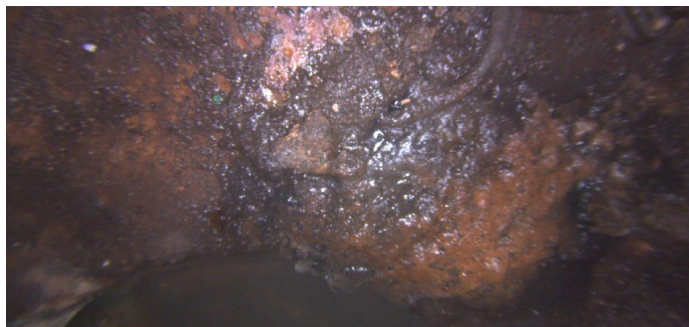
Code: **MGO**
Description: **General Observation**

Distance (ft): **10.9**
Structural Grade: **0**
O&M Grade: **0**
Clock Start/From:
Clock To:
1st Value:
2nd Value:
Value Percent:
Step: **NO**
Remarks: **Ins. Comp.**
