Manhole Inspection Report

Date:	04/17/2018	Weather:		Coding:	RZMACP
MH#:	M-707-054	Owner:	NA	Len. Surveyed:	6.7
P.O.#:		Surveyor:	John Kuglmaier	Rim to Invert:	7.1
Customer:		Cert. #:	U-1215-07002349	Wall Material:	Concrete (reinforced)

Street:	13th St. 270' West of Flemming St.	Project:	Hobart, IN
City:	Hobart, IN	GPS Northing:	2905070.601
Location:		GPS Easting:	2905070.601
Drain Area:	Southwest	GPS Accuracy:	Sub-Meter
Cover Shape:	Circular	Evidence of Surcharge:	No
Cover Size:	22.5	Potential for Runoff:	None
Comments:

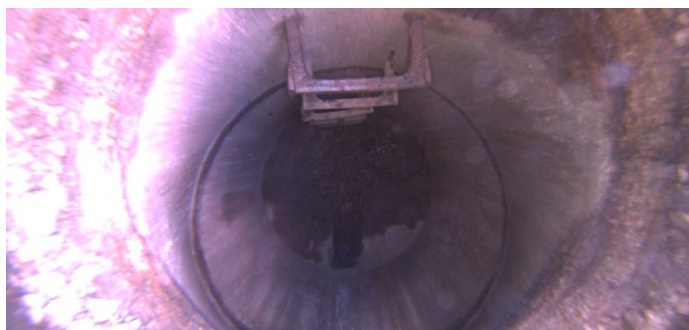
Code: **MGP**
Description: **General Photo**

Distance (ft): **.0**
Structural Grade: **0**
O&M Grade: **0**
Clock Start/From:
Clock To:
1st Value:
2nd Value:
Value Percent:
Step: **NO**
Remarks:

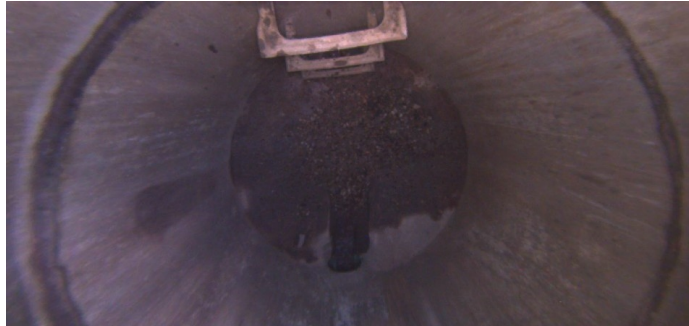
Code: **IS**
Description: **Infil Stain**

Distance (ft): **2.2**
Structural Grade: **0**
O&M Grade: **0**
Clock Start/From: **8**
Clock To:
1st Value:
2nd Value:
Value Percent:
Step: **NO**
Remarks:

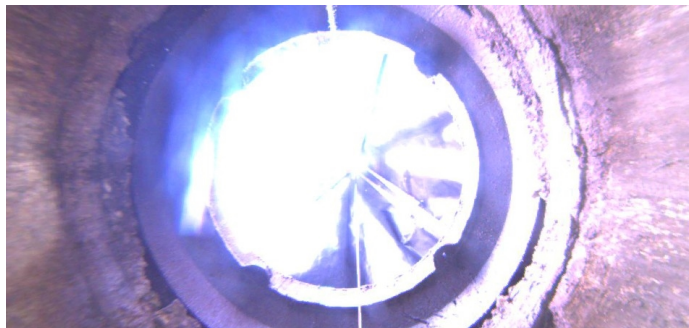
Code: **MGP**
Description: **General Photo**

Distance (ft): **2.6**
Structural Grade: **0**
O&M Grade: **0**
Clock Start/From:
Clock To:
1st Value:
2nd Value:
Value Percent:
Step: **NO**
Remarks:

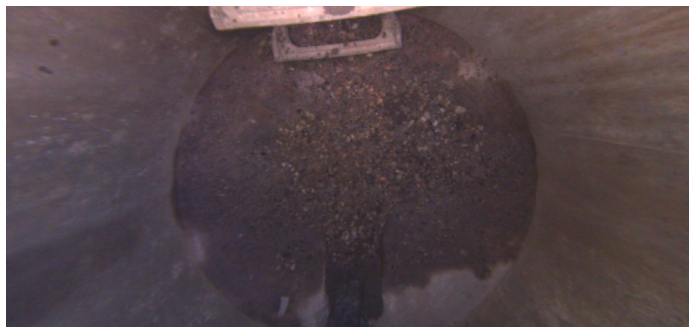
Code: **DSGV**
Description: **Deposits Settled Gravel**

Distance (ft): **3.8**
Structural Grade: **0**
O&M Grade: **2**
Clock Start/From: **12**
Clock To: **12**
1st Value:
2nd Value:
Value Percent: **10.000**
Step: **NO**
Remarks:

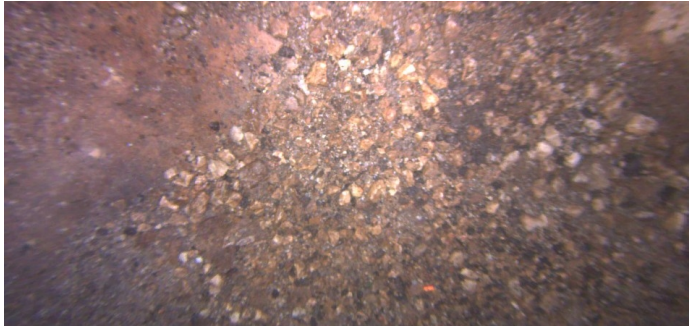
Code:	MGO
Description:	General Observation
Distance (ft):	6.0
Structural Grade:	0
O&M Grade:	0
Clock Start/From:	
Clock To:	
1st Value:	
2nd Value:	
Value Percent:	
Step:	NO
Remarks:	Ins. Comp.
