Manhole Inspection Report

Date:	04/17/2018	Weather:		Coding:	RZMACP
MH#:	M-707-055	Owner:	NA	Len. Surveyed:	8.4
P.O.#:		Surveyor:	John Kuglmaier	Rim to Invert:	6.6
Customer:		Cert. #:	U-1215-07002349	Wall Material:	Concrete (reinforced)

Street:	Intersection of 13th St. and Flemmin	Project:	Hobart, IN
City:	Hobart, IN	GPS Northing:	2905341.261
Location:		GPS Easting:	2905341.261
Drain Area:	Southwest	GPS Accuracy:	Sub-Meter
Cover Shape:	Circular	Evidence of Surcharge:	No
Cover Size:	22.5	Potential for Runoff:	None
Comments:

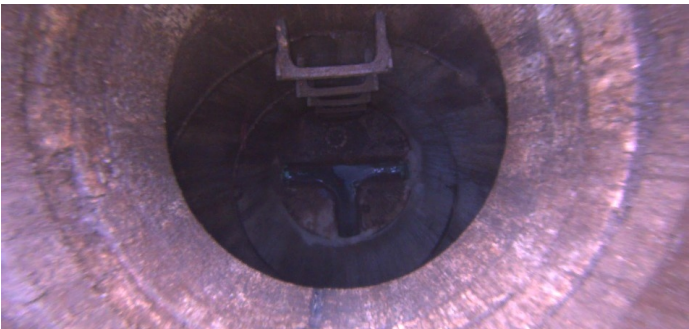
Code: **MGP**
Description: **General Photo**

Distance (ft): **.0**
Structural Grade: **0**
O&M Grade: **0**
Clock Start/From:
Clock To:
1st Value:
2nd Value:
Value Percent:
Step: **NO**
Remarks:

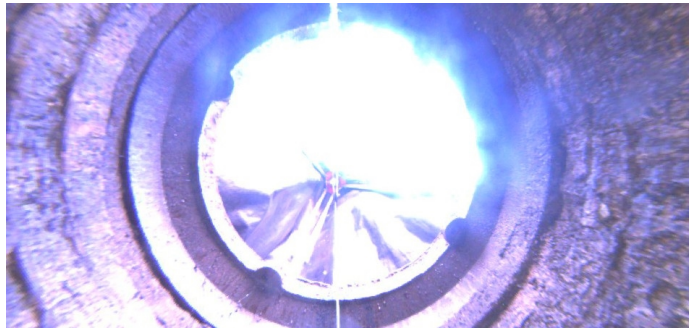
Code: **MGP**
Description: **General Photo**

Distance (ft): **2.6**
Structural Grade: **0**
O&M Grade: **0**
Clock Start/From:
Clock To:
1st Value:
2nd Value:
Value Percent:
Step: **NO**
Remarks:

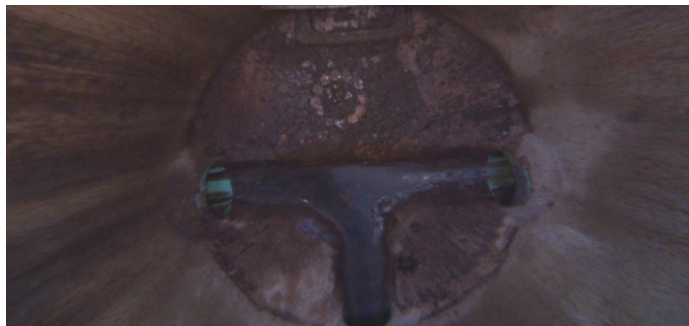
Code: **DSF**
Description: **Deposits Settled Fine**

Distance (ft): **5.3**
Structural Grade: **0**
O&M Grade: **2**
Clock Start/From: **12**
Clock To: **12**
1st Value:
2nd Value:
Value Percent: **5.000**
Step: **NO**
Remarks:

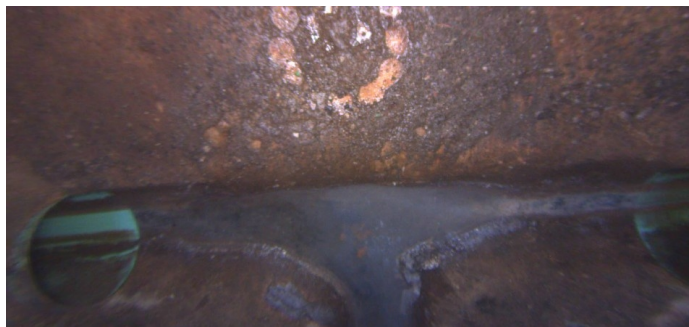
Code: **MGO**
Description: **General Observation**

Distance (ft): **7.4**
Structural Grade: **0**
O&M Grade: **0**
Clock Start/From:
Clock To:
1st Value:
2nd Value:
Value Percent:
Step: **NO**
Remarks: **Ins. Comp.**
