Manhole Inspection Report

Date:	04/17/2018	Weather:		Coding:	RZMACP
MH#:	M-707-059	Owner:	NA	Len. Surveyed:	9.5
P.O.#:		Surveyor:	John Kuglmaier	Rim to Invert:	9.7
Customer:		Cert. #:	U-1215-07002349	Wall Material:	Concrete (reinforced)

Street:	12th St. 629' East of Lake Park Ave.	Project:	Hobart, IN
City:	Hobart, IN	GPS Northing:	2905273.911
Location:		GPS Easting:	2905273.911
Drain Area:	Southwest	GPS Accuracy:	Sub-Meter
Cover Shape:	Circular	Evidence of Surcharge:	No
Cover Size:	22.5	Potential for Runoff:	None
Comments:

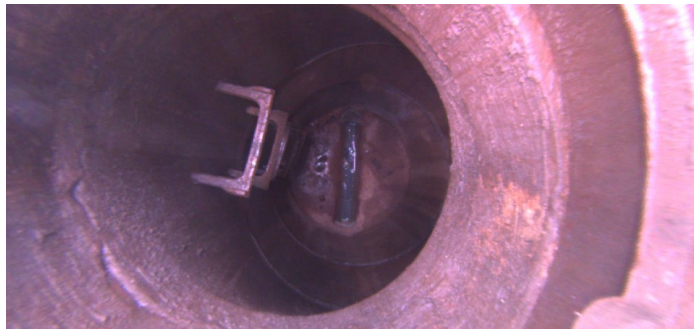
Code: **MGP**
 Description: **General Photo**

Distance (ft): **.0**
 Structural Grade: **0**
 O&M Grade: **0**
 Clock Start/From:
 Clock To:
 1st Value:
 2nd Value:
 Value Percent:
 Step: **NO**
 Remarks:

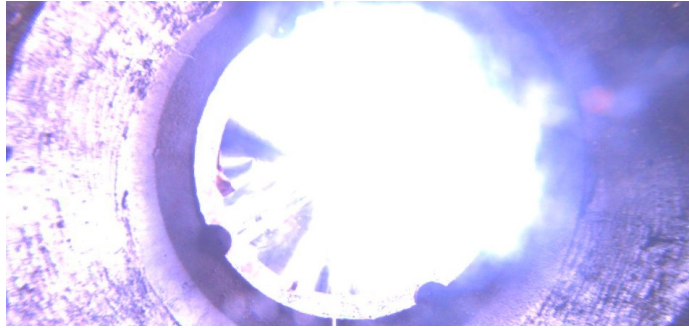
Code: **MGP**
Description: **General Photo**

Distance (ft): **2.6**
Structural Grade: **0**
O&M Grade: **0**
Clock Start/From:
Clock To:
1st Value:
2nd Value:
Value Percent:
Step: **NO**
Remarks:

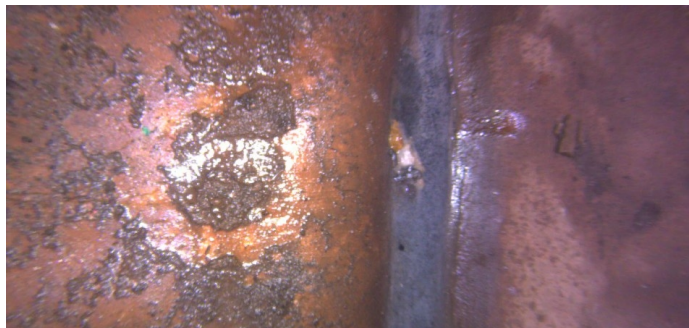
Code: **MGO**
Description: **General Observation**

Distance (ft): **8.7**
Structural Grade: **0**
O&M Grade: **0**
Clock Start/From:
Clock To:
1st Value:
2nd Value:
Value Percent:
Step: **NO**
Remarks: **Ins. comp.**
