Manhole Inspection Report

Date:	04/06/2018	Weather:		Coding:	RZMACP
MH#:	M-707-061	Owner:	NA	Len. Surveyed:	9.8
P.O.#:		Surveyor:	John Kuglmaier	Rim to Invert:	10.5
Customer:		Cert. #:	U-1215-07002349	Wall Material:	Concrete (reinforced)

Street:	Intersection of Lake Park Ave. and 1	Project:	Hobart, IN
City:	Hobart, IN	GPS Northing:	0.0
Location:		GPS Easting:	0.0
Drain Area:	Southwest	GPS Accuracy:	Nearest Meter
Cover Shape:	Circular	Evidence of Surcharge:	No
Cover Size:	22.5	Potential for Runoff:	None
Comments:

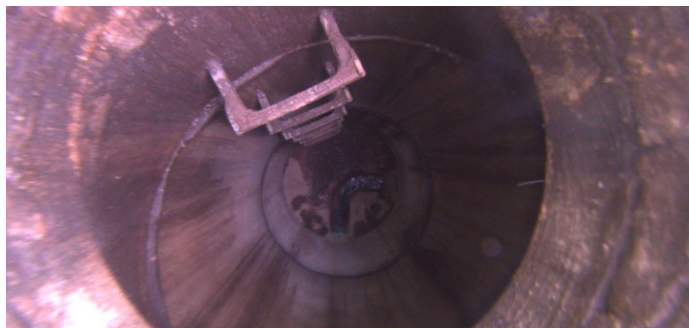
Code: **MGP**
Description: **General Photo**

Distance (ft): **.0**
Structural Grade: **0**
O&M Grade: **0**
Clock Start/From:
Clock To:
1st Value:
2nd Value:
Value Percent:
Step: **NO**
Remarks:

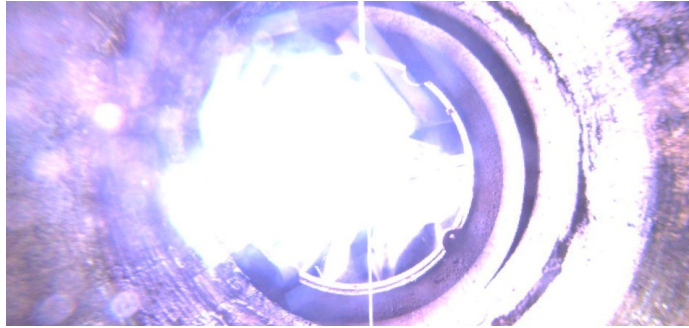
Code:	MGP
Description:	General Photo
Distance (ft):	2.6
Structural Grade:	0
O&M Grade:	0
Clock Start/From:	
Clock To:	
1st Value:	
2nd Value:	
Value Percent:	
Step:	NO
Remarks:

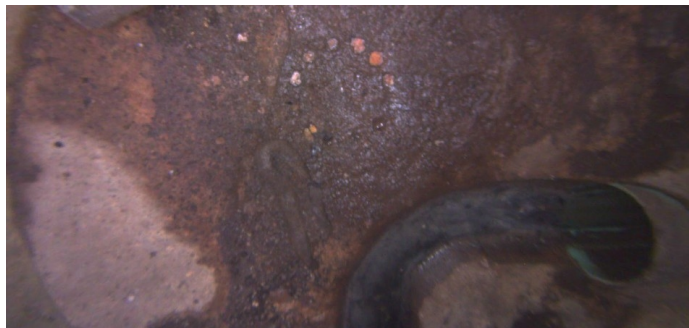
Code:	MGO
Description:	General Observation
Distance (ft):	8.5
Structural Grade:	0
O&M Grade:	0
Clock Start/From:	
Clock To:	
1st Value:	
2nd Value:	
Value Percent:	
Step:	NO
Remarks:	Ins. Comp.
